AIRPROX REPORT No 2018140

Date: 17 Jun 2018 Time: 1508Z Position: 5052N 00313W Location: Dunkeswell – elev 839ft

PART A: SUMMARY OF INFORMATION REPORTED TO UKAB

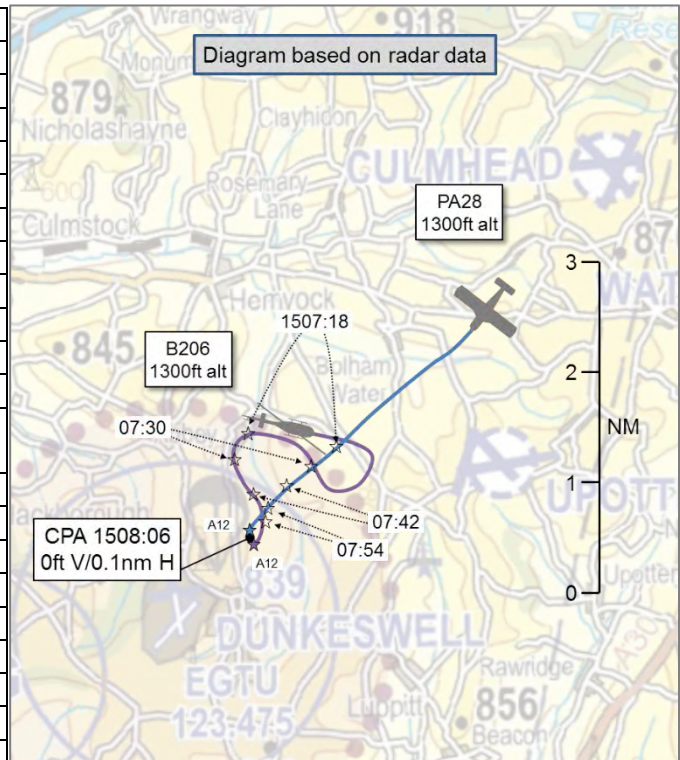
An Airprox was reported when a PA28 and a B206 flew into proximity in the Dunkeswell visual circuit at 1508hrs on Sunday 17th June 2018. Both pilots were operating under VFR in VMC, both in receipt of an Air Ground Communication Service from Dunkeswell Radio.

Members first discussed the relative situations of the two aircraft and noted that both pilots appeared to be operating in marginal VFR conditions. The B206 pilot was conducting pleasure flights in the immediate vicinity of Dunkeswell and so would have needed to be particularly sensitive to other traffic joining and intending to land. In this respect, members noted that the helicopter ground track did not conform to that expected of a left-hand circuit to RW22, although it might conceivably be construed as 'joining from the north not above 500ft' as detailed in the Dunkeswell AIP entry. Notwithstanding, the Board opined that the B206 pilot would have been better placed in remaining clear of the circuit pattern (and especially the finals track) until established on left-base for RW22, especially given the prevailing marginal weather conditions.

Turning to the cause and risk, the Board noted that the B206 pilot had not reported at what stage he became visual with the PA28 other than to state that he heard the PA28 pilot call final 'as they came through the clouds', which some members thought implied that he may have been visual with the PA28 at that point. On the other hand, other members noted that the B206 was not in the promulgated left-hand circuit for RW22, and that because he had crossed in front of the PA28 in close proximity from a 'right-base' position as he turned final himself, he had probably not seen the PA28. The PA28 front-seat passenger had said he saw the helicopter in the right 2 o'clock position, which would correspond to approximately 35sec before CPA. The two aircraft had then closed to 0.1nm lateral separation at the same level before the PA28 pilot orbited right to increase separation. Unable to definitively determine who called finals when, or who saw whom or when, the Board felt that the cause was probably best described as a conflict in the visual circuit resolved by the PA28 pilot. Turning to the risk, the Board agreed that the circumstances, actions and separation pertaining at the time indicated that safety had been much reduced below the norm. The Board expressed their regret that the Dunkeswell A/G Operator had not responded to the request for a narrative report, which could have done much to inform the Board in these respects.

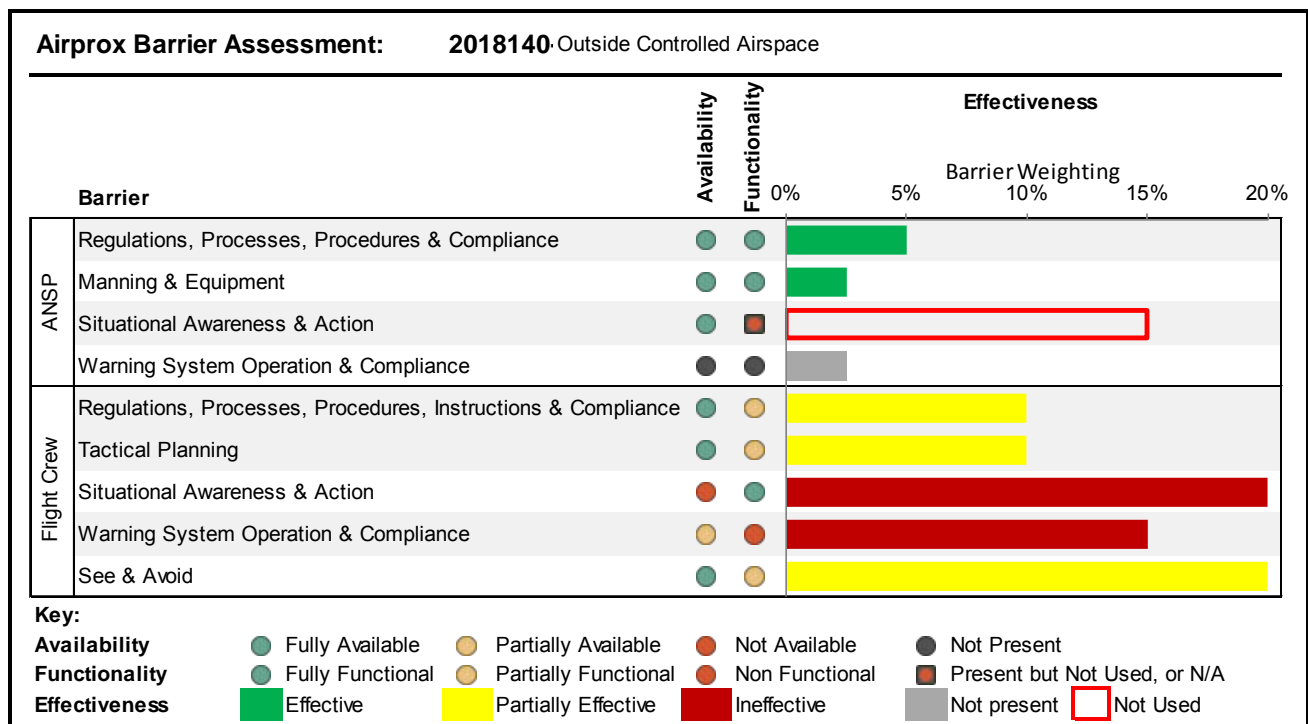
In assessing the effectiveness of the safety barriers associated with this incident, the Board concluded that the key factors had been that:

Situational Awareness and Action were assessed as **not used** because the AGCS Operator apparently did not provide information on traffic (and was not required to do so).

Regulations, Processes, Procedures, Instructions and Compliance were assessed as **partially effective** because the PA28 pilot conducted a straight-in approach and the B206 pilot was manoeuvring across the final approach path from a right-base location; both of which were ambiguous within the AIP.

Tactical Planning was assessed as **partially effective** because neither pilot fully followed notified or established procedures.

Situational Awareness and Action were assessed as **ineffective** because neither pilot was aware of the proximity of the other until visually sighted.

Warning System Operation and Compliance were assessed as **ineffective** because the B206 TAS did not alert on the approaching PA28.

See and Avoid were assessed as **partially effective** because the PA28 pilot only saw the B206 at a late stage, and the Board could not determine when the B206 pilot saw the PA28 other than to say that it did not appear to be at a timely point.
