## AIRPROX REPORT No 2018141

Date: 17 Jun 2018 Time: 1059Z Position: 5517N 00142W Location: Eshott Airfield

### PART A: SUMMARY OF INFORMATION REPORTED TO UKAB

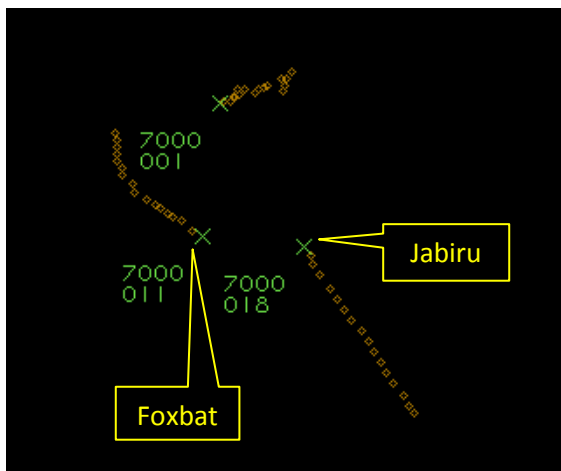
Figure 1: 1056:07

The following screenshots were taken from the NATS radars. At Figure 1, the Jabiru is joining the circuit from the south; two aircraft appear to be in the circuit, the Foxbat is crosswind and another aircraft is on finals. By 1058:11, Figure 2, the Foxbat is turning onto base and the Jabiru is turning crosswind. At 1059:42 (Figure 3), the Foxbat is on finals and the Jabiru is turning base. Shortly afterwards, the Foxbat disappears from radar cover, but the Jabiru can be seen at 400ft on finals.

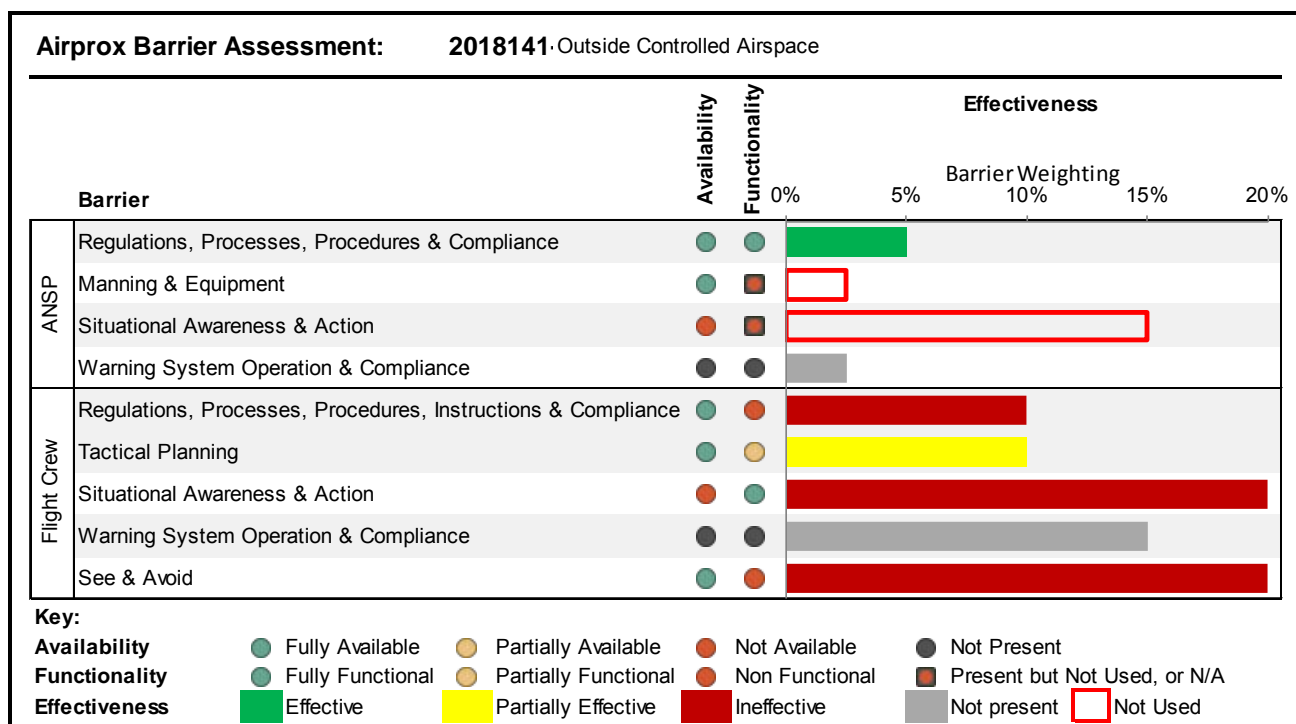
In assessing the effectiveness of the safety barriers associated with this incident, the Board concluded that the key factors had been that:

**Manning and Equipment** were assessed as **not used** because although Eshott sometimes provides AGCS at the time of the Airprox the radio was not being manned at the time.

**Situational Awareness and Action** were assessed as **not used** because there was no-one available to provide situational awareness to the pilots.

**Regulations, Processes, Procedures, Instructions and Compliance** were assessed as **ineffective** because the Jabiru pilot did not integrate with the Foxbat in the visual circuit.

**Tactical Planning** was assessed as **partially effective** because the Jabiru pilot flew a non-standard, tight visual circuit which likely sapped his capacity to also lookout effectively.

**Situational Awareness and Action** were assessed as **ineffective** because the Jabiru pilot was not aware of the Foxbat in the circuit.

**Warning System Operation and Compliance** were assessed as **not present** because neither aircraft was fitted with a CWS.

**See and Avoid** were assessed as **ineffective** because the Jabiru pilot did not see the Foxbat, and the Foxbat pilot could only take emergency action after CPA.
