**AIRPROX REPORT No 2018187**

Date: 18 Jul 2018 Time: 1831Z Position: 5150N 00040E Location: ivo Rivenhall

**PART A: SUMMARY OF INFORMATION REPORTED TO UKAB**

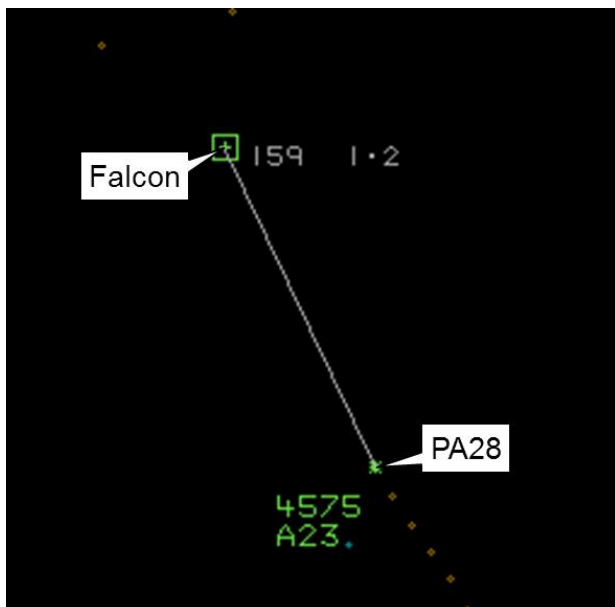
Figure 1 - 1830:34

At 1821:50 the PA28 pilot agreed a Basic Service was with the Southend Radar controller. At 1830:34 (Figure 1), the Falcon primary contact first appeared on area radar replay, 1.2nm north-northwest of the PA28.

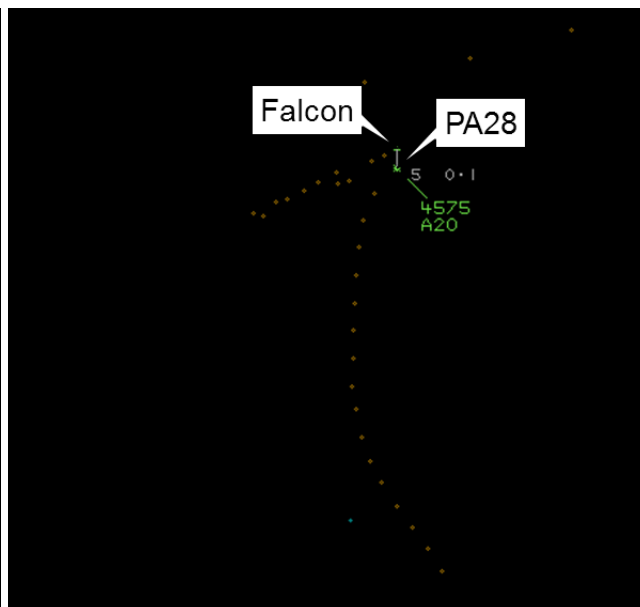
Figure 2 - 1831:18

CPA occurred at about 1831:18 (Figure 2), with the aircraft separated by 0.1nm laterally. The vertical separation was reported as 20ft but could not be assessed due to there being no SSR returns from the Falcon.
