AIRPROX REPORT No 2018208

Date: 07 Aug 2018 Time: 2223Z Position: 5005N 00504W Location: 8nm E Culdrose

PART A: SUMMARY OF INFORMATION REPORTED TO UKAB

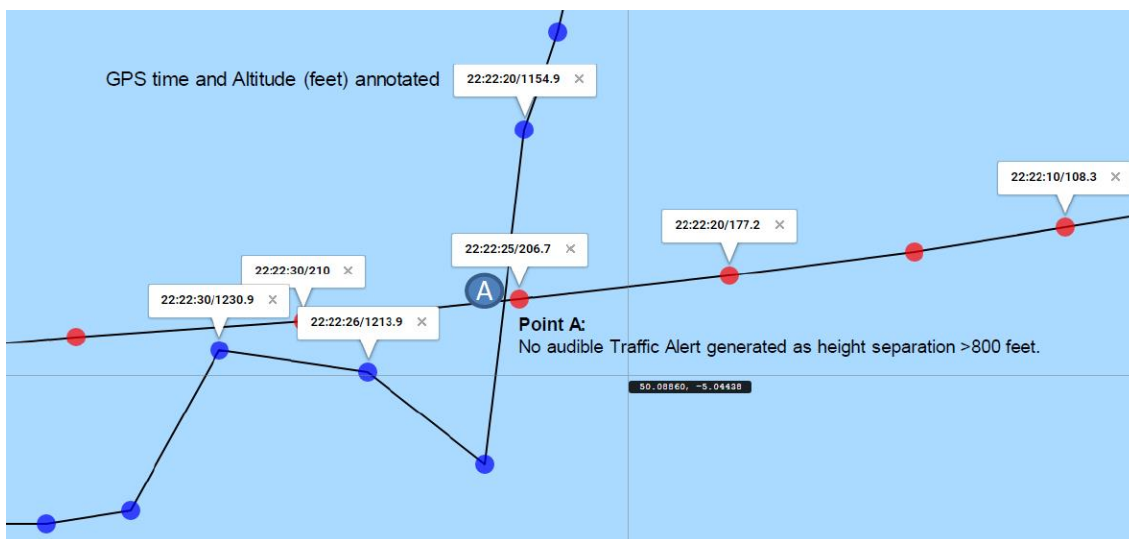
Figure 1. 2222:10 to 2222:30 showing initial crossing Point A (>800ft vertical separation)

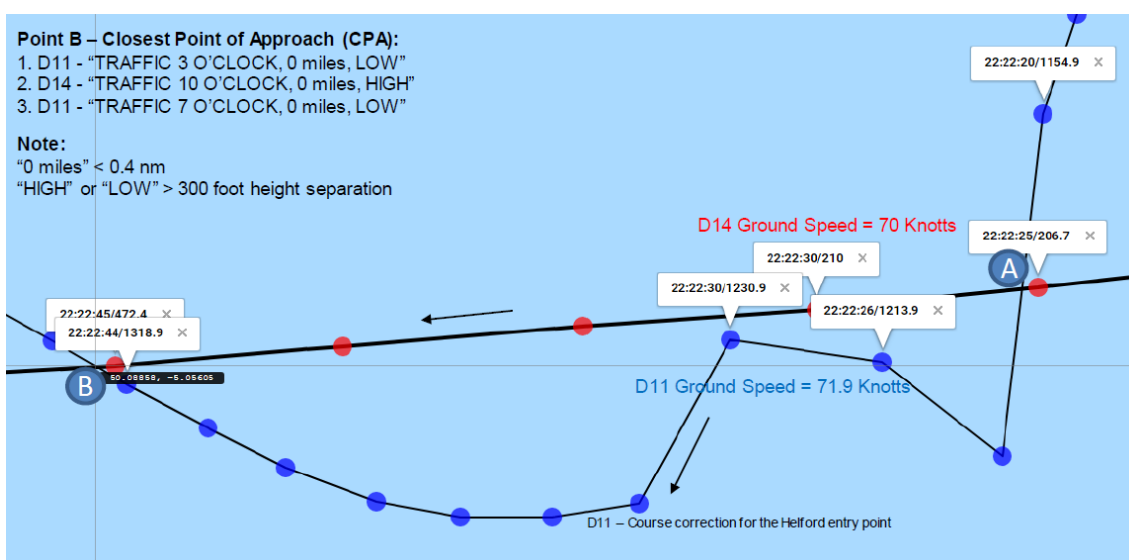
Figure 2. 2222:20 to 2222:44 showing second crossing Point B (>800ft vertical separation)

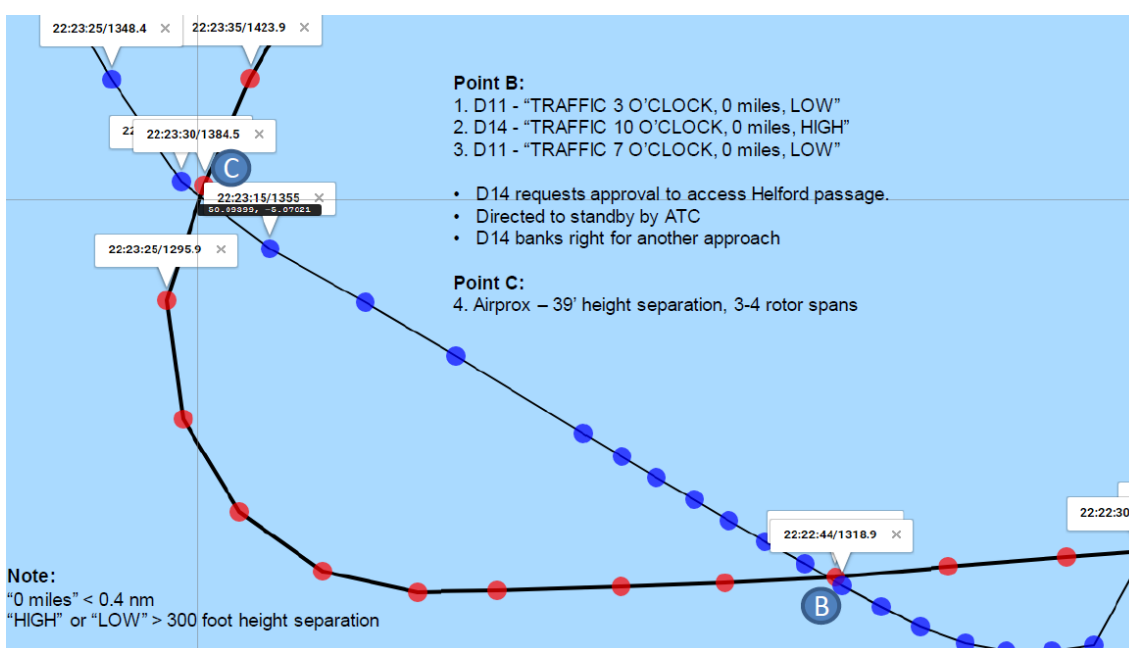
Figure 3 – 2222:44 to 2223:30 showing CPA at third crossing Point C

Finally, the Board looked at the cause and risk and, in reviewing the 2 aircraft tracks prior to CPA, concluded that the 2 aircraft had been on converging headings for upwards of 20-25 secs as Merlin(A) pilot had turned and climbed towards Point C. As such, with Merlin(B) on his right, it was for Merlin(A) pilot to give way. Some members thought that the cause was simply the effective non-sighting by both pilots, but the majority agreed that, notwithstanding a plethora of contributory factors, ultimately Merlin(A) pilot had climbed into conflict with Merlin(B) which he knew at least was operating somewhere near the recovery route at 1000ft. Principle amongst the contributory factors were: Merlin(A) crew were tasked focused to the detriment of look-out and situational awareness; the TAS display in the Merlin was not located in an appropriate position; the Merlin TAS procedures were ambiguous; and Merlin(A) crew perceived the valid TAS alert as a false alert. In assessing the risk the Board agreed that there had been a serious risk of collision, and that providence had played a major part in events; risk Category A.
