AIRPROX REPORT No 2018211

Date: 09 Aug 2018 Time: 0927Z Position: 5817N 00260W Location: 10nm SE Wick

PART A: SUMMARY OF INFORMATION REPORTED TO UKAB

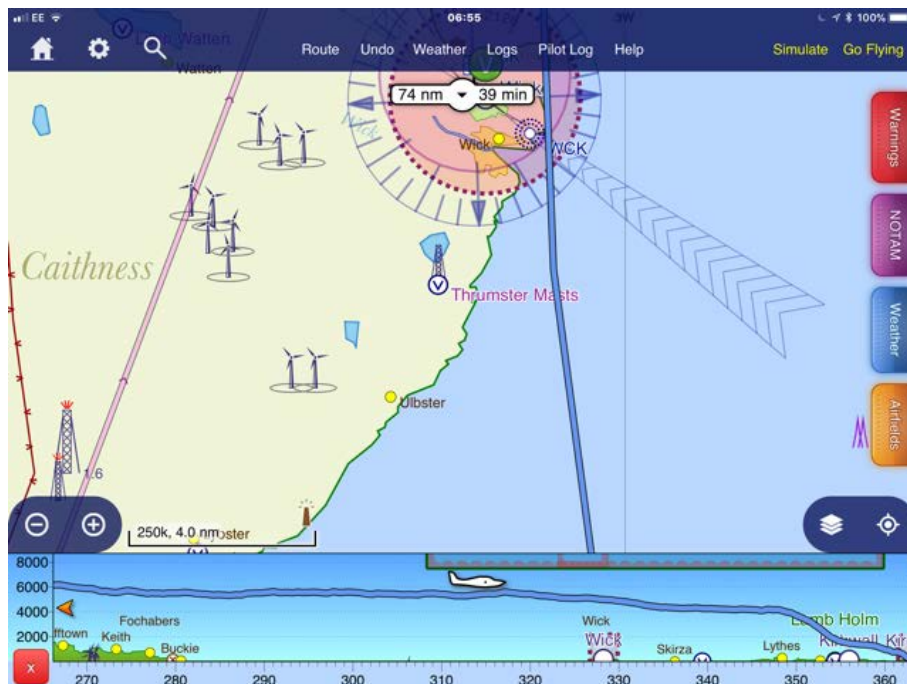
Figure 1. TB10 flight log.

THE TB10 PILOT reports that he did not consider that an Airprox had taken place. The weather was CAVOK at the time and both pilots in the TB10 were listening and watching the aircraft take off. They were at about 5500ft at the time talking to Wick, reporting their position (the last one was at Thumster masts). They thought it unlikely that the JS41 could have climbed to their altitude in such a short space of time. The TB10 pilot provided a flight log of their track at the time (Figure 1).

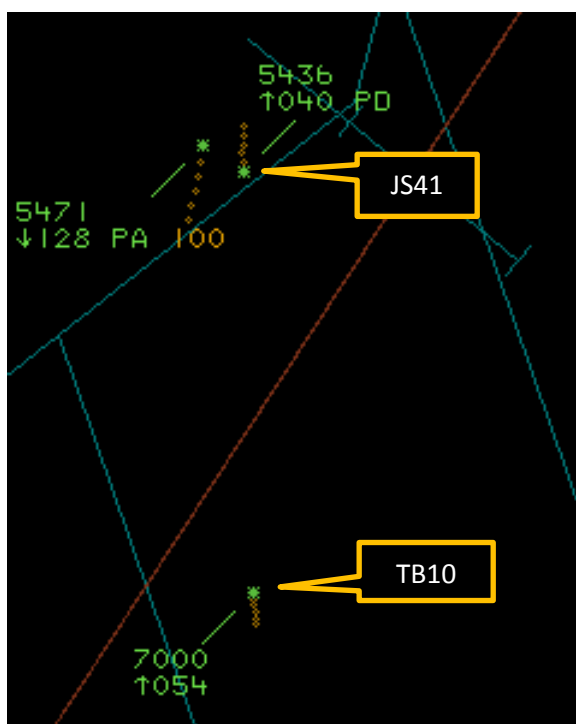
Figure 2 - 0925:30.

At 0925:30 (Figure 2), the Wick controller asked the TB10 pilot to report their position; the pilot advised that they were 14nm south. The controller acknowledged this and then asked the JS41 pilot to report their position; the JS41 pilot reported as being ***“at 4000ft, 5 miles south west...south east”***. The controller then issued the JS41 pilot with an instruction to ***“climb now FL90”***, the JS41 pilot readback the climb FL90 instruction and the controller instructed the JS41 pilot to contact the Moray controller.

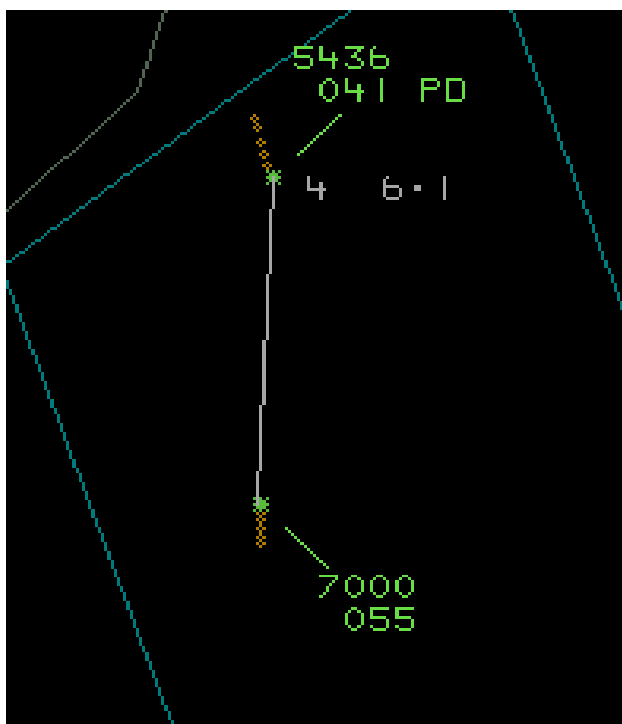
Figure 3 - 0926:20.

At 0926:20 (Figure 3), the JS41 pilot made initial contact with the Moray controller and advised that they were climbing FL90, the controller responded by passing Traffic Information at one o'clock, 2nm, a TB10, indicating FL55. The pilot advised that they were looking. The controller immediately updated the Traffic Information to 1 o'clock, 1nm, indicating FL56, the pilot advised that they were still looking. The controller then issued an avoiding action left turn immediately, 090° and advised that the traffic was now half a mile, 3 o'clock.

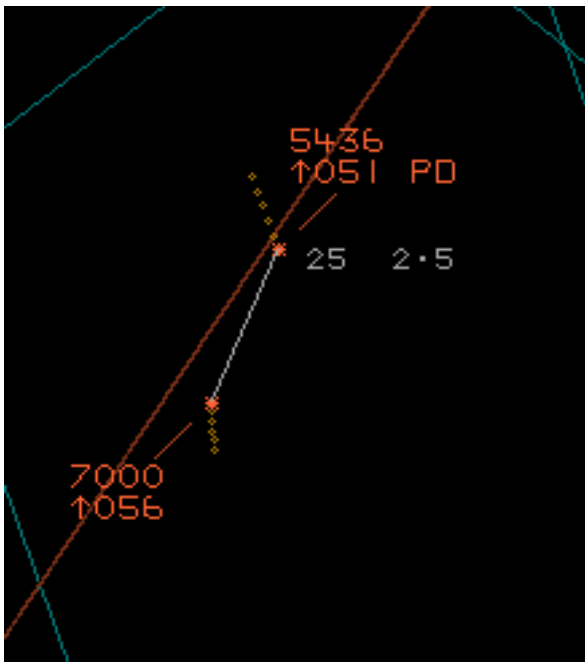
Figure 4 - 0927:01.

At 0927:01 (Figure 4), the JS41 pilot acknowledged the avoiding action to Prestwick and, at 0927:10, the TB10 pilot called the Wick controller and advised that they were visual with the traffic; the Wick controller acknowledged this.

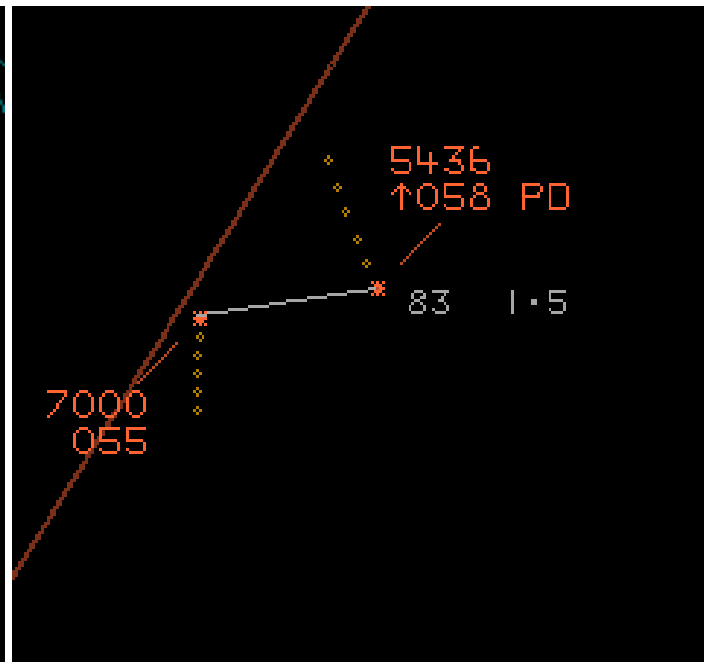
Figure 5 - 0927:24 CPA.

At 0927:24 (Figure 5), CPA occurred with the aircraft separated by 1.5nm laterally and 300ft vertically. [Note: Prestwick's ATS investigation, using their radar replay, measured the CPA being slightly before at 0927:20, with 200ft vertically and 1.5nm horizontally.]
