AIRPROX REPORT No 2018240

Date: 01 Sep 2018 Time: 0836Z Position: 5217N 00047W Location: Sywell

PART A: SUMMARY OF INFORMATION REPORTED TO UKAB

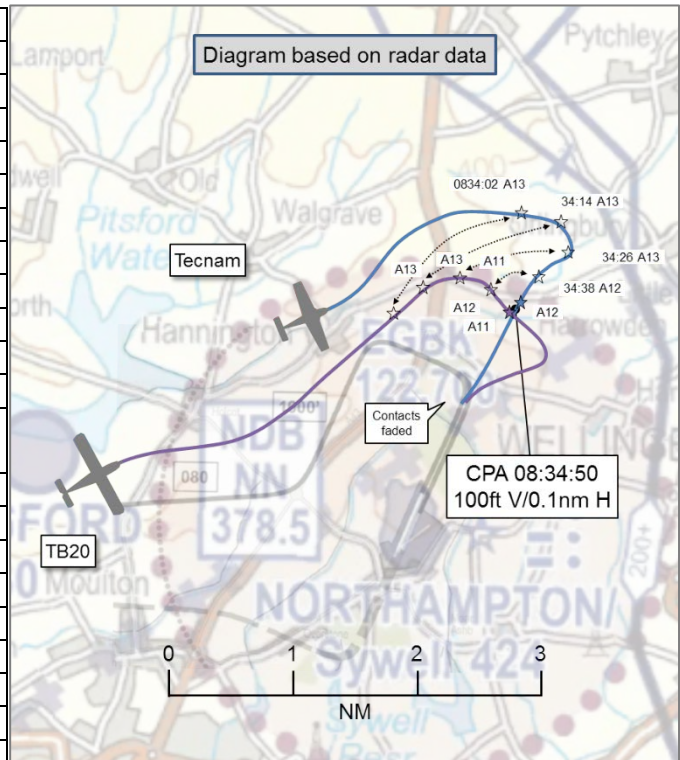
Comparing his radar track to that of the procedure (see diagram on Page 1), the Board noted that the Tecnam pilot had extended downwind to the extent that he was now outside the ATZ and well beyond the normal turn-point before turning onto long-final. Members questioned why the Tecnam pilot had flown so far downwind when he had reported that there were no aircraft ahead. Members then noted that the TB20 pilot had also not flown the procedure's track, had also extended towards the ATZ boundary, and that the TB20 had either not been aware of or had not kept the Tecnam in sight as it departed ahead from the hold. The Board noted that the TB20 pilot had gone around from his previous approach, and some members wondered whether the slot system sufficiently allowed for a potential build-up of aircraft conducting further approaches along with those arriving for their allocated slot time; GA members assured the Board that the slot system contained in-built 'flex' to allow for just such a situation. Some members wondered whether self-induced pressure on having conducted a previous go-around and rejoin of the hold had heightened the TB20 pilot's navigation task-focus to the detriment of his situational awareness of other aircraft leaving the hold, and his subsequent visual acquisition of the Tecnam before turning base-leg. Ultimately, although reiterating that strict adherence to a marked track was not always practical or safe, members agreed that both pilots had flown so far off track that their failure to follow the joining procedure accurately was contributory to the Airprox.

Tactical Planning was assessed as **partially effective** because the Tecnam pilot flew downwind beyond the normal turn point (to the extent that he left the ATZ) as did the TB20 pilot to a lesser extent.

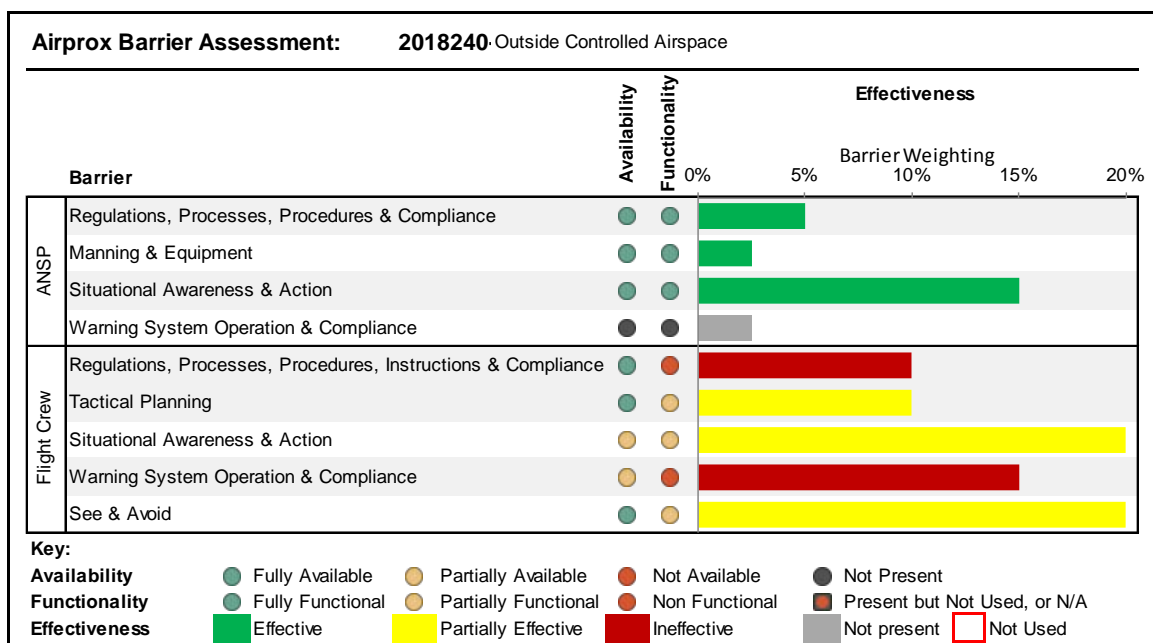
Regulations, Processes, Procedures, Instructions and Compliance were assessed as **ineffective** because neither pilot followed the AIC procedure sufficiently, and the TB20 pilot did not integrate with the Tecnam on long final.

Situational Awareness and Action were assessed as **partially effective** because the TB20 pilot was told the Tecnam was 'Number one' but did not act on that information.

Warning System Operation and Compliance were assessed as **ineffective** because the TB20 TAS either did not alert, or the TB20 pilot did not assimilate the TAS alert.

See and Avoid were assessed as **partially effective** because neither pilot acted sufficiently when visual with an aircraft in close proximity.
