AIRPROX REPORT No 2018246

Date: 03 Sep 2018 Time: 1811Z Position: 5250N 00042E Location: 2nm SW Sculthorpe

PART A: SUMMARY OF INFORMATION REPORTED TO UKAB

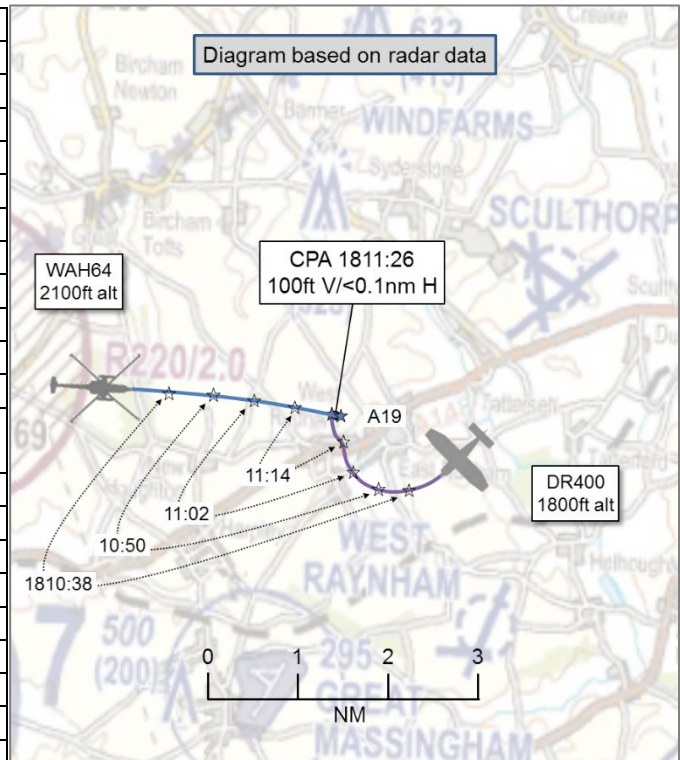
Recorded	Aircraft 1	Aircraft 2
Aircraft	Apache WAH64	DR400
Operator	HQ AAC	Civ FW
Airspace	London FIR	London FIR
Class	G	G
Rules	VFR	VFR
Service	Basic	Listening Out
Provider	Holbeach	(Little Snoring)
Altitude/FL	1900ft	1800ft
Transponder	A, C, S	A, C
Reported		
Colours	Green	White, blue
Lighting	Nav, HISL, landing	Wingtip strobes, nav
Conditions	VMC	VMC
Visibility	>10km	10km
Altitude/FL	1700ft	1350ft
Altimeter	QNH (1019hPa)	QFE (NK hPa)
Heading	080°	080°
Speed	120kt	100kt
ACAS/TAS	Not fitted	Not fitted
Separation		
Reported	140ft V/0m H	400ft V/NK H
Recorded	100ft V/<0.1nm H

radar-equipped provider, they may have received TI on each other. There is some doubt surrounding the nature of the DR400s track and the assessment of where the AH was in relation to this aircraft.

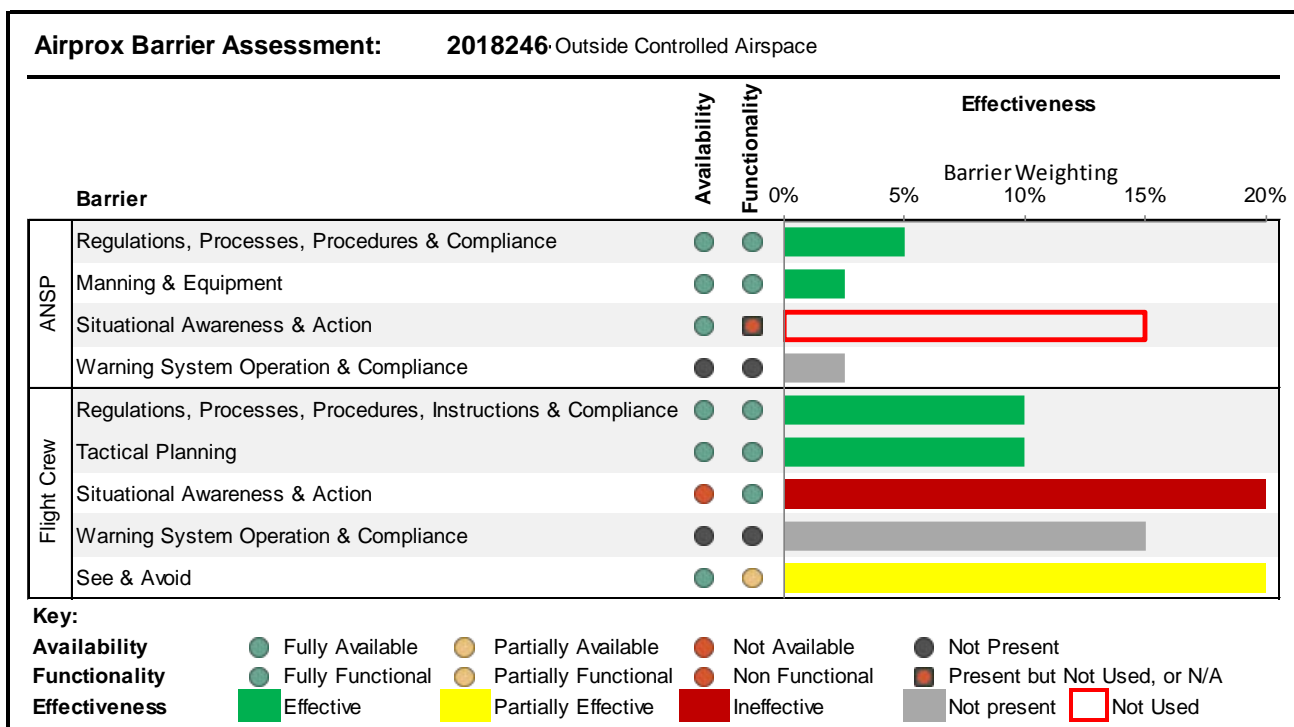
Situational Awareness and Action were assessed as **not used** because the Holbeach RSO did not have access to a surveillance picture.

Situational Awareness and Action were assessed as **ineffective** because neither pilot was aware of the other aircraft until at a late stage, the Apache FCR did not identify the DR400, and the DR400 was not fitted with a TAS.

See and Avoid were assessed as **partially effective** because the Apache pilot saw the DR400 at a late stage and had had to take emergency avoiding action.
