**AIRPROX REPORT No 2018310**

Date: 30 Nov 2018 Time: 1138Z Position: 5136N 00046E Location: Southend CTR

**PART A: SUMMARY OF INFORMATION REPORTED TO UKAB**

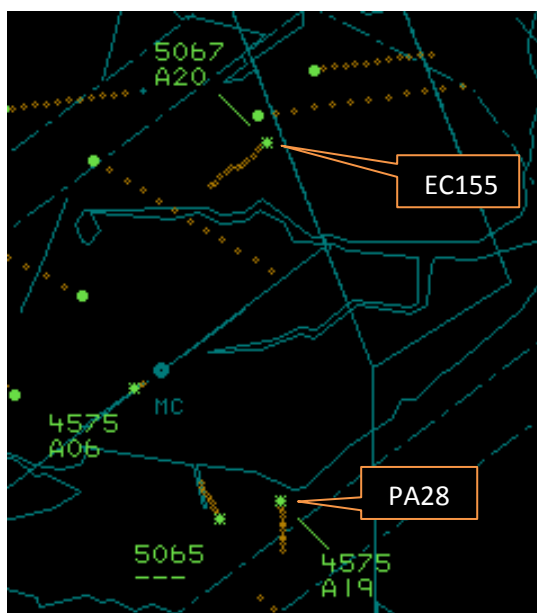
Figure 1-1134:20

At 1134:20 (Figure 1), the PA28 was routing direct to left-base for RW23 and was instructed to change to the Tower frequency.

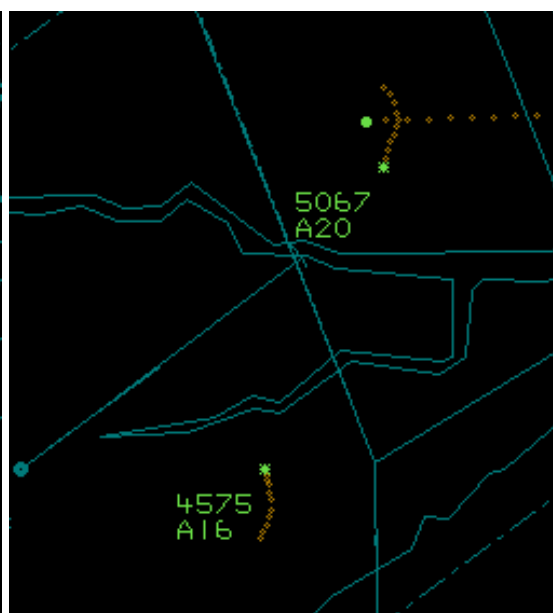
Figure 2-1136:15

At 1136:15 (Figure 2), the Tower controller asked the PA28 pilot if they could take a short approach due to helicopter traffic establishing on the ILS at 6.5nm. The PA28 pilot responded that they were looking for the traffic. The controller then instructed the pilot to route direct to final from their present position.

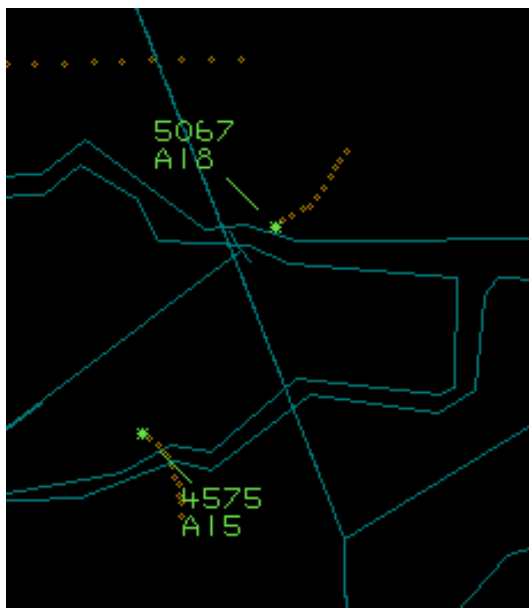
Figure 3-1137:10

At 1137:10 (Figure 3), the Radar controller passed traffic information to the EC155 pilot on the PA28 as 'eleven o'clock, 3 miles, orbiting to position behind you VFR in the circuit'. The pilot reported having the traffic in sight and was instructed to transfer to the Tower frequency.

Based on the traffic information passed to the pilot of the EC155 prior to transfer from the Radar controller to the Tower controller at 1137:10 (Figure 3), the EC155 pilot could expect that the PA28 would be positioning behind them on final approach. This was a reasonable assumption by the Radar controller based on the relative positions of the aircraft at the time and the slight left turn by the PA28. However, it was apparent from the relative positions of both aircraft at 1136:15 (Figure 2) that, if the PA28 continued onto final approach, the EC155 would be approximately 1.5nm behind the PA28; with the EC155 being slightly faster than the PA28 and also planning to go around from the approach, that this would further erode the distance between the two aircraft.

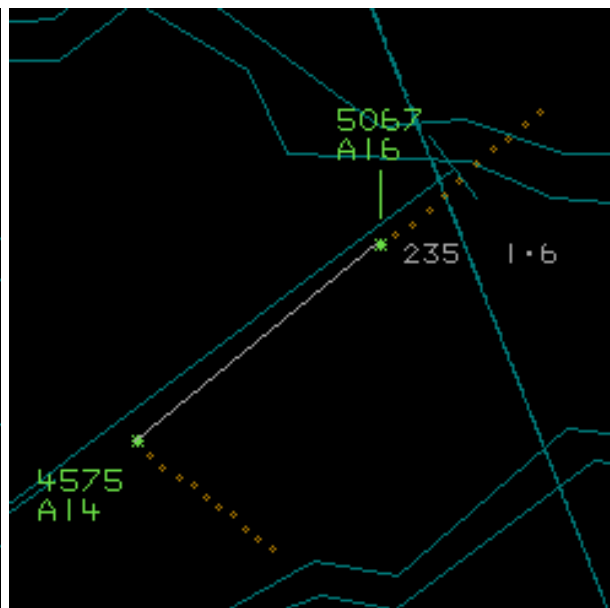
Figure 4-1137:50

At 1137:50 (Figure 4), the controller instructed the PA28 pilot to continue to route northbound, this instruction was repeated three times in total. There was no response from the pilot.

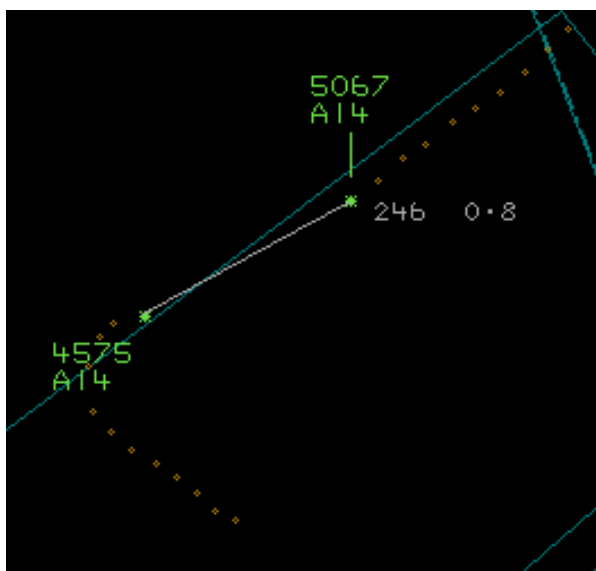
Figure 5-1138:00

At 1138:00 (Figure 5), the PA28 pilot made a right turn toward the EC155 and the controller instructed the EC155 pilot to “make a left turn, track southbound, left turn track southbound, opposite direction PA28”. The EC155 pilot responded that they had the traffic in sight and were turning left and that they were also climbing.

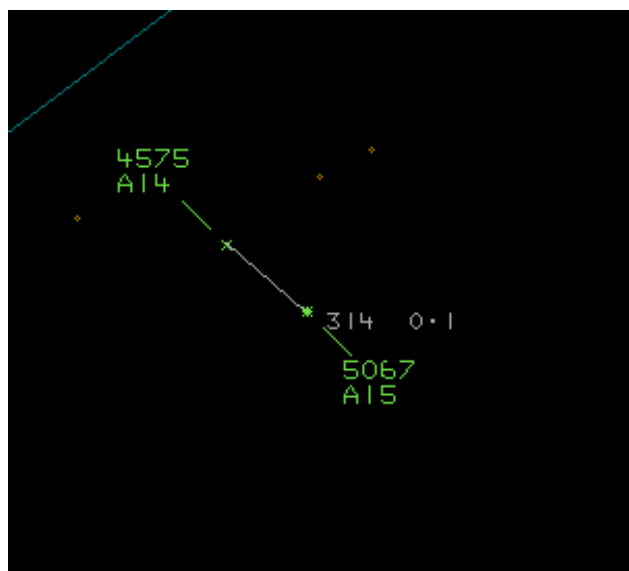
Figure 6-1138:20

CPA was at 1138:20 (Figure 6), with the aircraft separated by 0.1nm laterally and 100ft vertically.
