AIRPROX REPORT No 2018315

Date: 10 Dec 2018 Time: 1825Z Position: 5055N 00318W Location: 4nm NW Dunkeswell

PART A: SUMMARY OF INFORMATION REPORTED TO UKAB

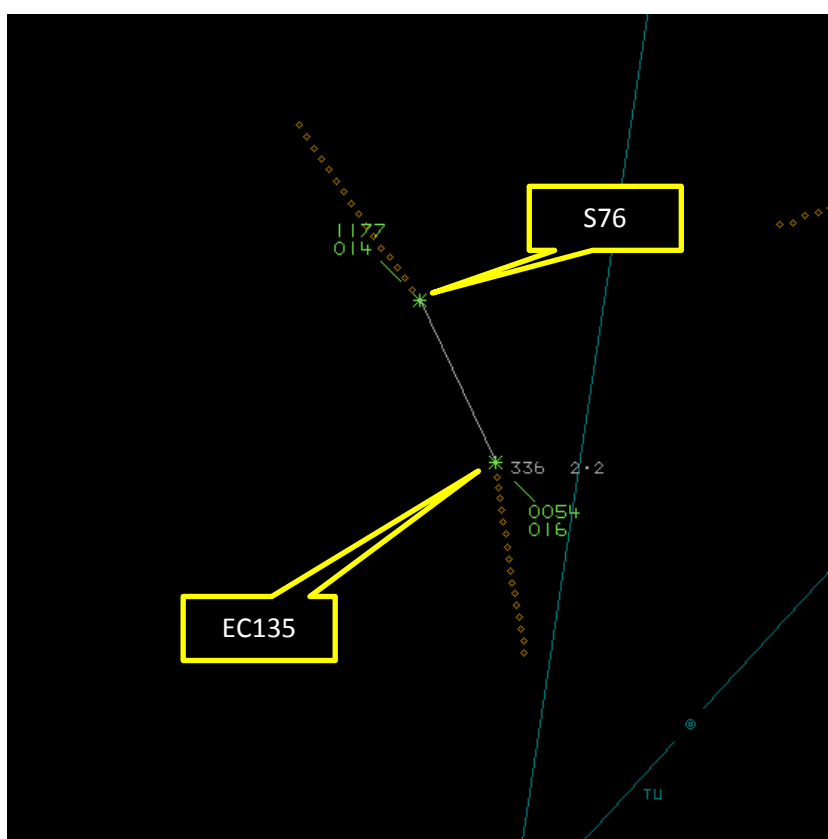
Figure 1: 1824:59

An Airprox was reported when an EC135 and a S76 flew into proximity NW of Dunkeswell at 1825hrs on Monday 10th December 2018. Both pilots were operating under VFR in VMC, the EC135 pilot in receipt of a Basic Service from Exeter and the S76 pilot in receipt of a Basic Service from London Information.

The Board then looked at the cause and risk. They agreed that the S76 pilot was visual with the EC135 from 8nm but had not deviated from his track even though the EC135 was converging on his right. Given that it was night and that the S76 pilot could not have known the intentions of the EC135 even if he had judged that vertical separation was sufficient, the Board concluded that the cause of the incident was that the S76 pilot had flown into conflict with the EC135. Turning to the risk, members noted that both pilots were visual with the other aircraft at range, and that the EC135 pilot had turned to avoid the S76 in plenty of time. They were unanimous in agreeing that this turn had been timely and effective and so, although safety had been reduced, they determined that there had been no risk of collision; risk Category C.

Cause: The S76 pilot flew into conflict with the EC135.
