**AIRPROX REPORT No 2018316**

Date: 14 Dec 2018 Time: 1521Z Position: 5626N 00322W Location: Perth/Scone aerodrome

**PART A: SUMMARY OF INFORMATION REPORTED TO UKAB**

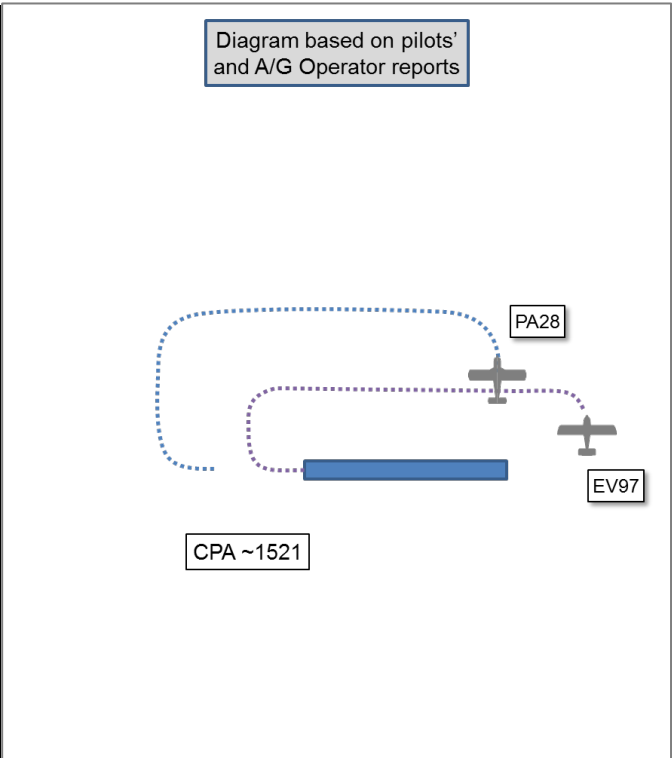
**THE PA28 INSTRUCTOR** reports that he returned to Perth to carry out circuits as part of a dual check for currency on a qualified PPL holder. The handling pilot contacted Perth radio and elected to carry out an overhead join as there was other traffic in the circuit and joining. RW09 was in use with a left hand circuit pattern. A standard overhead join was made with a radio call to confirm descending on deadside. A descending left turn was made down to circuit height (1000ft agl) and crosswind flown wings level heading 360°. The EV97 was in the circuit pattern and made a radio call that he was going around off RW09. From overhead the runway it was observed that the EV97 was climbing away on runway heading. As a downwind turn was made the EV97 was seen to be turning left outside of the PA28 circuit pattern. Standard calls were made but no further calls were made by the EV97 pilot he thought. On turning left base in the descent, a radio call on left base was made and another aircraft (a C152) was observed on a short final. As a turn onto final was initiated the EV97 was observed turning inside their pattern. He did not recall any radio transmission from the EV97 pilot from the initial go-around call to suggest that they had proceeded downwind or that the intention was to carry out a circuit pattern within the circuit pattern flown by the PA28. A frustrated call was broadcast by the PA28 pilot questioning the 'reckless and dangerous' actions of the EV97 pilot, with no response. He did not think the EV97 pilot had called Perth to confirm that they were on final. Due to the close proximity and the inability of the EV97 pilot to exit and clear the runway in time, he felt that it was necessary to carry out a go-around.

**THE EV97 EXAMINER** reports that he was conducting a test on the EV97 pilot. Both the EV97 and the PA28 pilots were operating in the visual circuit. Each pilot had the other aircraft in sight throughout the circuit with the PA28 following the EV97 in the pattern. The EV97 pilot conducted a low-level circuit to short-field landing and the PA28 pilot conducted a normal circuit.

**THE PERTH A/G OPERATOR** reports that he was not aware that a report had been filed until the acknowledgment correspondence from the Airprox Board arrived. However, because of comments made on R/T by the reporting pilot at the time, he had made a few notes in case he was asked, at a later date, to comment. The A/G Operator stated that he did not see or hear anything that warranted his filing a report of any kind. The weather at the time was reasonable and visibility was good enough to be able to observe aircraft in the circuit. There were a number of aircraft in the circuit at the time as well as aircraft re-joining; the frequency was very busy. The A/G Operator had had a phone call earlier in the afternoon from the Examiner who was to carry out a flight check of some sort on the EV97 pilot. The Examiner informed him that it was a check flight and that there might be a simulated engine failure and other such exercises carried out during the flight. The A/G Operator noted that this Examiner always pre-warned Perth Tower when such events may occur. The A/G Operator kept a close watch on the EV97 while it was in the circuit because he had been told about the check taking place. The EV97 pilot reported going around from his penultimate circuit and, after a radio call from another aircraft, said '[EV97 C/S] bad weather circuit about to turn downwind', or words to that effect. The A/G Operator observed the EV97 at low-level, at about 500ft, and well within the normal circuit pattern. The EV97 pilot flew a very tight circuit, as expected, and when he turned finals he did report on finals, fitting neatly in between a Jabiru on very short finals and another aircraft which had turned finals further out, at about the same time as the EV97. This turned out to be the PA28. Perhaps 5 to 10sec after the EV97 pilot's finals call, another pilot, which turned out to be that of the PA28, made a transmission asking whether a red aircraft had cut in front of him. At that point the EV97 pilot reported very short finals, and the A/G Operator confirmed the PA28 was number two. The Jabiru landed ahead and cleared the runway as the EV97 pilot reported very short finals. The EV97 landed and as he cleared and reported clear of the runway, the A/G Operator saw that the PA28 pilot had initiated and then called a go-around although the runway was, by then, clear.
