## AIRPROX REPORT No 2017045

Date: 25 Mar 2017 Time: 1028Z Position: 5217N 00136W Location: 6.5nm SW Coventry

### PART A: SUMMARY OF INFORMATION REPORTED TO UKAB

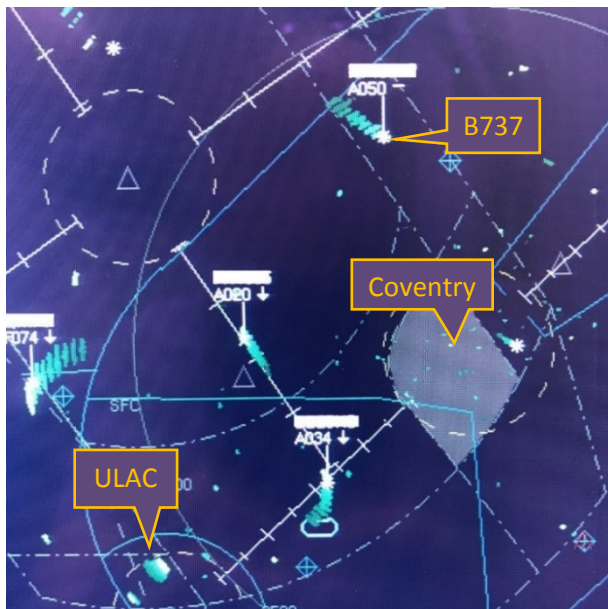
Figure 1 – 1021:58

The B737 pilot, having been released by Birmingham Radar whilst still inside Birmingham's controlled airspace, contacted Coventry Radar at 1021:58 and reported being at altitude 5000ft. The Coventry Radar controller acknowledged the call, descended the aircraft to an altitude of 1900ft and advised that it would be radar vectors for an NDB approach to Runway 05 at Coventry, which was all acknowledged by the pilot (Figure 1).

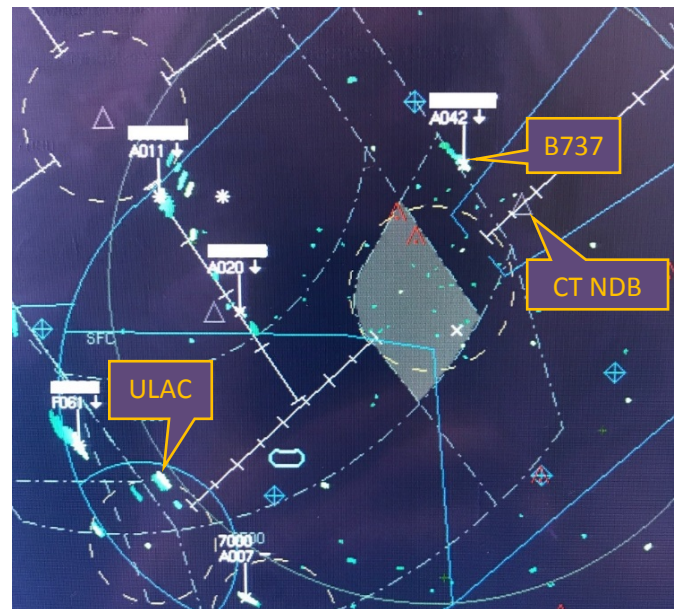
Figure 2 – 1023:10

At 1023:10 the controller instructed the B737 to leave the Coventry NDB ("CT") on a heading of 180 degrees, advised the pilot that the aircraft had just left controlled airspace, and requested the type of ATC service they required. The pilot requested a Basic Service, which was confirmed by the controller (Figure 2).

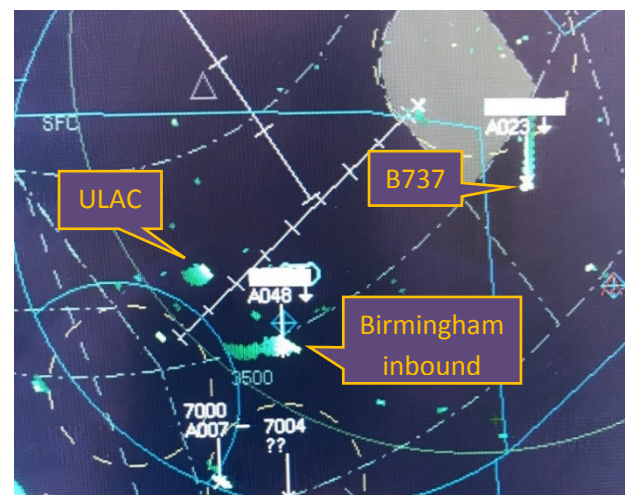
Figure 3 – 1025:05

At 1025:05 the controller instructed the B737 to turn right onto a heading of 230° for downwind right-hand (Runway 05) (Figure 3).

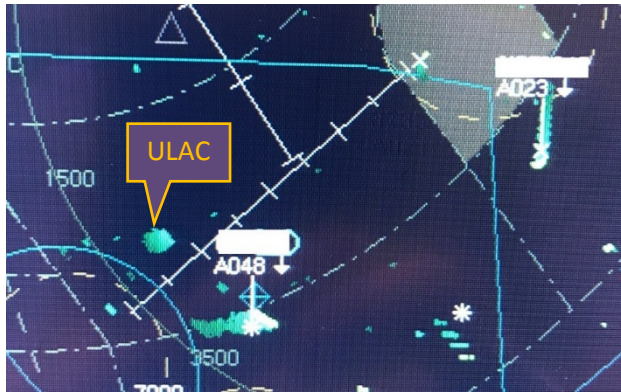
Figure 4 – 1025:16

At 1025:16 the radar contact believed to be the ULAC started to fade (Figure 4).

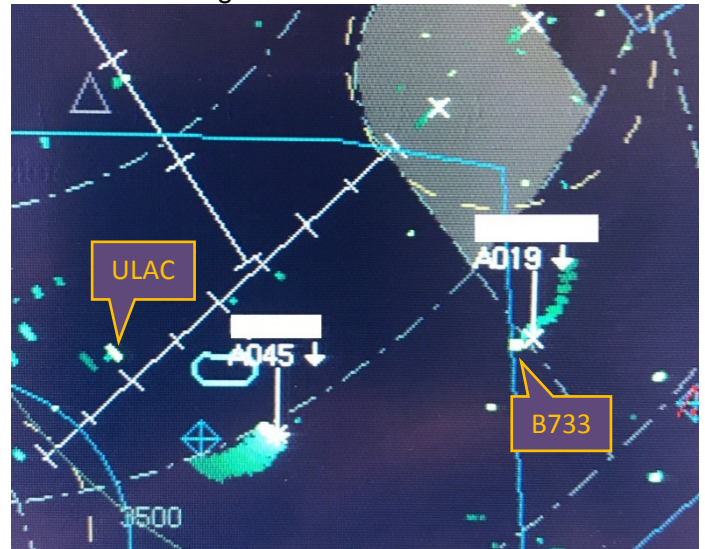
Figure 5 – 1025:44

At 1025:44 the radar contact believed to be the ULAC reappeared (Figure 5), and at 1025:48 the controller descended the B737 to 1500ft.

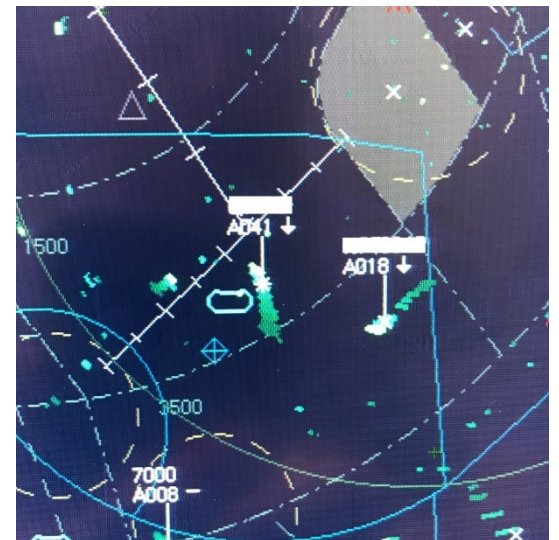
Figure 6 – 1026:20

At 1026:20 the controller instructed the B737 to turn right onto a heading of 300 degrees, advising that they were on base leg with 10 miles to touchdown (Figure 6).

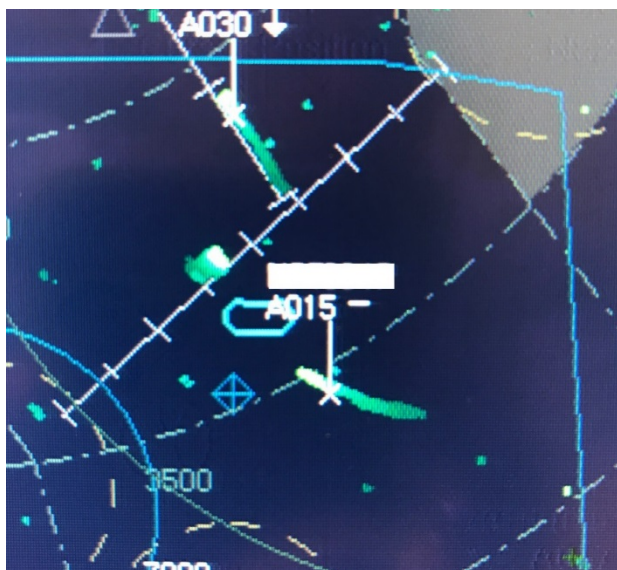
Figure 7 – 1027:15

At 1027:15 the controller instructed the B737 to run right onto a heading of 020 degrees, advising the pilot that they were closing the final approach track from the right at 7 miles (Figure 7).

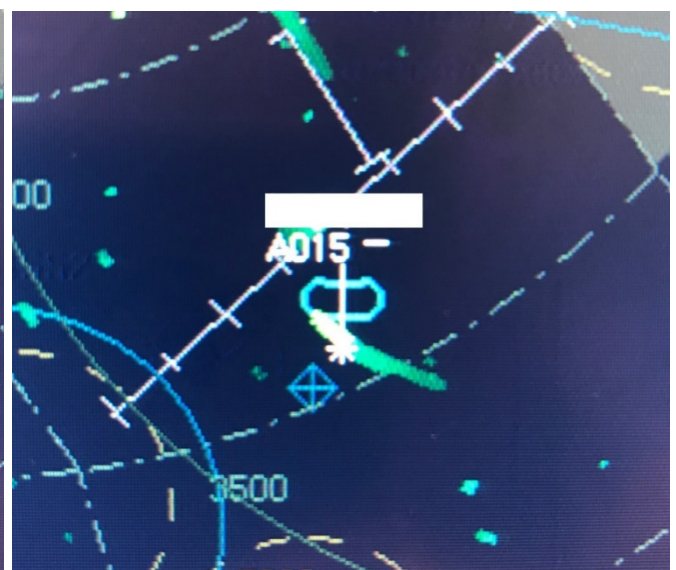
Figure 8 – 1027:38

At 1027:38 the controller advised the B737 that they had: *“pop-up traffic north of you by one mile, primary only er, whether it’s just a microlight but er just started painting er in front of you”* (Figure 8).

(B737 label overlaying ULAC return)

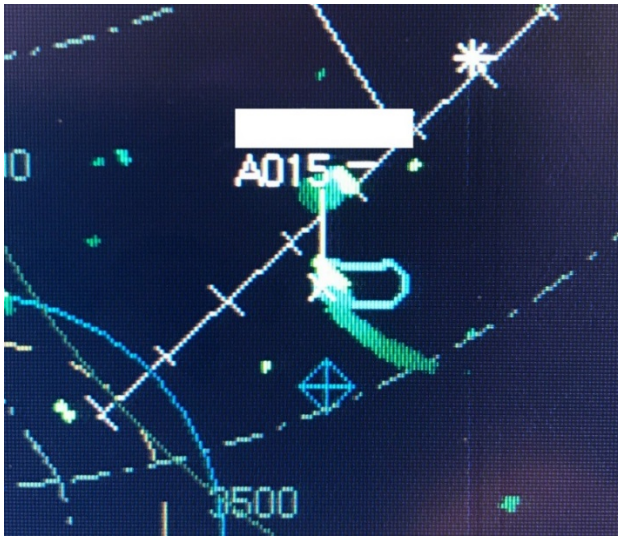
Figure 9 – 1027:50

The controller responded (at 1027:50), “roger – turn left” (Figure 9).

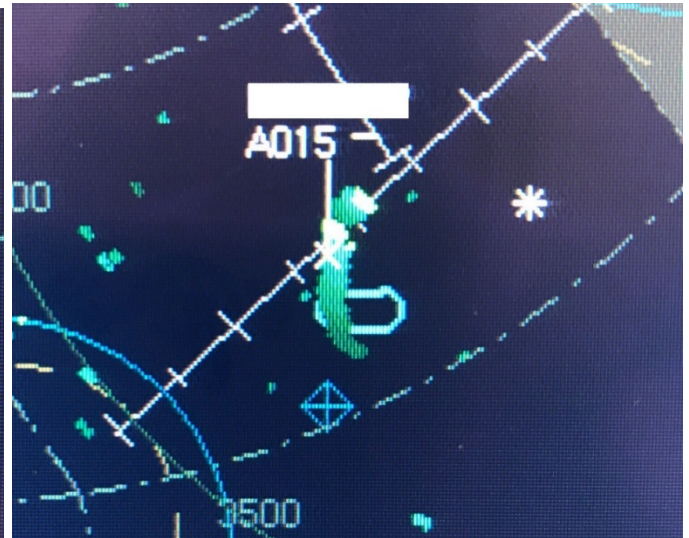
Figure 10 – 1028:11

At 1027:56 the pilot reported: “yeah he’s on exactly our level and, er yeah, that’s very close”. They reported that they couldn’t see the registration, but reported it as a blue microlight (Figure 10 at 1028:11)

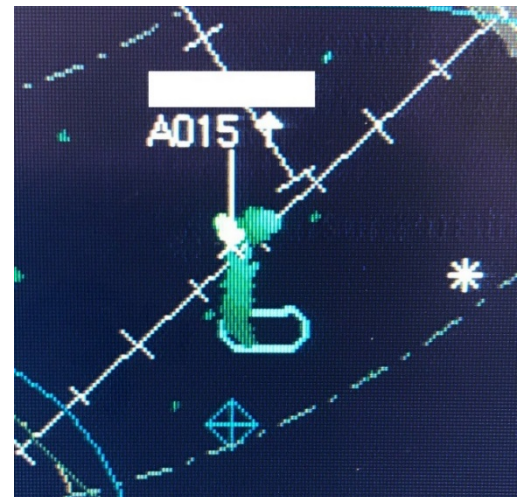
Figure 11 – 1028:18

CPA could not be measured, but was estimated to take place between 1028:11 and 1028:18 (Figure 12), when the left turn implemented by the B737 could be seen. The B737 pilot subsequently stated in their written report, that the lateral distance was 1nm with both aircraft being at the same level. (Centreline range markers are 1nm intervals).
