AIRPROX REPORT No 2017046

Date: 26 Mar 2017 Time: 1208Z Position: 5141N 00006E Location: North Weald

PART A: SUMMARY OF INFORMATION REPORTED TO UKAB

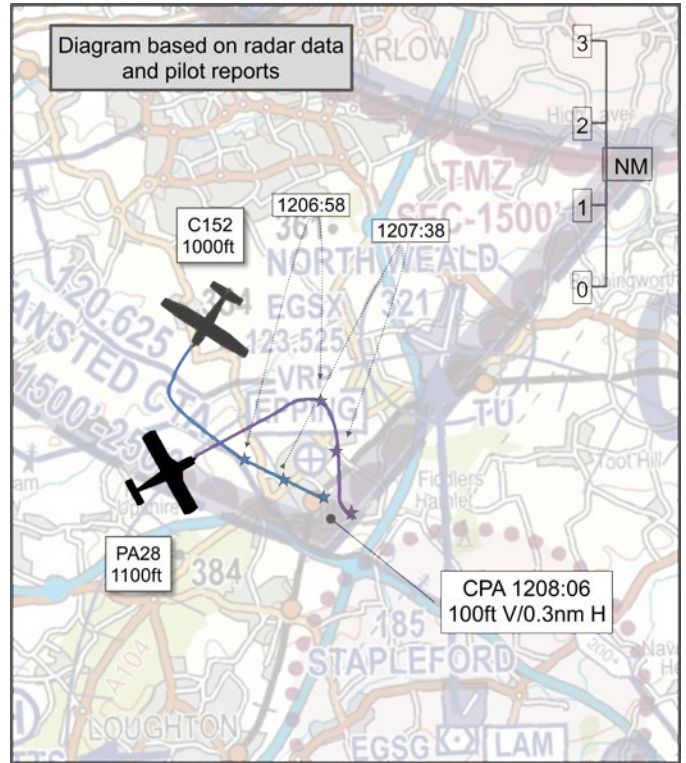
Recorded	Aircraft 1	Aircraft 2
Aircraft	C152	PA28
Operator	Civ Trg	Civ Pte
Airspace	London FIR	London FIR
Class	G	G
Rules	VFR	VFR
Service	AGCS	AGCS
Provider	North Weald	North Weald
Altitude/FL	1000ft	1100ft
Transponder	Mode A, C	A, C
Reported		
Colours	Maroon, White	White, Blue
Lighting	Nav	NR
Conditions	VMC	VMC
Visibility	10km	'Good'
Altitude/FL	1100ft	700ft
Altimeter	QNH (1024hPa)	NK
Heading	230°	020°
Speed	100kt	80kt
ACAS/TAS	Not fitted	Unknown
Separation		
Reported	0ft V/0.25nm H	400ft V/0.5nm H
Recorded	100ft V/0.3nm H

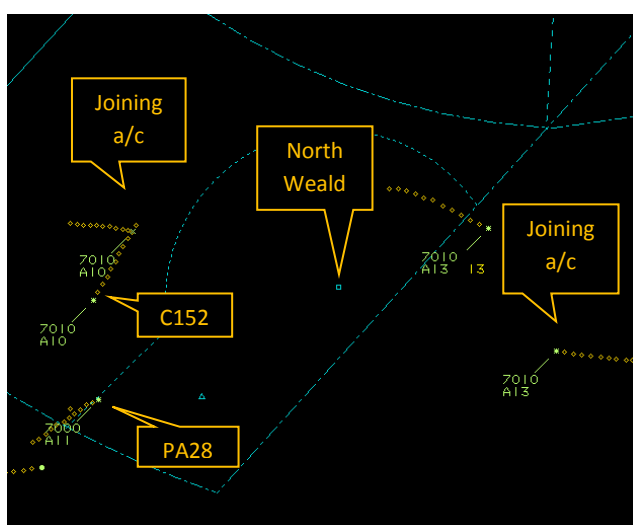
Figure 1 – 1205:55

At 1205:55 the C152 already in the circuit called downwind, which was acknowledged by the A/G operator who then went on to pass joining information to a further aircraft (Figure 1).

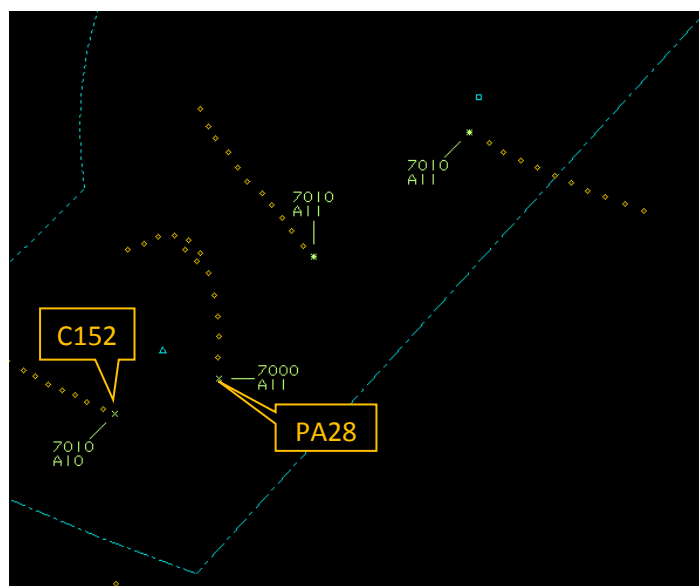
Figure 2 – 1207:40

At 1207:40 the PA28 pilot called downwind which was acknowledged by the A/G operator, but no traffic information was passed on the C152 ahead (Figure 2).

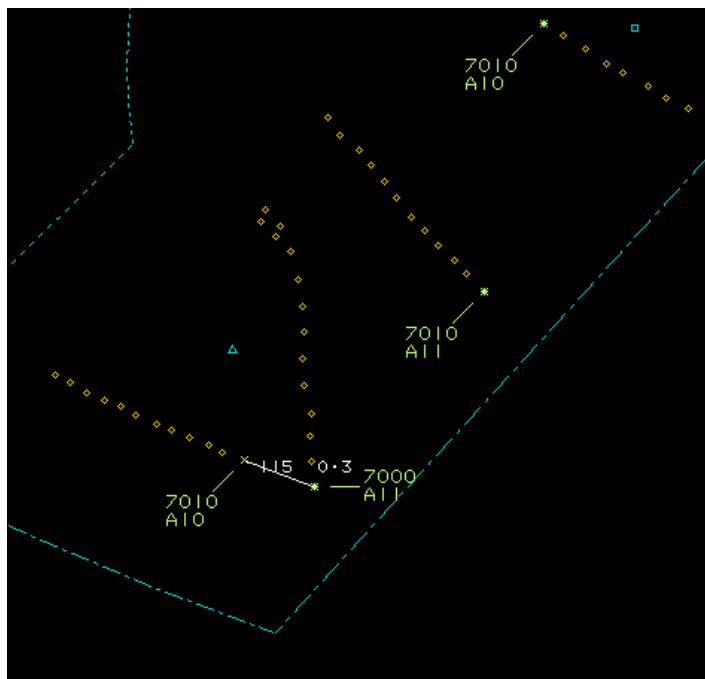
Figure 3 – 1207:56

CPA was believed to take place at 1207:56 with the aircraft separated by 0.3nm laterally and 100ft vertically (Figure 3).

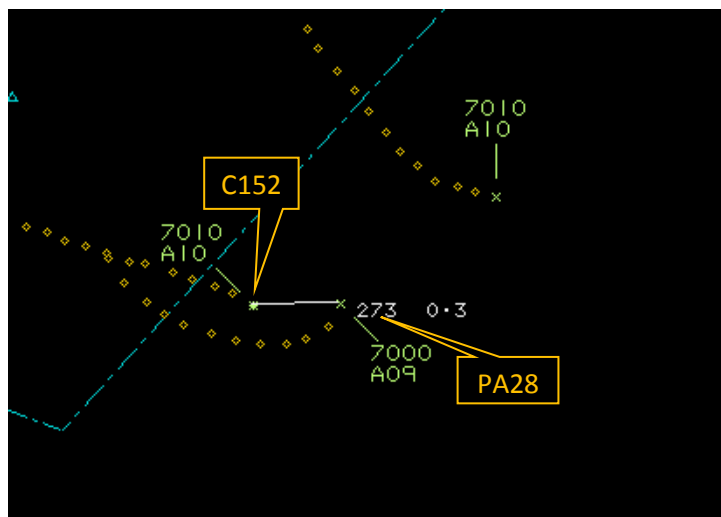
Figure 4 – 1208:40

At 1208:40 the C152 pilot asked if (c/s) was a PA28 which was confirmed by the pilot of the PA28 themselves. The C152 acknowledged this and stated that they would make themselves Number 2 to that PA28. At this time both aircraft were again within 0.3nm laterally and 100ft vertically of each other.

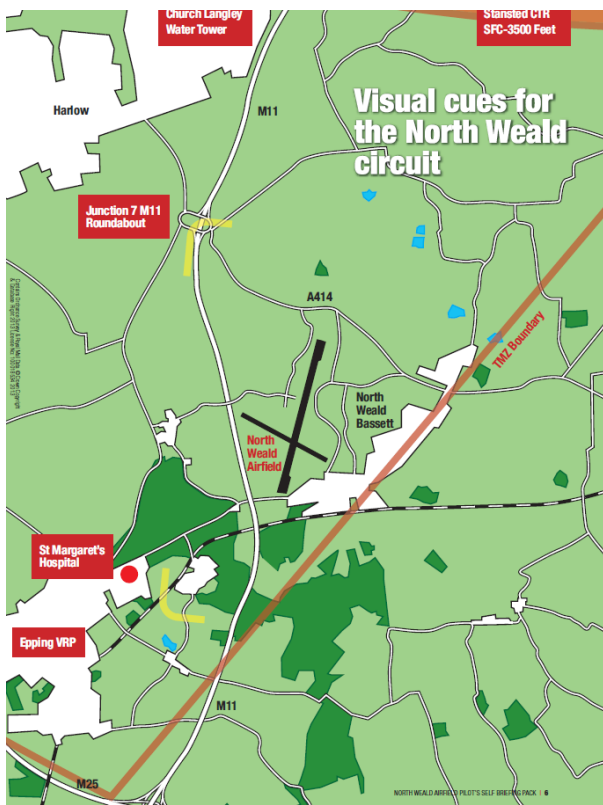
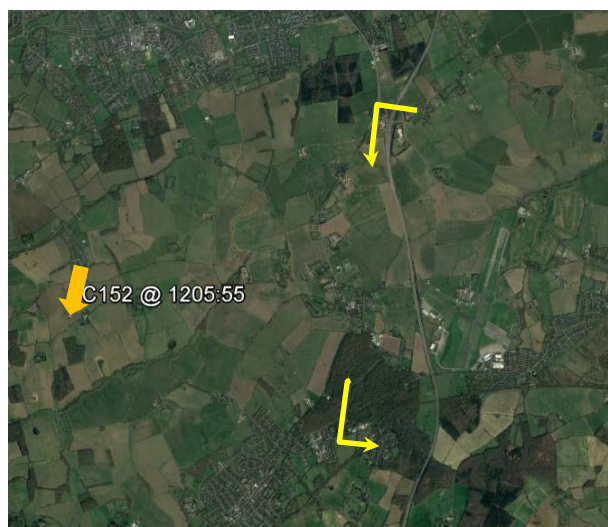
Figure 6
Comparative position of C152

On the area radar replay the C152 was observed to be flying a circuit which, compared with other aircraft, and in the opinion of A/G staff interviewed on the day, was considered to be outside the standard circuit, with its downwind leg being nearly 3nm from the airfield, as opposed to the recommended 1nm (Figures 5 & 6).

Contributory Factor: The C152 pilot flew a downwind track which was significantly wider than that published in the North Weald 'Pilots' Self Briefing Pack'.

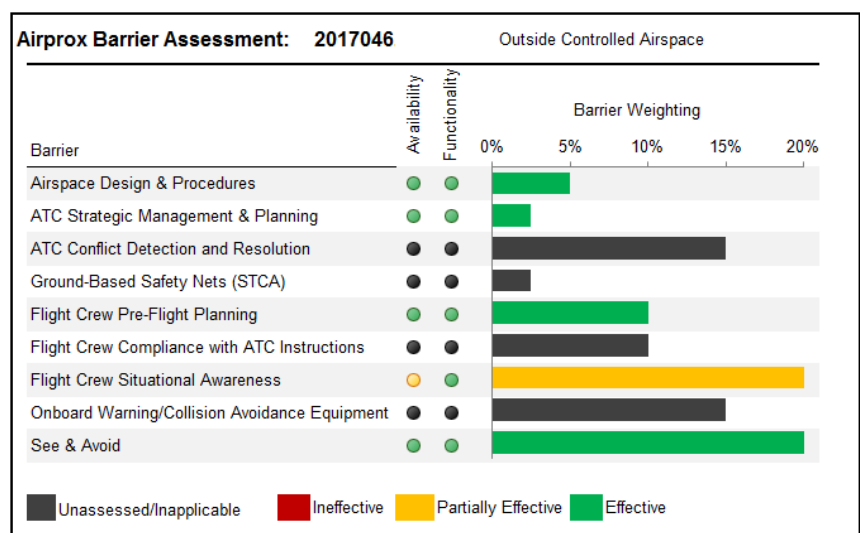
Flight Crew Situational Awareness was assessed as **partially effective** because neither pilot seemed fully aware of where the other was.

Onboard Warning/Collision Avoidance System was assessed as **inapplicable** because neither aircraft was fitted with a CWS.

See and Avoid was assessed as **effective**.
