AIRPROX REPORT No 2017088

Date: 11 May 2017 Time: 1144Z Position: 5237N 00030E Location: Marham MATZ

PART A: SUMMARY OF INFORMATION REPORTED TO UKAB

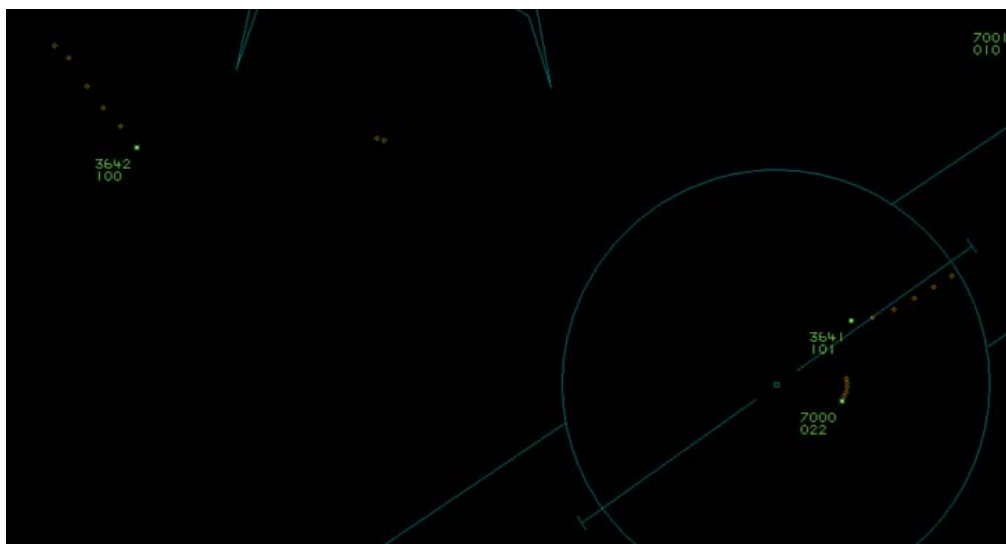
Figure 1: Geometry at 11:42:06 (Tornado 3642; C150 7000)

At 11:42:06 (Figure 1), the Marham Approach controller informed the Tornado that there was a C150 in the Marham circuit maintaining 1500ft QFE. The information was repeated prior to sending the Tornado to the Marham Tower frequency for visual recovery.

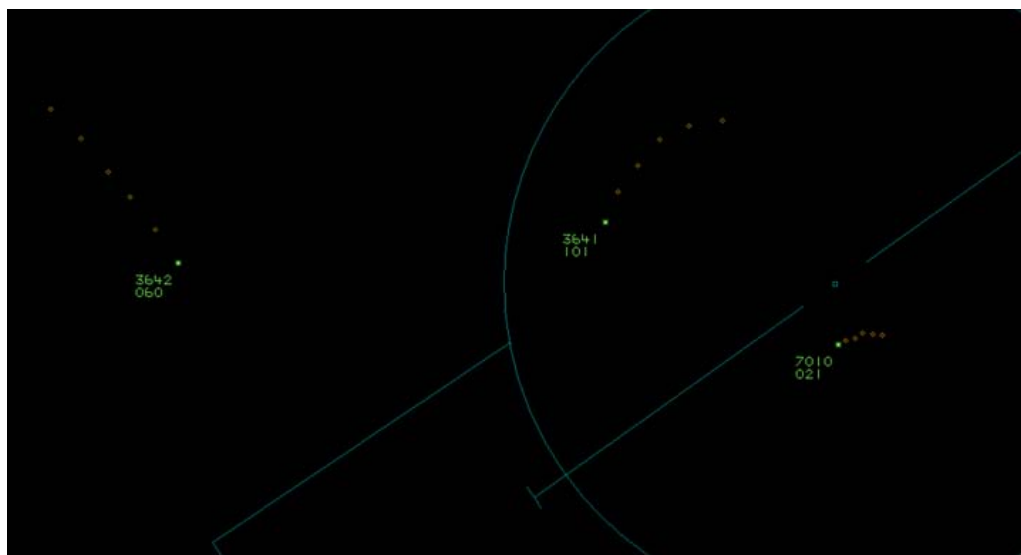
Figure 2: Geometry at 11:43:07 (Tornado 3642; C150 7010)

At 11:43:07 (Figure 2), the Marham Tower controller passed joining details to the Tornado, including information that the visual circuit was clear but that there was one at 1500ft conducting a photo survey.

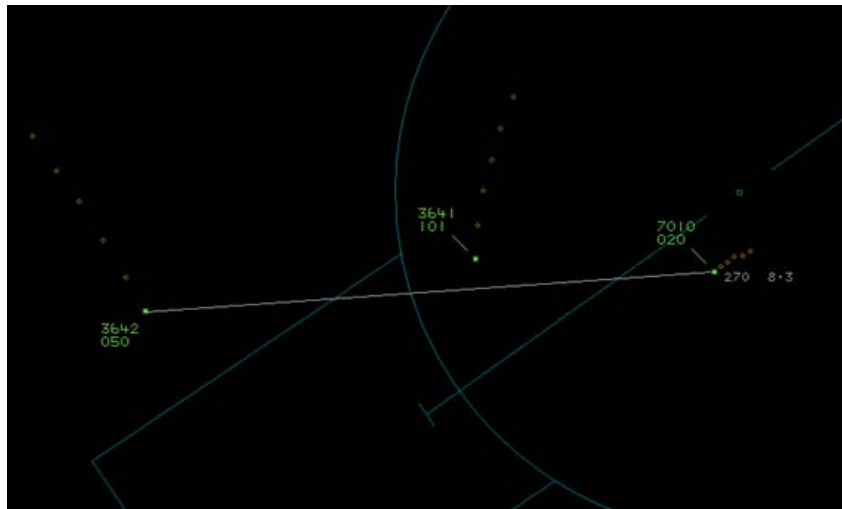
Figure 3: Geometry at 11:43:25 (Tornado 3642; C150 7010)

At 11:43:25 (Figure 3), the Marham Tower controller passed traffic information to the Tornado on the C150, describing its position as east of 'you' by 10nm, tracking west. The C150 was actually 8nm to the east of the Tornado at the time; however the Tower controller only had reference to an ATM from which to glean the information. Shortly afterwards, the Approach controller called the Tower controller and suggested that he pass TI relative to the airfield.

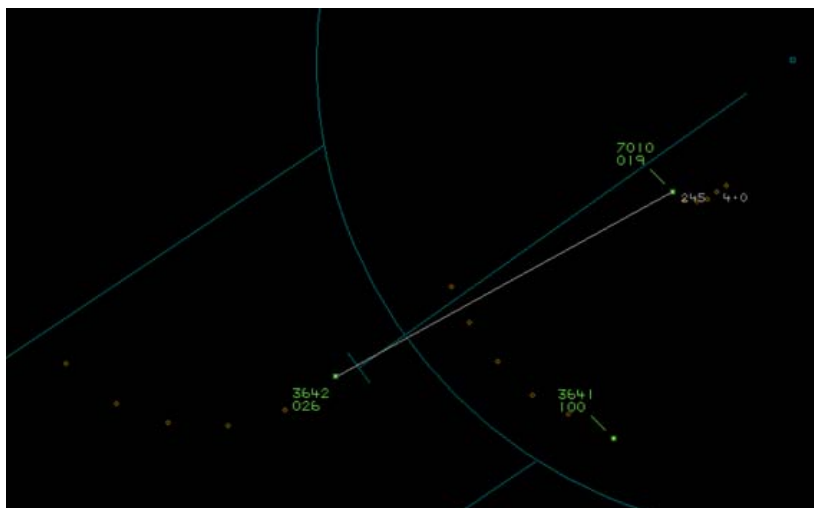
Figure 4: Geometry at 11:44:07 (Tornado 3642; C150 7010)

At 11:44:07 (Figure 4), the Marham Tower controller passed TI to the Tornado on the C150 as Marham 220 [degrees], 2nm; the Tornado pilot responded he was climbing to 2000ft.

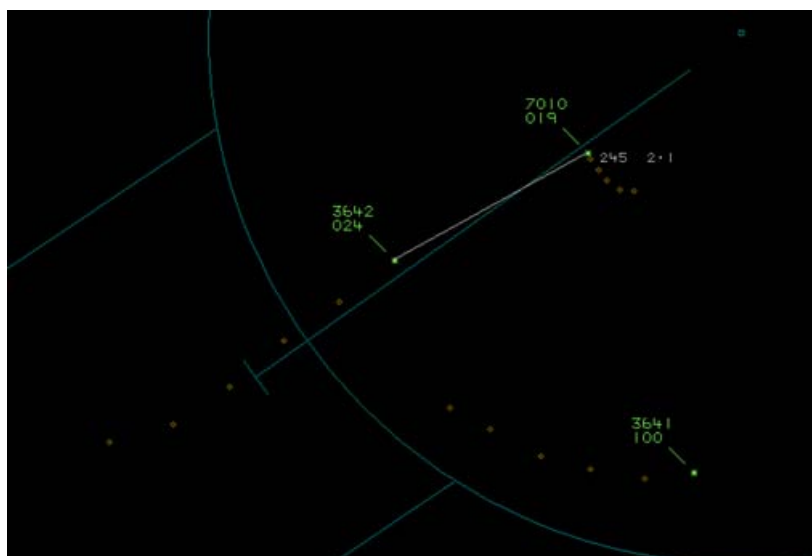
Figure 5: Geometry at 11:44:19 (Tornado 3642; C150 7010)

At 11:44:19 (Figure 5), the Marham Tower controller updated the TI to the Tornado, reiterating that the C150 traffic was at 1500ft. Its position was described as east by 1.5nm, 500ft below.

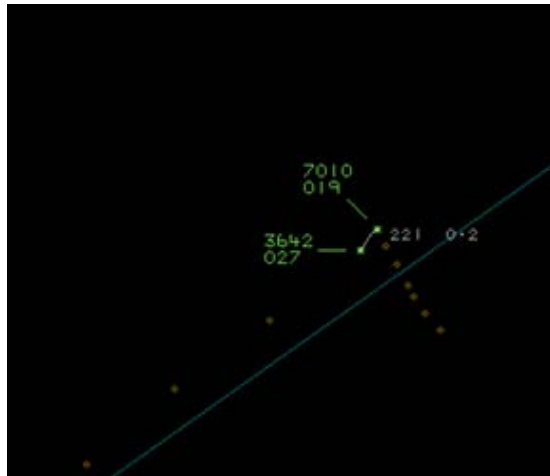
Figure 6: Geometry at 11:44:34 (Tornado 3642; C150 7010)

At 11:44:34 (Figure 6), the 2 aircraft passed at a CPA of approximately 0.1nm laterally and 800ft vertically. The Tornado pilot asked whether the C150 intended to stay on the centreline, prompting the Tower controller to ask the C150 pilot his intentions. Simultaneously, the Tornado pilot stated that he was joining the circuit at 1000ft.
