AIRPROX REPORT No 2017107

Date: 03 Jun 2017 Time: 1714Z Position: 5344N 00105W Location: Burn

PART A: SUMMARY OF INFORMATION REPORTED TO UKAB

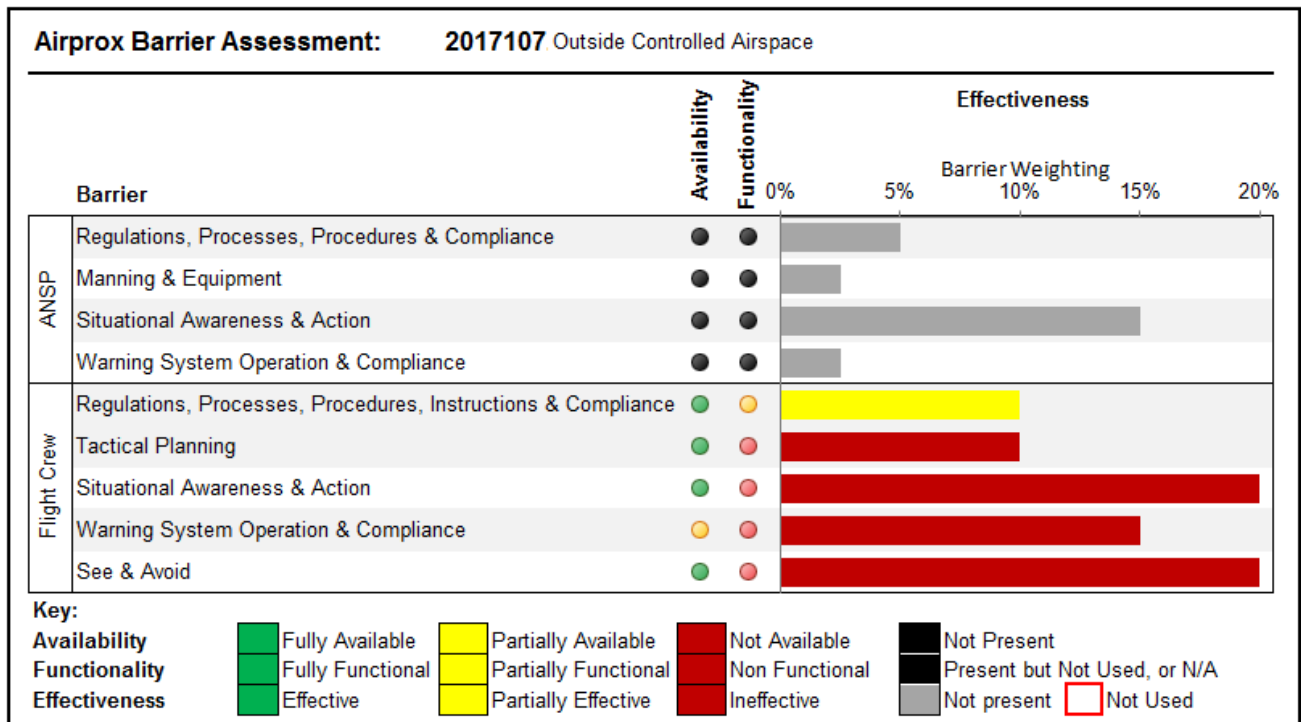
Safety Barrier Assessment³

Regulations, Processes, Procedures, Instructions & Compliance was assessed as **partially effective** because the DA40 pilot had overflown Burn.

Tactical Planning was assessed as **ineffective** because the DA40 pilot did not modify his routing to avoid overflying Burn after he had tracked further south than usual to clear the Sherburn circuit.

Situational Awareness & Action was assessed as **ineffective** because the DA40 pilot was not aware that he had overflown Burn until after the event, and neither pilot had any knowledge of the other's presence.

Warning System Operation and Compliance was assessed as **ineffective** because although the Glider had P-FLARM it did not warn the glider pilot (or he did not assimilate it) and the DA40 was not fitted with a CWS at the time.

See and Avoid was assessed as **ineffective** because neither pilot saw the other in time to take avoiding action.
