**AIRPROX REPORT No 2017130**

Date: 21 Jun 2017 Time: 1721Z Position: 5040N 00133W Location: Freshwater Bay, IoW

**PART A: SUMMARY OF INFORMATION REPORTED TO UKAB**

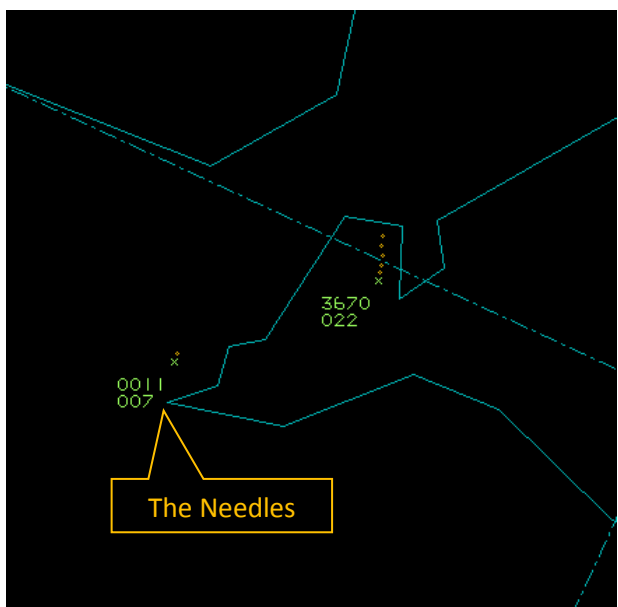
Figure 1 – 1719:55

At 1719:40, the DR400 pilot reported his intention to descend to 500ft in the vicinity of The Needles, which was acknowledged by the controller. Figure 1 shows the situation at 1719:55.

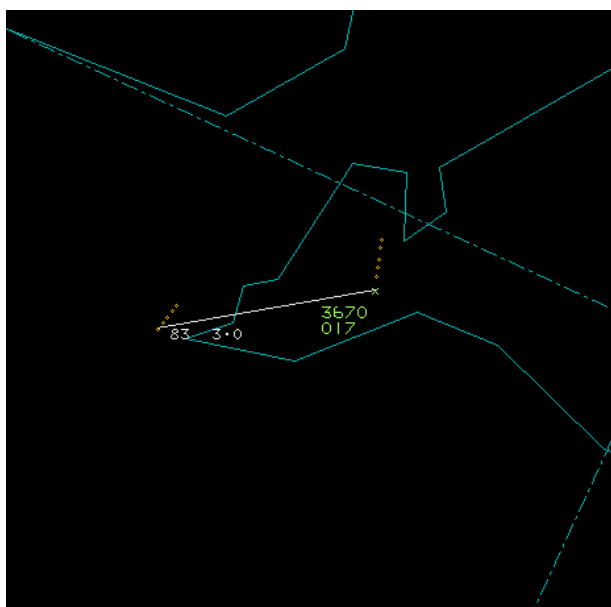
Figure 2 - 1720:25

The C172 faded from radar cover at 1720:25 in the vicinity of the Needles, still indicating 700ft and 3nm west of the DR400 (Figure 2).

The DR400 then faded from the radar recording at 1720:40, whilst still tracking south, passing 1600ft in the descent, 2.9nm from the last observed position of the C172.
