**AIRPROX REPORT No 2017131**

Date: 26 Jun 2017 Time: 1316Z Position: 5204N 00044W Location: W Cranfield

**PART A: SUMMARY OF INFORMATION REPORTED TO UKAB**

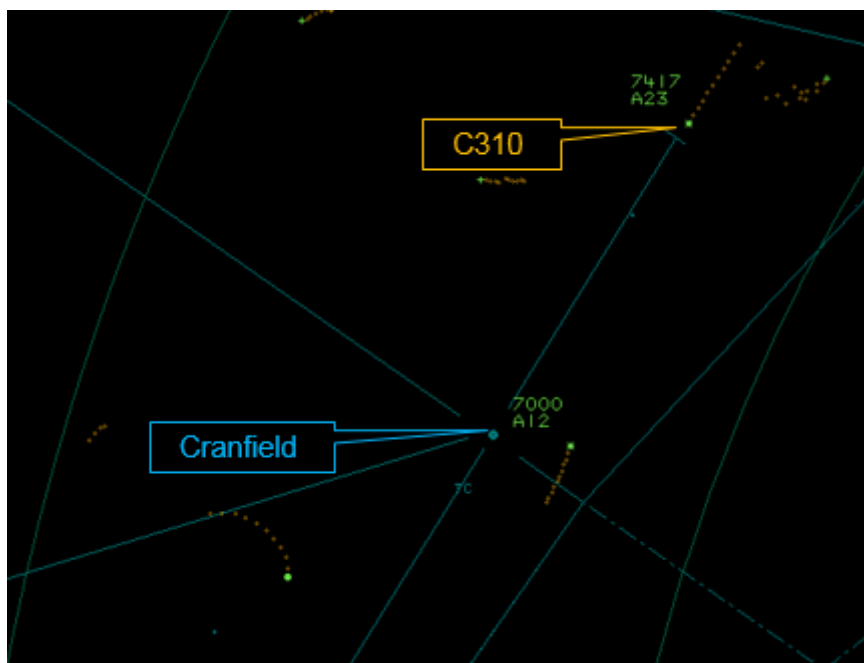
Figure 1 – 1309:52

The C310 was IFR and had requested an RNAV approach to Cranfield. At 1302:47, Cranfield issued the conspicuity code of 7417 and a Procedural Service was agreed. Then, at 1302:58, the C310 was cleared for the RNAV approach to RW21. At 1309:52, (Figure 1), the C310 was established inbound on the approach and at 1312:12, the C310 was observed to commence a climb, consistent with a missed approach.

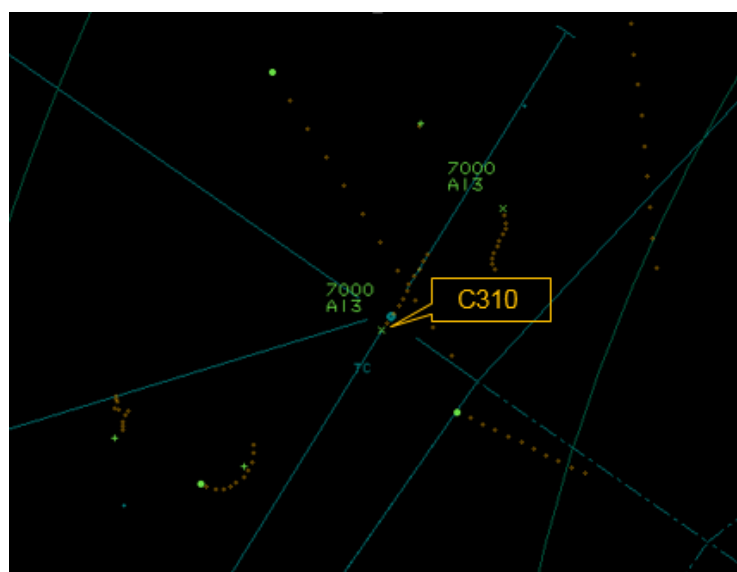
Figure 2 – 1312:39

At 1312:39, (Figure 2), the SSR code changed to 7000 as Cranfield had instructed, and a Basic Service was agreed because the C310 was now departing to the north-west VFR.

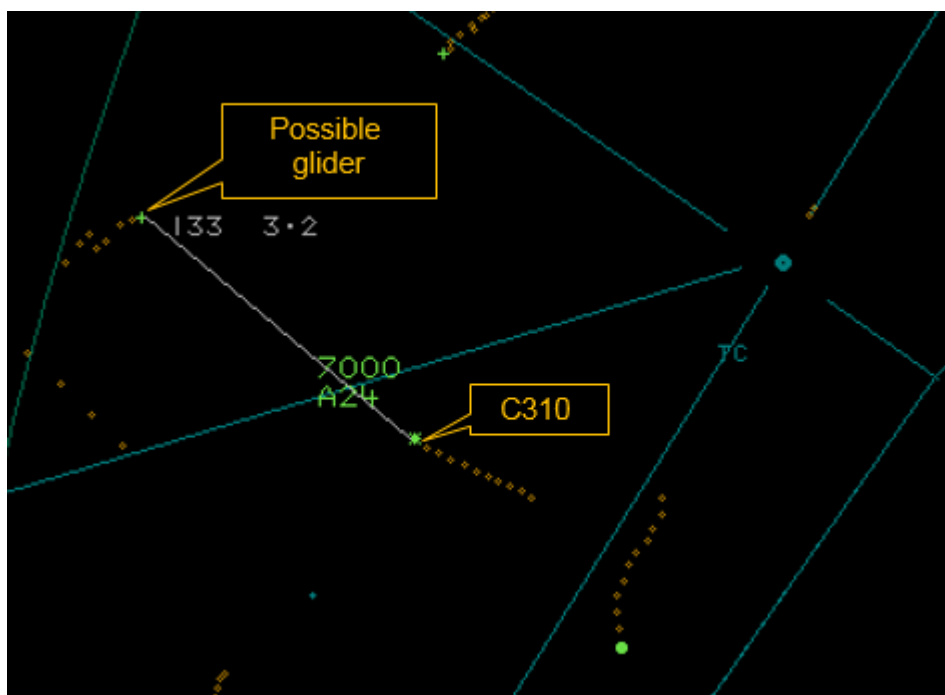
Figure 3 – 1315:04

At 1315:04 (Figure 3) the radar indicated a primary-only contact 3nm north-west of the C310. There was no height information and the Cranfield controller would not have been able to observe this contact because they were not using surveillance equipment.

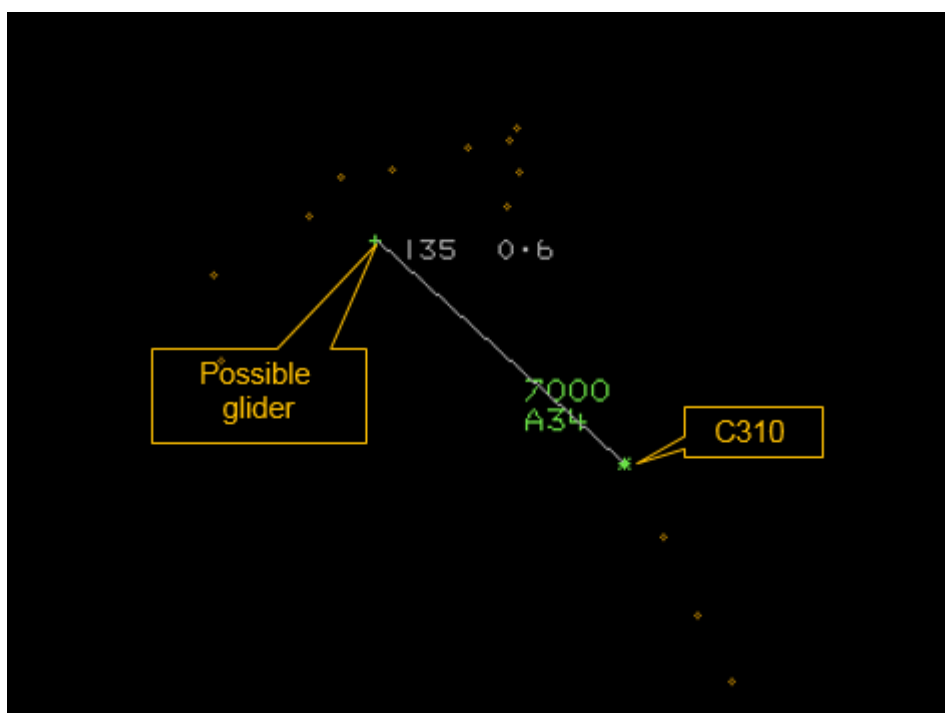
Figure 4 – CPA on radar 1316:11

On the radar, the closest that the C310 came to the primary returns was at 1316:11, (Figure 4), when the C310 appeared to be 0.6nm from the primary-only contact. Based on the pilot reports, and the altitudes and tracks observed, there is a strong likelihood that this primary contact is the glider pilot that reported the Airprox.

The difference in separation reported by the aircraft involved and that from the radar traces suggests that the primary return may not have been from the glider which reported the Airprox.
