AIRPROX REPORT No 2017190

Date: 10 Aug 2017 Time: 1046Z Position: 5213N 00251W Location: Shobdon (elev: 317ft)

PART A: SUMMARY OF INFORMATION REPORTED TO UKAB

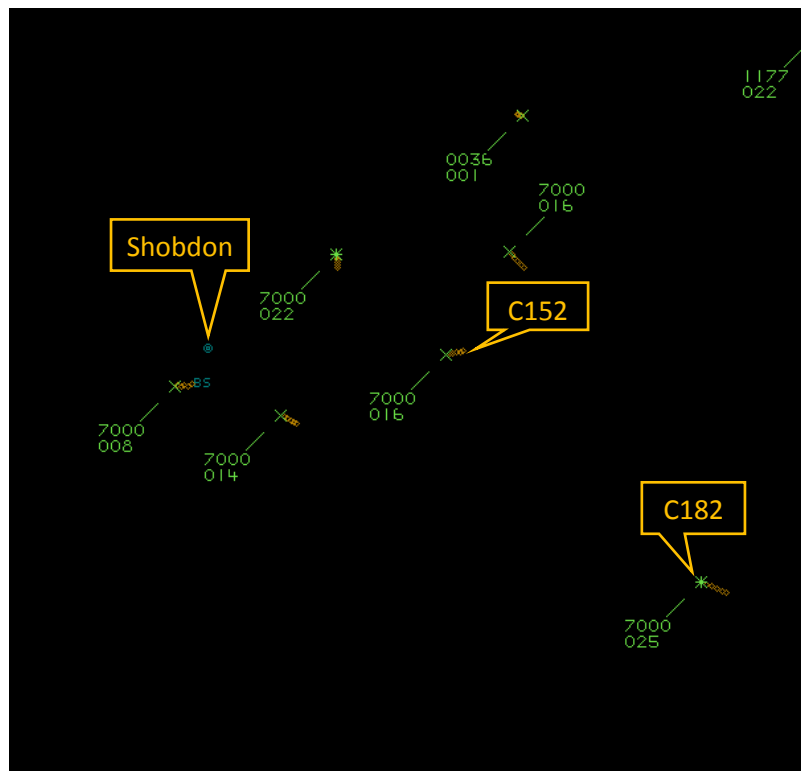
Figure 1 – 1038:18

At approximately 1038 the C182 pilot reported being inbound. The AFISO advised that RW08 was in use with a right-hand pattern, and passed the QFE. Shortly afterwards, the AFISO requested a position report from the C182 pilot, which was given as 15nm east of the airfield. The AFISO acknowledged this, requested that the pilot report the airfield in sight and advised him that it was a Basic Service, Figure 1.

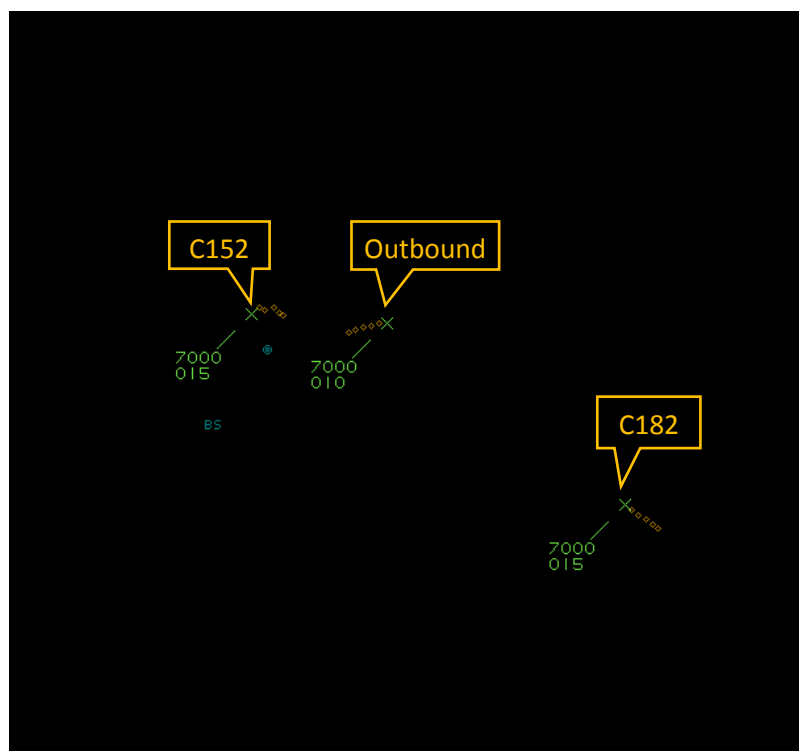
Figure 2 – 1043:40

At approximately 1043 the C152 pilot reported turning onto the deadside. The AFISO requested a call in the downwind position which was acknowledged by the student pilot, Figure 2.

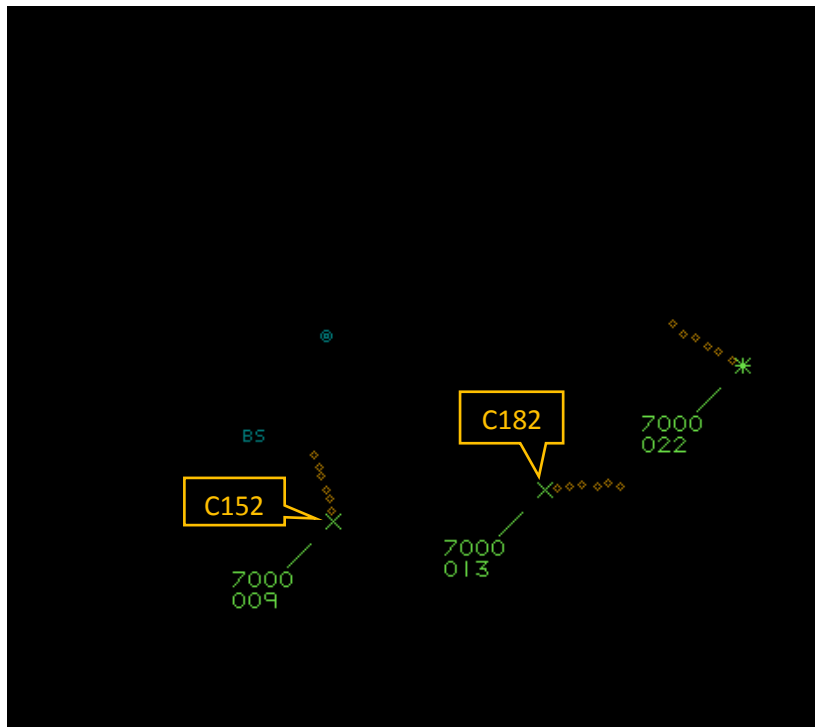
Figure 3 – 1045:20

At approximately 1044 the C182 pilot reported the airfield in sight and advised that he would be joining downwind. The AFISO acknowledged this and passed Traffic Information to him on an outbound aircraft and to the outbound pilot on the C182. At approximately 1045 the C182 pilot reported downwind and was requested by the AFISO to report final, Figure 3.

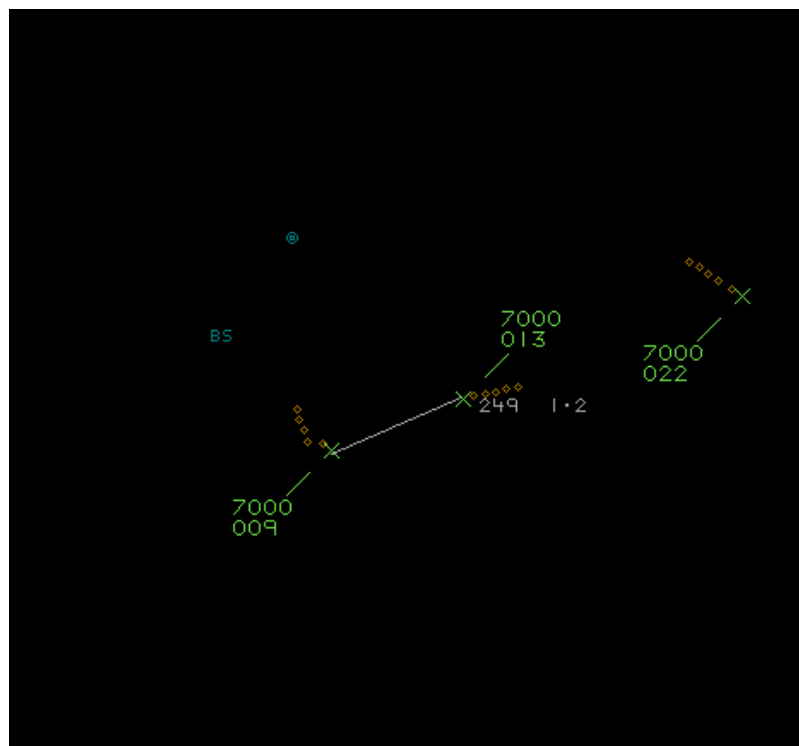
Figure 4 – 1045:10

Shortly afterwards the C152 pilot also reported downwind, Figure 4.

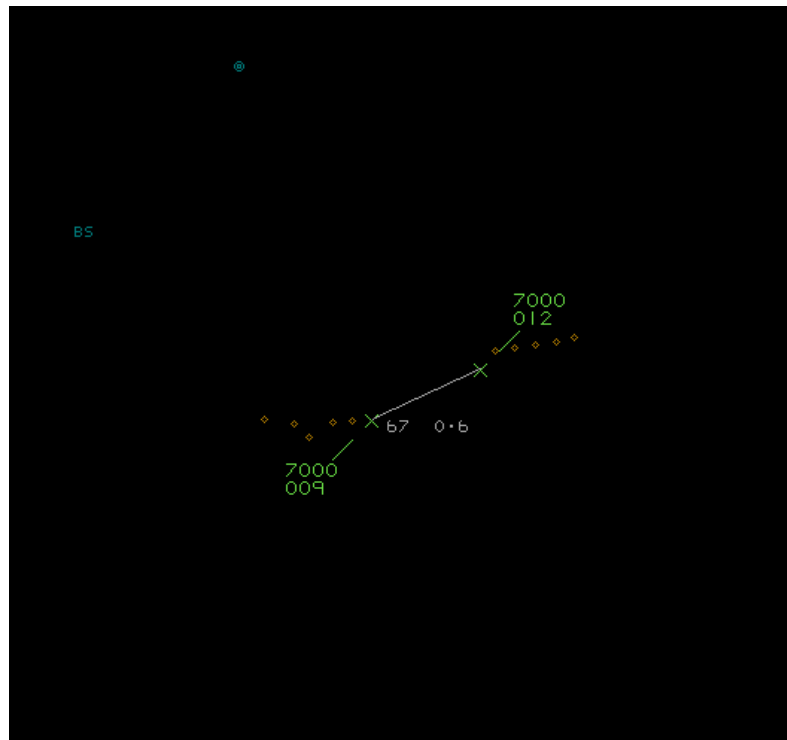
Figure 5 – 1045:35

The AFISO acknowledged this and at approximately 1045:35, asked the C152 pilot to confirm whether he was eastbound at that time. The student pilot asked the AFISO to repeat the message, who then received an acknowledgement and confirmation of easterly track from the C152 pilot, Figure 5.

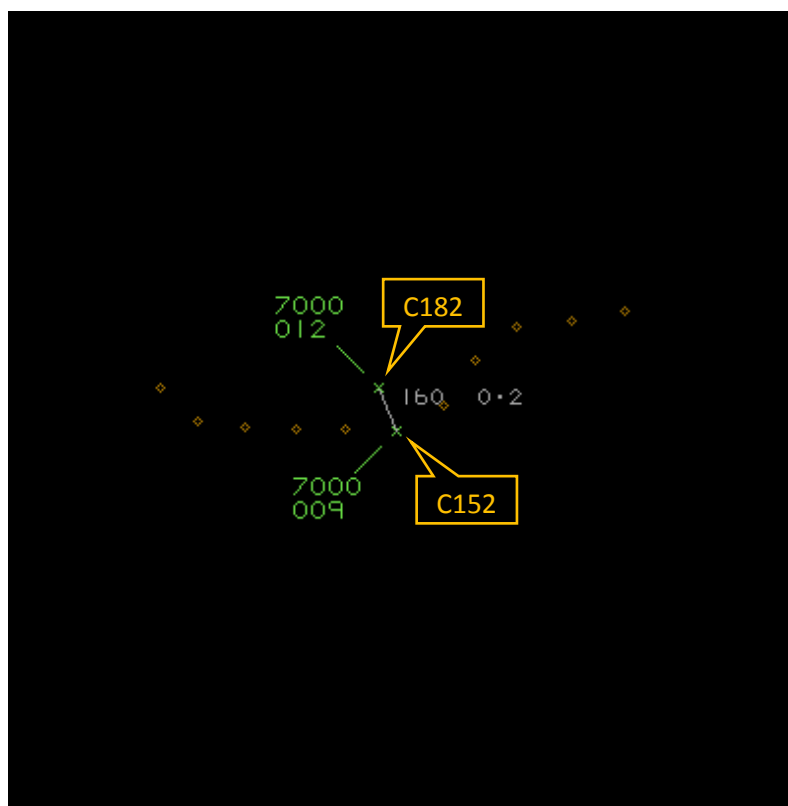
Figure 6 – 1045:53

CPA was assessed as taking place at 1045:53, with the C182 pilot having initially made a turn to the left, followed by a sharper turn to the right, and with the aircraft separated by 0.2nm laterally and 300ft vertically, Figure 6.
