AIRPROX REPORT No 2017210

Date: 25 Aug 2017 Time: 1220Z Position: 5729N 00333W Location: 15nm S Lossiemouth

PART A: SUMMARY OF INFORMATION REPORTED TO UKAB

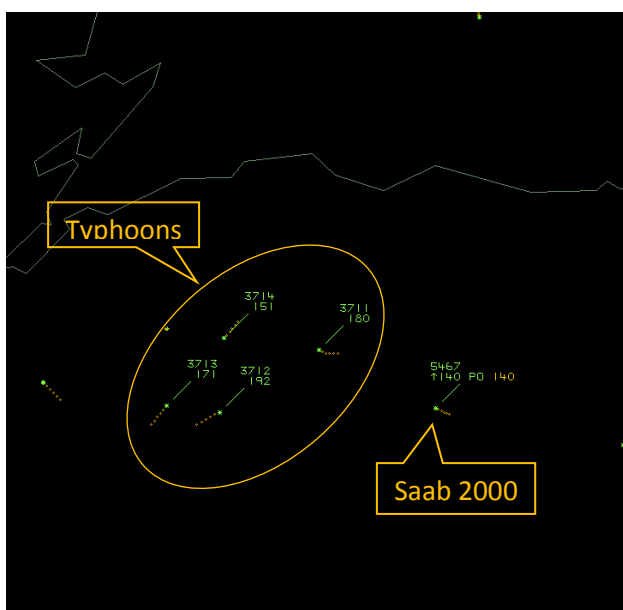
Figure 1 – 1215:20.

The Typhoon was one of four similar types which had been observed by the Scottish controller to have been operating in the area to the south of Lossiemouth for approximately one hour. With the Saab 2000 due to leave controlled airspace on departure from Aberdeen, the controller initiated early coordination (at 1208) with the Lossiemouth controller against the Typhoons. It was agreed that the Saab 2000 would not be above FL140, (although flight-planned to cruise at FL160), with the Typhoons to be not below FL150. At 1211:51 the Scottish controller instructed the Saab 2000 pilot to climb to FL140 advising that they would be leaving controlled airspace in 10nm and requested the type of ATC service they required. A Deconfliction Service was agreed and at 1212:47 the controller advised the Saab 2000 pilot of the presence of the Typhoons, stating that there might be an opportunity for further climb once clear of them. The controller went on to pass updated Traffic Information on the Typhoons at 1215:20 (Figure 1).

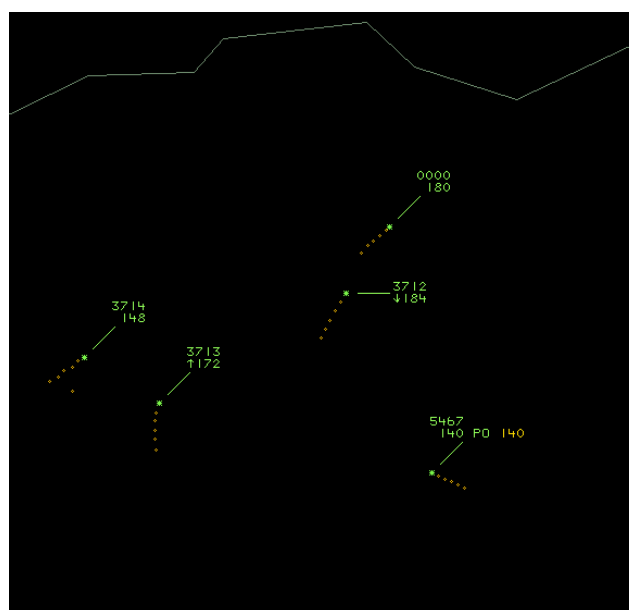
Figure 2 – 1217:25

At 1217:25 the Saab 2000 pilot requested a right turn of 15° to avoid weather, which was approved (Figure 2).

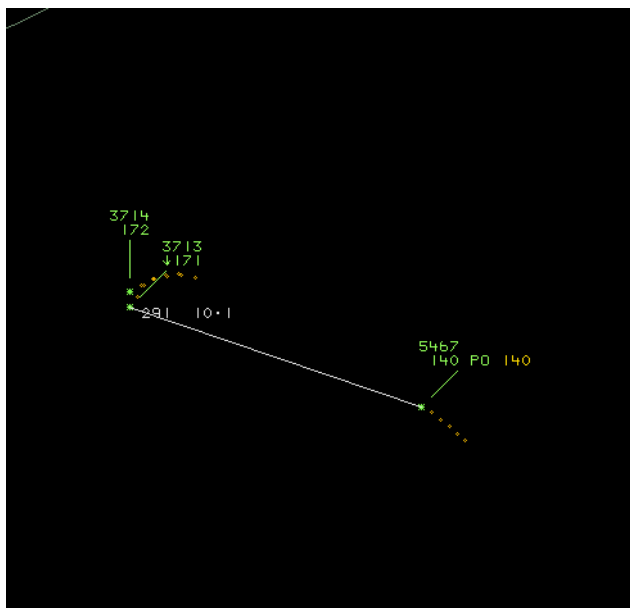
Figure 3 – 1219:10.

Between 1217:40 - 1219:10 the controller was dealing with other traffic (Figure 3 at 1219:10).

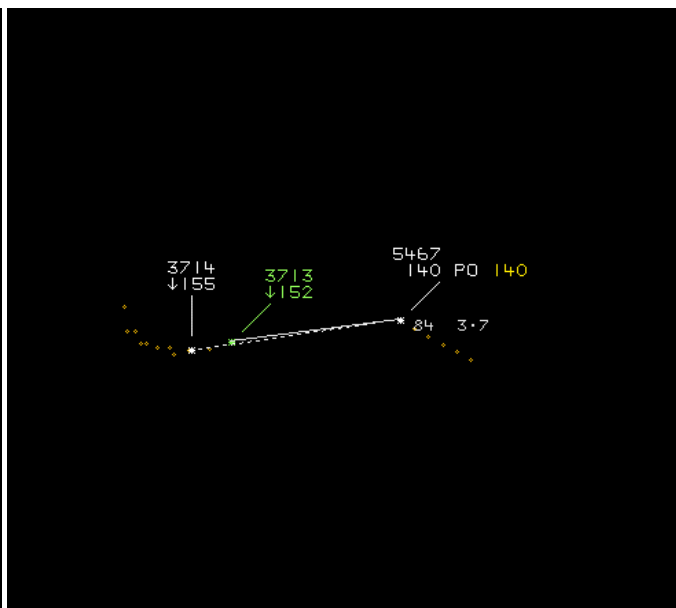
Figure 4 – 1219:50.

At 1219:50 the controller passed Traffic Information on the Typhoon to which the pilot replied that they (the Typhoons) were passing overhead (Figure 4).

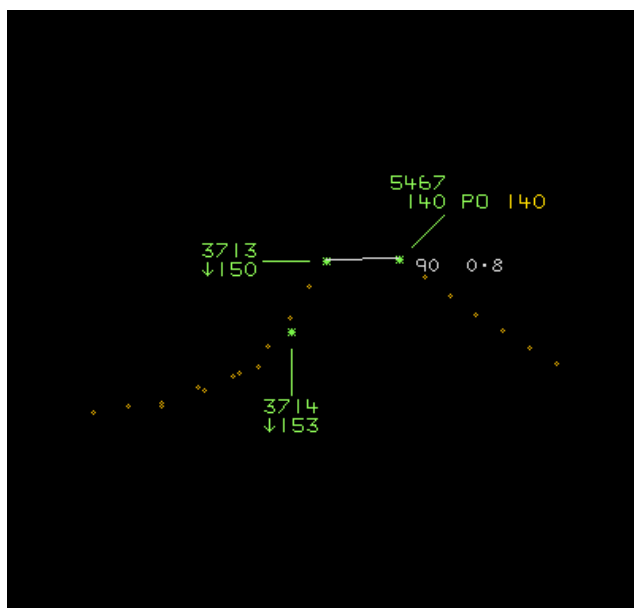
Figure 5 – 1220:07.

At 1220:07 the Saab 2000 pilot reported receiving a TCAS RA (Figure 5).

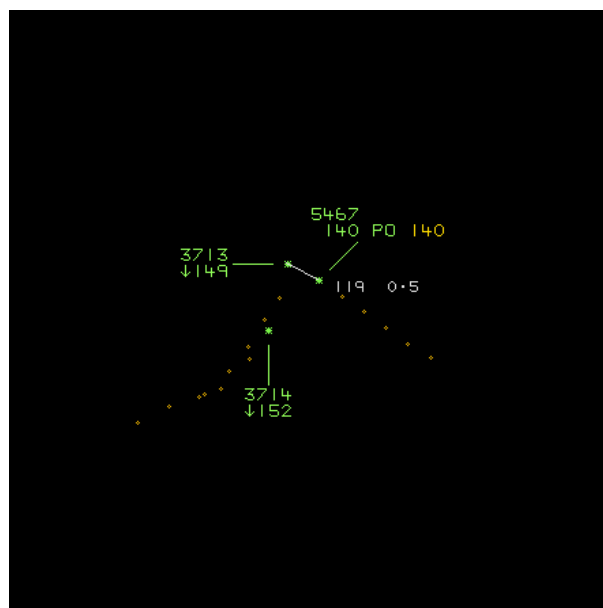
Figure 6 – 1220:13.

The first Typhoon passed ahead of and 1000ft above the Saab 2000 at 1220:13 (Figure 6).

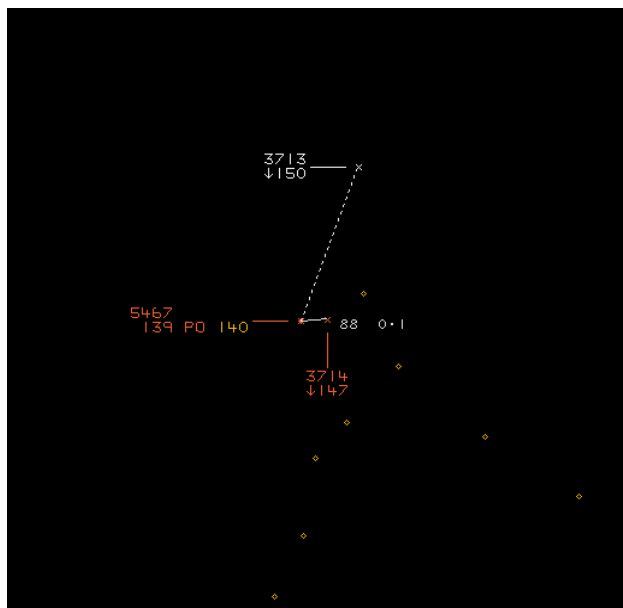
Figure 7 – 1220:21.

CPA with the second Typhoon took place at 1220:21 with the aircraft separated by <0.1nm laterally and 800ft vertically (Figure 7).

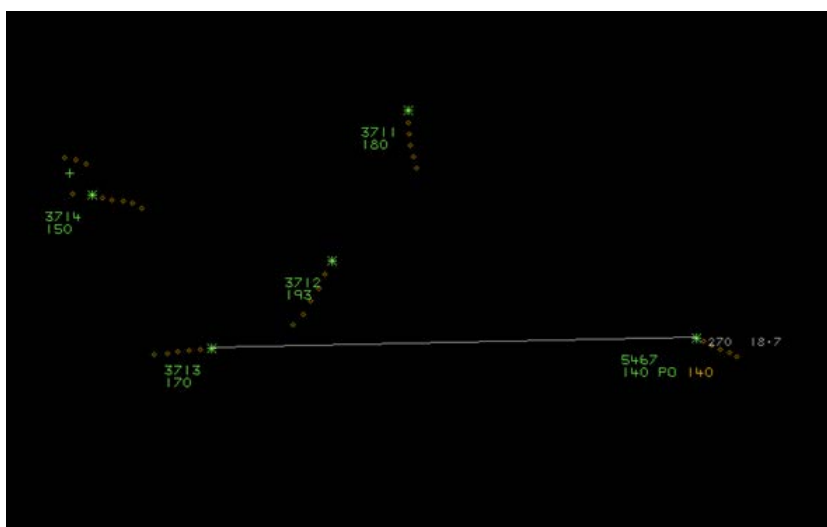
Figure 8: Geometry at 12:16:15 (Saab 2000 5467; Typhoons 3713/4).

At 12:16:15 (Figure 8), the Lossie Approach Controller requested that all elements of the two pairs of Typhoons under his control remain not below FL150 for coordination. The lead pilot of pair (3711/2) acknowledged, but the lead pilot of the Airprox pair (3713/4) did not.

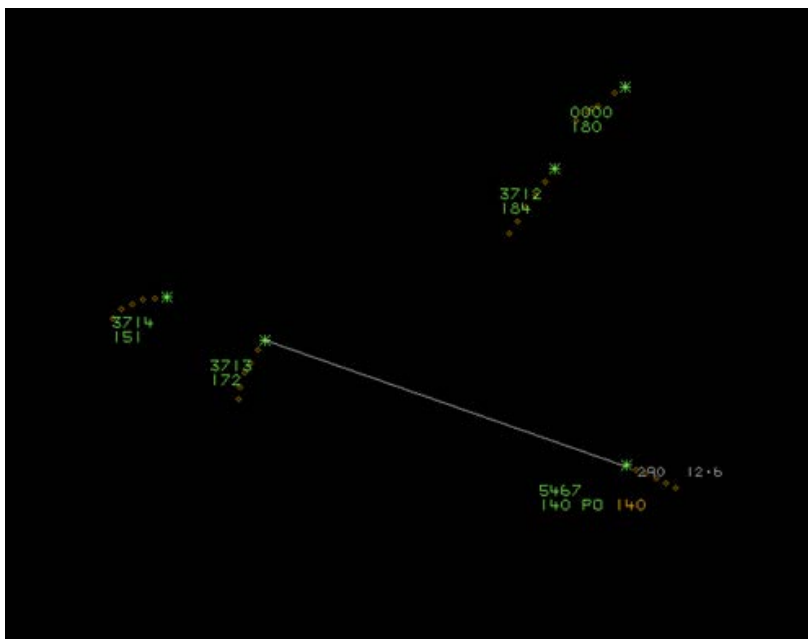
Figure 9: Geometry at 12:17:38 (Saab 2000 5467; Typhoons 3713/4).

At 12:17:38 (Figure 9), the Lossie Approach Controller instructed the other pair of Typhoons, now clear of the coordinated Saab 2000, to descend for recovery back to RAF Lossiemouth.

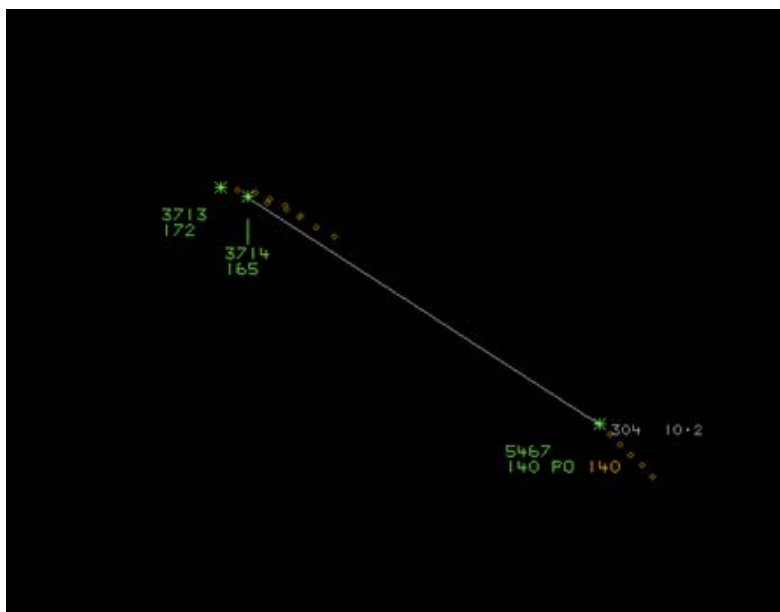
Figure 10: Geometry at 12:18:47 (Saab 2000; 5467; Typhoons 3713/4).

At 12:18:47 (Figure 10), the Lossie Approach Controller requested that the Airprox pair of Typhoons, now ready for recovery to RAF Lossiemouth, remain not below FL150 for coordination. The lead pilot gave a readback of not below FL50, which the Controller heard and corrected. The lead pilot then read back FL150.

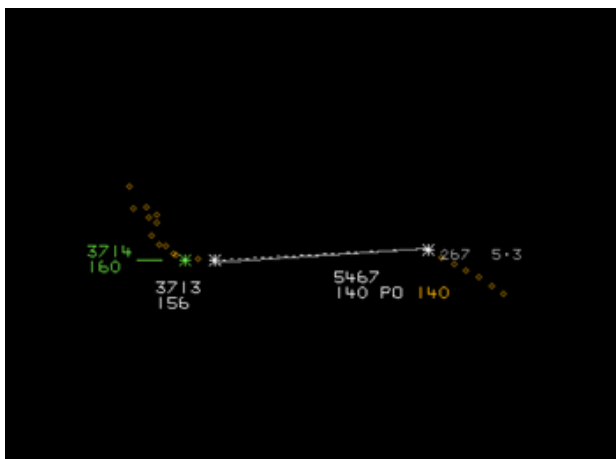
Figure 11: Geometry at 12:19:40 (Saab 2000 5467; Typhoons 3713/4).

At 12:19:40 (Figure 11), the Lossie Approach Controller passed Traffic Information to the Typhoon pair on the traffic coordinated below at FL140.

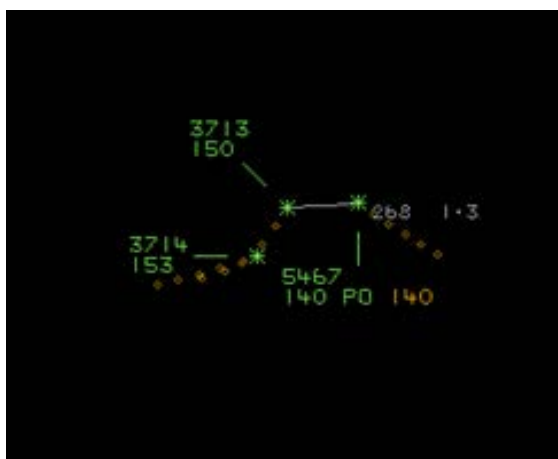
Figure 12: Geometry at 12:20:05

At 12:20:05 (Figure 12), the lead Typhoon pilot stated that the pair would be at minimum fuel in one minute, requesting to begin descent. The Controller responded that the pair was ‘on top of’ the coordinated traffic, which was acknowledged by the lead pilot.

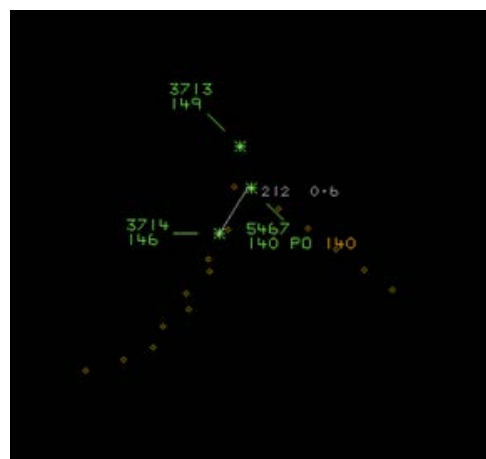
Figure 13: Geometry at 12:20:16

At 12:20:16 (Figure 13), the second Typhoon mode C was seen to read FL146, followed by FL142 (Figure 14), before climbing back up to FL147 as the Saab 2000 began to descend (Figure 15).

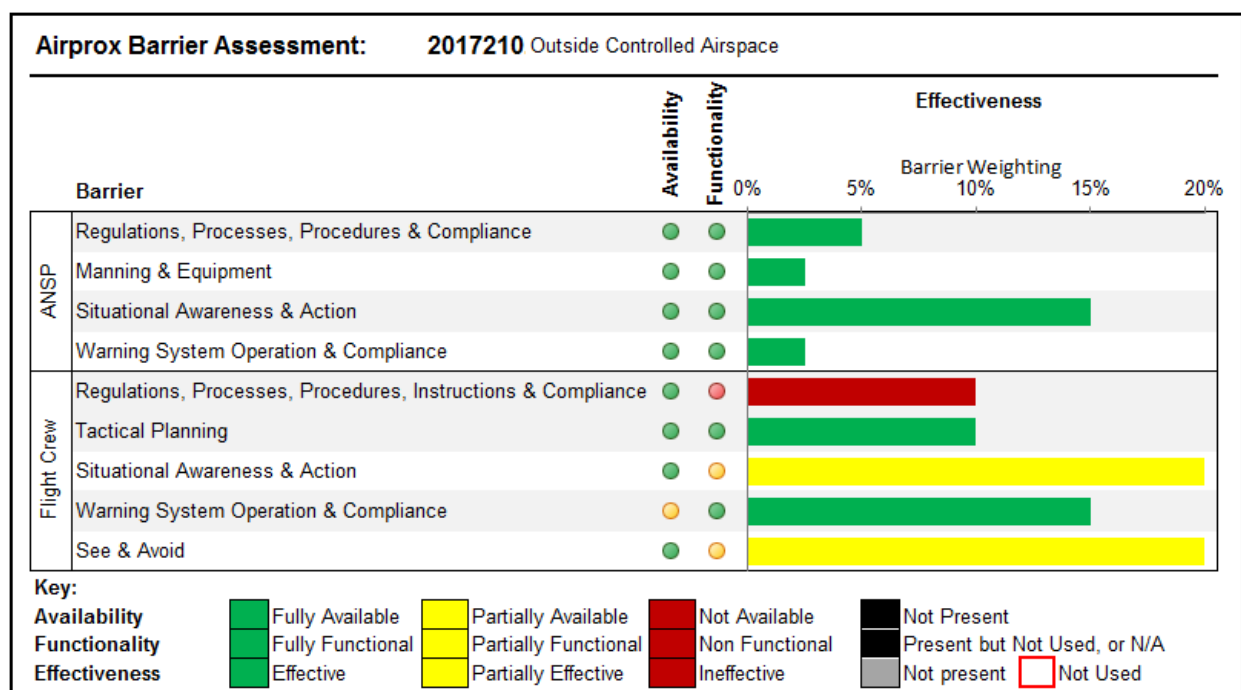
Regulations, Processes, Procedures, Compliance and Instructions were assessed as **ineffective** because the Typhoon No2 pilot descended below his cleared level.

Situational Awareness and Action were assessed as **partially effective** because the Typhoon pilots were generally aware of the presence of the Saab 2000 in the area but not its exact position relative to their aircraft.

See and Avoid were assessed as **partially effective** because only the Saab 2000 pilot saw the other aircraft, and that was at a late stage when he had few options to increase separation.
