AIRPROX REPORT No 2017209

Date: 28 Aug 2017 Time: 1519Z Position: 5255N 00242W Location: Tilstock

PART A: SUMMARY OF INFORMATION REPORTED TO UKAB

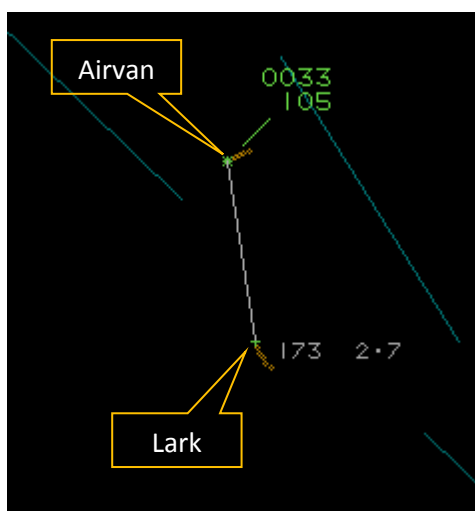
Figure 1 - 1516:30

At 1516:30 the Lark pilot called the Hawarden Radar Controller, advised that they were inbound from Ternhill at 4500ft, and that the aircraft was not transponder equipped. The controller instructed the pilot to join left base for RW22 and to report at Wrexham. A Basic Service was agreed and the controller advised the pilot that Tilstock para dropping site appeared to be active. The pilot readback their joining instructions and responded that they would avoid the para dropping site. At this point the Airvan was maintaining FL105 (Figure 1). The Airvan commenced descent having completed the live drop of a freefall load, and the Lark was slightly east of the Airvan and last reported at 4500ft (Figure 2).

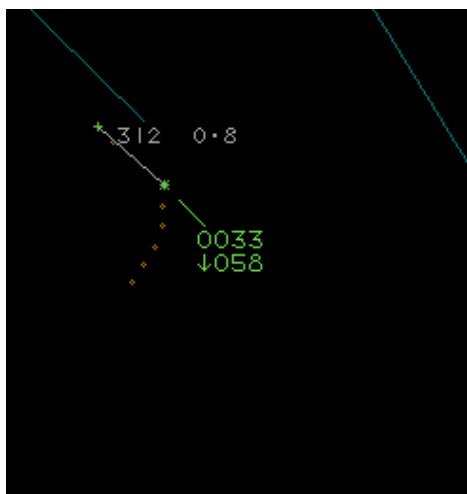
Figure 3 – 1518:16

At 1518:16 the Airvan was still in the descent, had undertaken a sweeping left turn, and started to tail the Lark (Figure 3). At 1518:38 the primary contact on the Lark faded leaving just the track history trail. The Airvan was on the right-hand side of the Lark, 100ft above the Lark's reported level (now 4400ft), and descending (Figure 4).

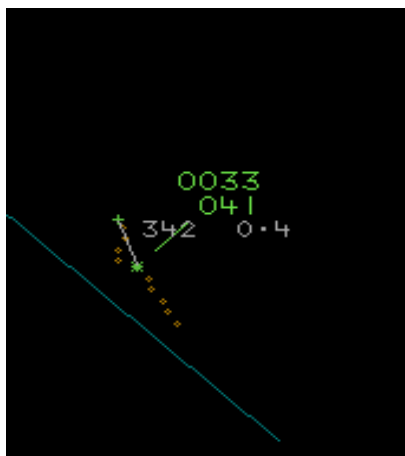
Figure 5 – 1520:02

At 1519:00, the Lark pilot reported the Airprox to the Hawarden controller but the primary return of the aircraft and the track history trail had faded. At 1519:46, the Lark primary return re-appeared and the Airvan was 300ft below the reported level of the Lark. By 1520:02 the Airvan was 0.4nm in trail and still 300ft below the reported level of the Lark, the primary return of the Lark again faded immediately after this (Figure 5). At 1520:45, the Airvan was 0.5nm in trail and indicating 4000ft. (Figure 6). At 1522:08, the Airvan commenced a turn to the south and continued descent inbound to Tilstock Airfield to land.

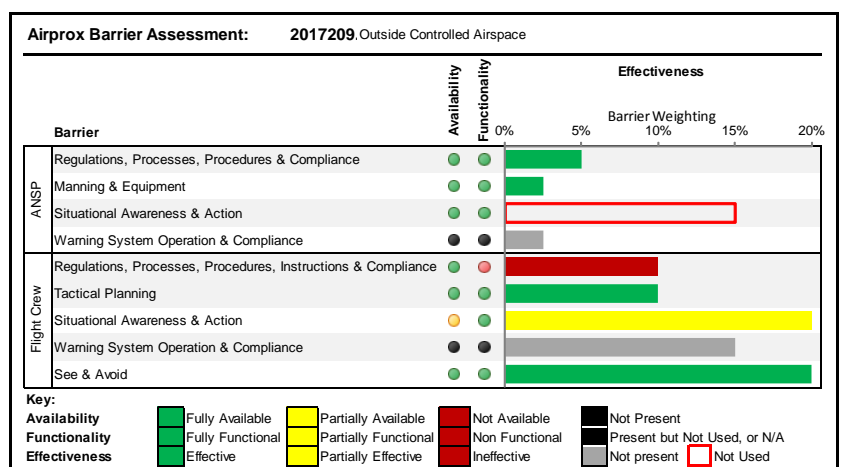
Regulations, Processes, Procedures, Instructions and Compliance were assessed as **ineffective** because the Airvan pilot flew too into close proximity with the Lark.

Situational Awareness and Action were assessed as **partially effective** because the Lark did not have any information on the Airvan prior to seeing him visually.

Warning System Operation and Compliance were assessed as **not present** because neither pilot had a CWS.
