AIRPROX REPORT No 2016001

Date: 6 Jan 2016 Time: 1300Z Position: 5054N 00233W Location: South of Yeovil

PART A: SUMMARY OF INFORMATION REPORTED TO UKAB

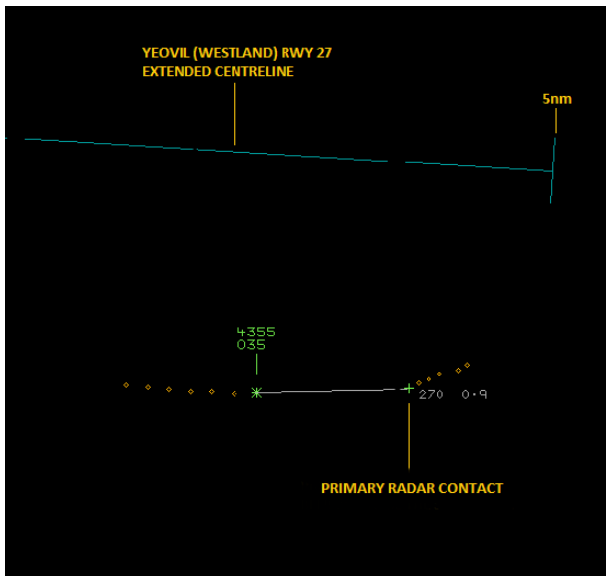
Figure 2: Swanwick MRT at 1259:23

At 1259:03, the Yeovil (Westland) controller passed traffic information on the Skyranger to the A109 pilot. Figure 2 shows the primary radar contact at 1259:23, 0.9nm east of the A109 and 1.4nm south of the Runway 27 extended centreline tracking west-southwest. It was not possible to accurately calculate CPA due to the primary radar contact fading in and out of radar coverage at the time the Airprox occurred. Figure 3 shows the relative positions of the A109 and the primary radar contact at 1259:25 when the contact faded from coverage. The primary contact briefly came back into coverage at 1259:32 but the track was inconsistent, and the primary radar return erratic and intermittent.

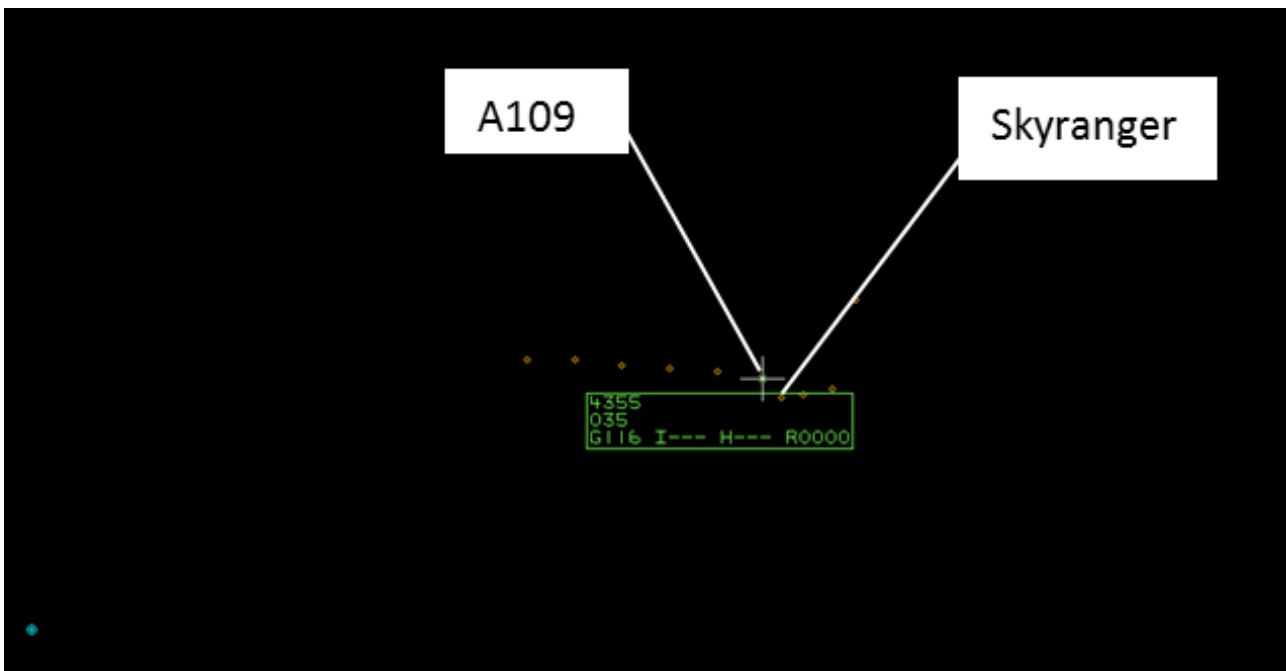
Figure 4: Area radar Screenshot

The A109 and Skyranger pilots shared an equal responsibility for collision avoidance and not to operate in such proximity to other aircraft as to create a collision hazard¹. If the incident geometry is considered as converging then the Skyranger pilot was required to give way to the A109². Figure 4 shows a screenshot of the area radar returns trail at 1259:36, shortly before the A109 pilot reported the Airprox at 1301:04.
