AIRPROX REPORT No 2016109

Date: 15 Jun 2016 Time: 1734Z Position: 4943N 00209W Location: ENE Alderney airport

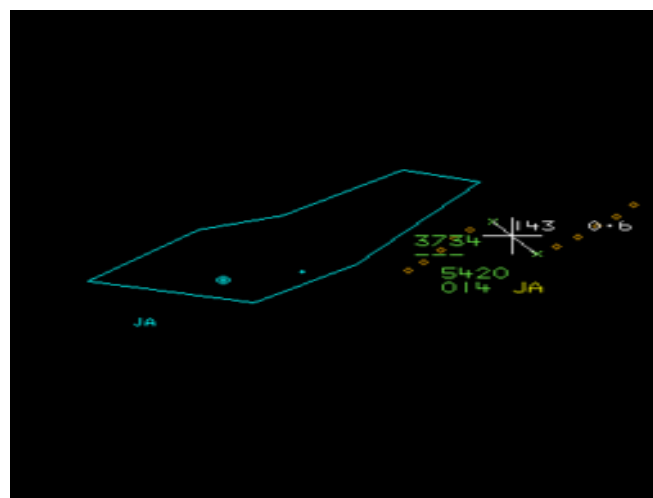
Figure 1 CPA 1734:54 (BN2 3734/D228 5420).

An Airprox was reported when a BN2 and a D228 flew into proximity at 1734 on Wednesday 15th June 2016. The D228 was inbound under IFR in VMC; the BN2 was on a training flight under VFR in VMC. Both pilots were in receipt of an Aerodrome Control Service from Alderney, within Class D airspace. Traffic Information was passed to both pilots. The BN2 pilot was instructed to remain south of the Island but crossed to the north through the RW26 approach path in front of the D228.

The Board quickly agreed that the BN2 pilot had clearly not complied with his clearance to remain to the south, but noted that the circumstances were such that the BN2 pilot had probably become task-focussed at low-level in conducting his cliff search and had only realised that he would fly through the centre-line at a late stage. Although prevention would have been better than recovery action, members noted that the BN2 pilot had then made a cogent risk assessment and had decided that the best course of action was to continue away from the conflict with the D228 and across the centre-line rather than attempt to comply with his clearance at such a late stage, which would likely have resulted in a closer encounter. Furthermore, realising that he was going to cross the final approach, the BN2 pilot had tried to advise ATC of the situation but the frequency was too busy at the time to be able to make the call.
