AIRPROX REPORT No 2016115

Date: 25 Jun 2016 Time: 1459Z Position: 5347N 00106W Location: Burn

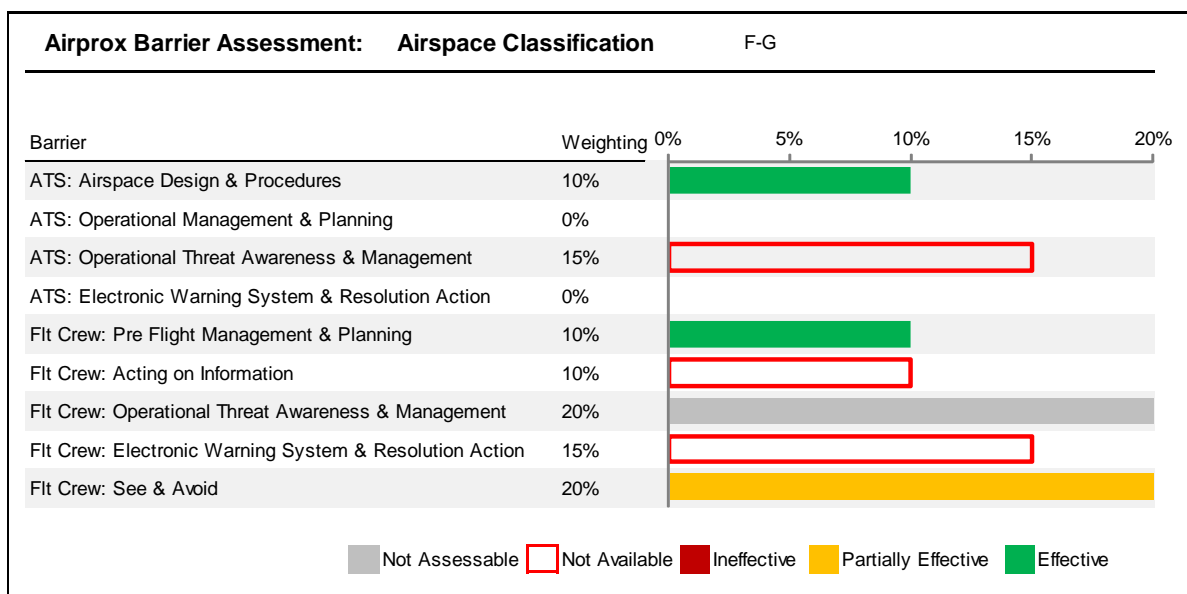
Barrier Assessment:

In assessing the barriers in this incident, the Board noted that many of the barriers were not available: in particular, an ATS was unlikely to have been practicable, and the lack of a CWS on either the Glider or the PA25 meant that this was another absent barrier. See-and-avoid had become the last line of defence, which the Board thought had only been partially effective in that it had been a

late/non-sighting by the glider/tug pilots, and probably a late sighting by the light-aircraft pilot based on his apparently last-ditch manoeuvre.
