**AIRPROX REPORT No 2016193**

Date: 29 Aug 2016 Time: 1119Z Position: 5111N 00105W Location: 1.5nm NW Lasham

**PART A: SUMMARY OF INFORMATION REPORTED TO UKAB**

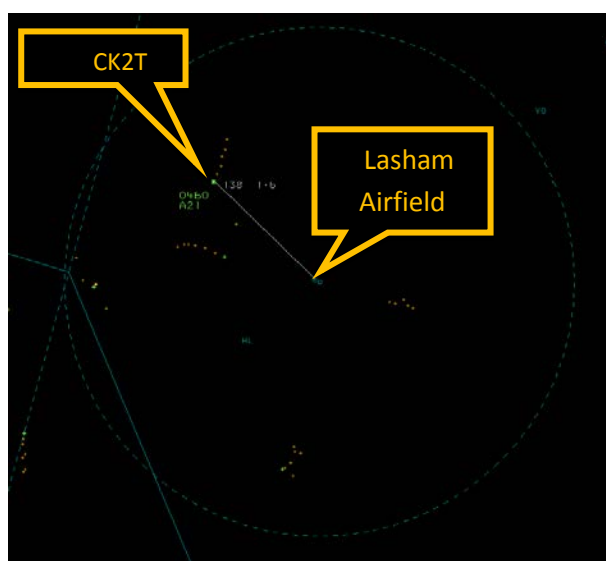
Figure 1 – 1120:38 UTC

Other than a request for the CT2K pilot to report his altitude at 1110:33 in order for the LARS West controller to verify his Mode C, there was no further communication with him until 1120:38 (Figure 1), when the controller, whilst handing over the LARS West position to another controller, noticed that the CT2K was close to Lasham. At this time, it was 1.6nm north-west of Lasham tracking south. Information was once again passed to the pilot regarding gliding in progress around Lasham, and the controller advised him to keep a very good lookout. In response to this, the CT2K pilot reported that he had just seen three aircraft in close proximity. The PA18 could not be identified nor CPA determined. During the period in which the CT2K transited the area of Lasham Airfield, numerous slow-moving, intermittent primary radar contacts were observed on the area surveillance recordings in the vicinity of Lasham.

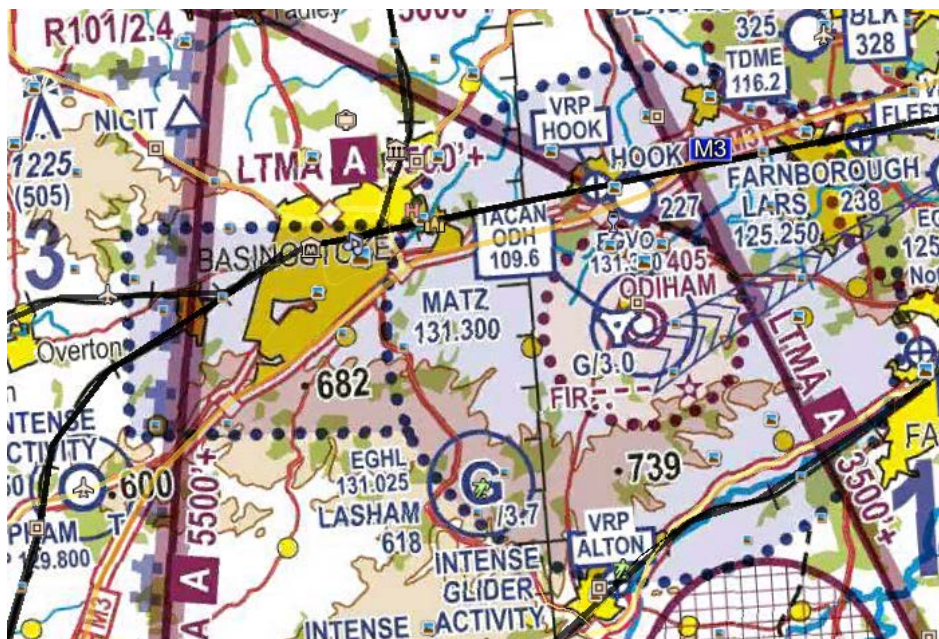
Figure 2 – Southern England and Wales 1:500,000 Aeronautical Chart

Lasham Airfield is notified in the UK AIP as being a gliding site with an upper winch-launch limit of 3700ft. It is marked on the Southern England 1:500:000 aeronautical chart as being an area of intense glider activity. For illustrative purposes the area around Lasham and RAF Odiham is reproduced in Figure 2.

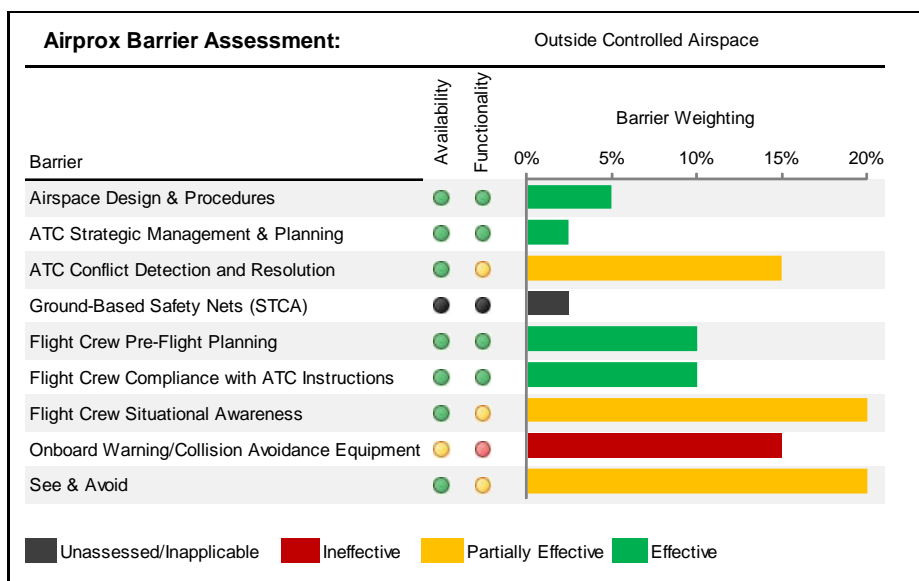
- **ATC Conflict Detection and Resolution** was considered to have been **partially effective** because although Farnborough ATC could not have seen the PA18 on their radar, and despite their not being required to do so under the terms of a Basic Service, they had given valuable generic Traffic Information about likely gliding activity in the region of Lasham.

- **Situational Awareness** was considered to be **partially effective** because neither pilot was aware of the other's close proximity until a late stage, and the CT2K pilot only had generic Traffic Information regarding the likely presence of gliders and tugs.

- **Onboard Warning/Collision Warning Equipment** was considered **ineffective** because although the PA18 had FLARM fitted, CT2K did not have a compatible system.

- **See-and-Avoid** was also assessed as only **partially effective** because only the CT2K pilot saw the other aircraft and took any form of avoiding action.
