## AIRPROX REPORT No 2016219

Date: 10 Oct 2016 Time: 1220Z Position: 5046N 00008E Location: 3nm NE Seaford VOR

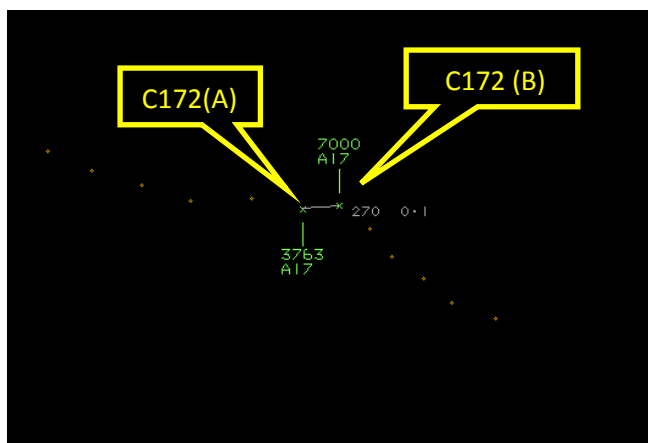
Figure 1 – 1220:19 UTC

CPA occurred between 1220:19 (Figure 1) and 1220:23 (Figure 2) with a minimum horizontal distance of less than 0.1nm and a minimum vertical distance of 0ft.

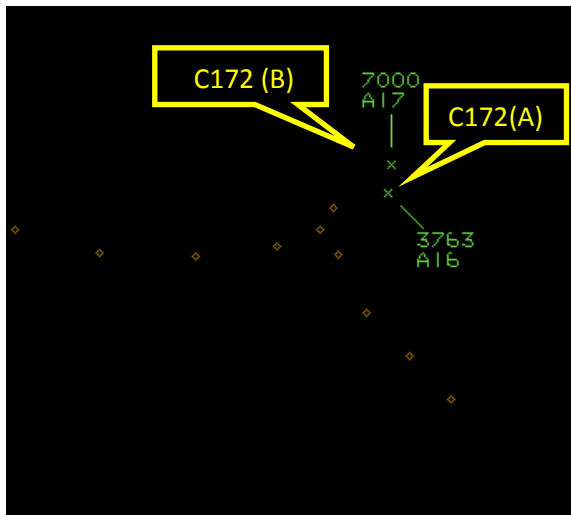
Figure 3 - 1220:32

C172(B)'s report and diagram did not match the C172(A) pilot's description of the event or the radar replay. However, shortly after CPA, the two aircraft again came into proximity and it is possible that this is the part of the incident that the pilot recalls, not initially having seen C172(A) when they initially closed. Screen shots of the radar just after the Airprox are reproduced at Figures 3 and 4.

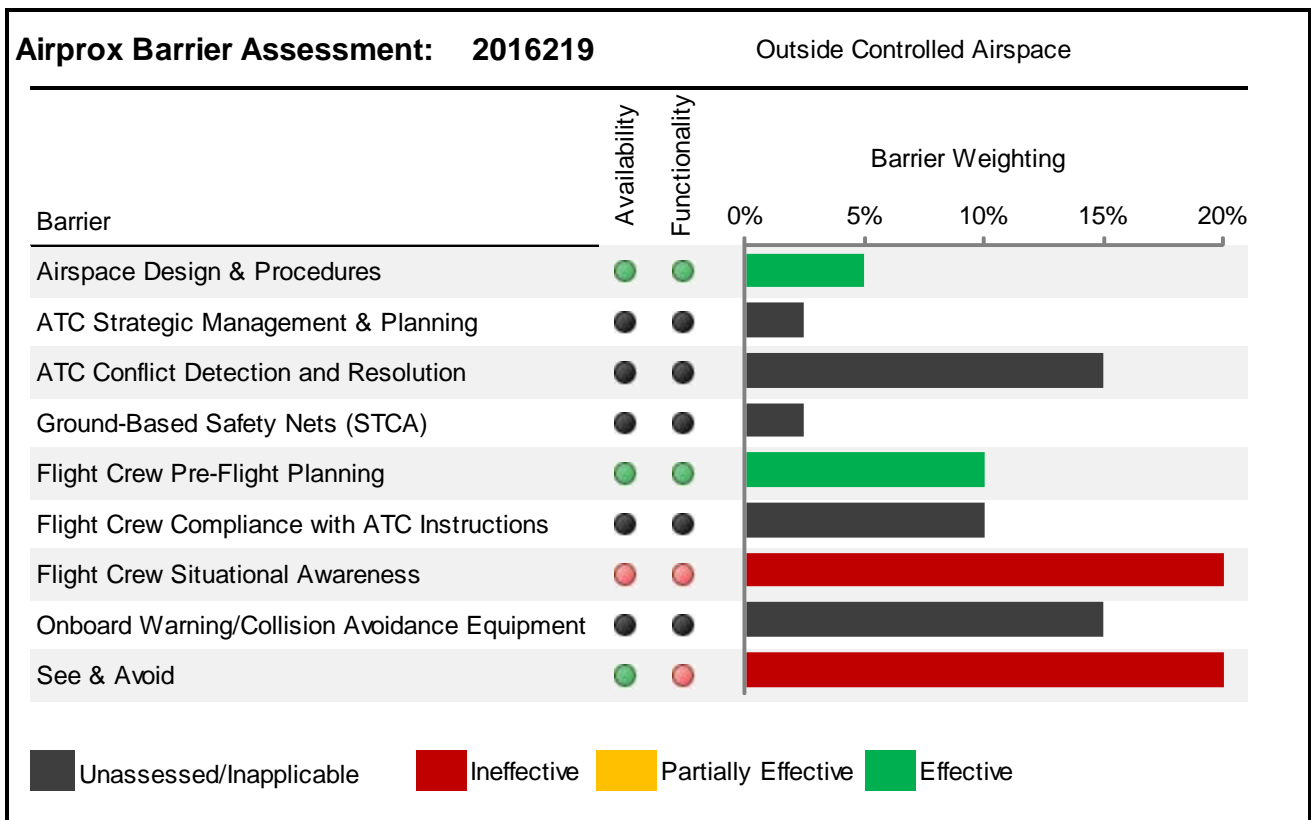
- **Flight Crew Situational Awareness** was **ineffective** because neither pilot knew about the other aircraft.
- **Onboard warning/Collision Avoidance Equipment** was **inapplicable** because neither aircraft was fitted with any form of TAS.
- **See and Avoid** was **ineffective** because neither pilot saw the other aircraft in time to take any avoiding action.

The colour of each bar represents the Board's assessment of the effectiveness of the associated barrier in this incident (either Fully Effective, Partially Effective, Ineffective, or Unassessable/Absent). The chart thus illustrates which barriers were effective and how important they were in contributing to collision avoidance in this incident.
