AIRPROX REPORT No 2016223

Date: 19 Oct 2016 Time: 1114Z Position: 5112N 00105W Location: Odiham

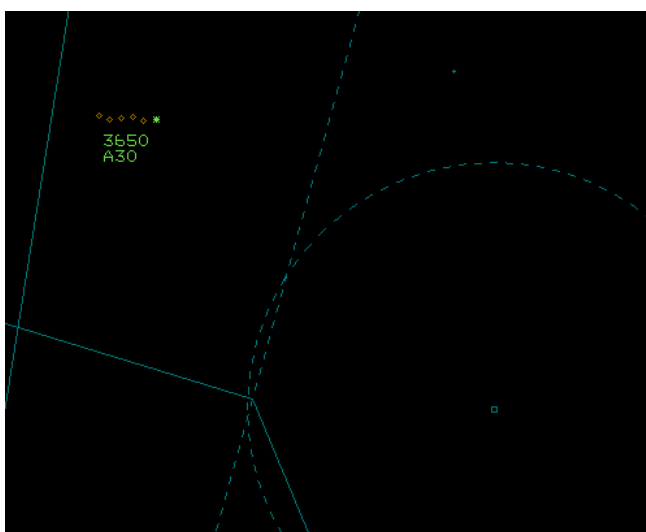
Figure 1: Geometry at 11:13:30
(Chinook SSR 3650)

At 11:13:30 (Figure 1), the Odiham Approach controller passed Traffic Information to the Chinook pilot on traffic south east, range 3nm, tracking north, no height information, believed to be a glider out of Lasham. No traffic was visible on the radar replay provided by the RAC.

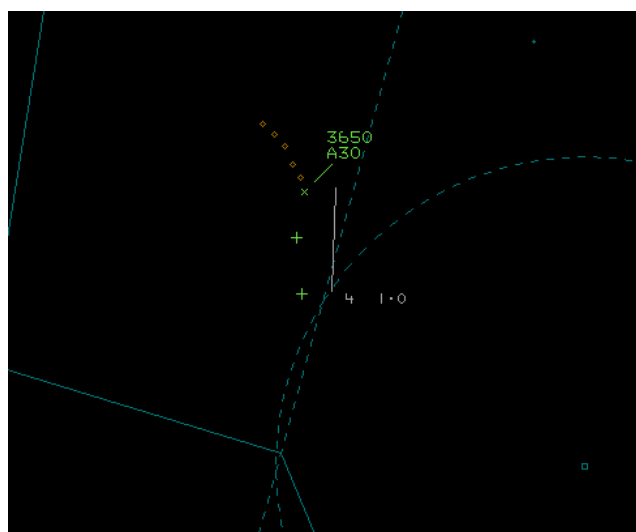
Figure 2: Geometry at 11:14:20

At 11:14:20 (Figure 2), two primary contacts began to appear in the area where the Odiham Approach controller had previously called traffic.

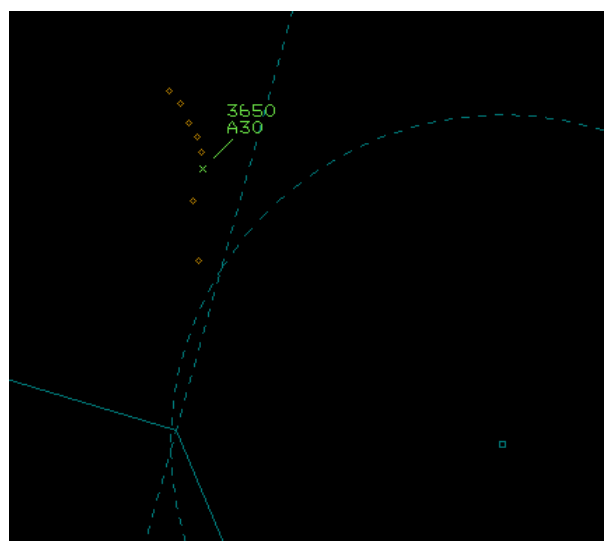
Figure 3: Geometry at 11:14:23

At 11:14:23 (Figure 3), the Odiham Approach controller updated the Traffic Information and Chinook described being visual with two vintage aircraft operating in and around the cloud. The description was subsequently changed to be a towing aircraft and glider.

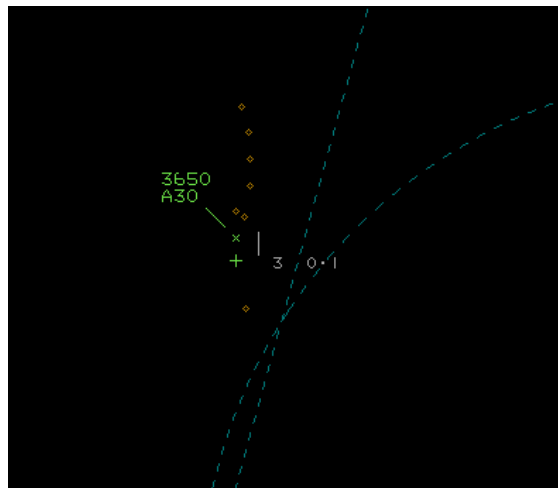
Figure 4: Geometry at 11:14:37 (Chinook SSR 3650; primary contact)

At 11:14:37 (Figure 4), the aircraft passed each other with a CPA of 0.1nm.

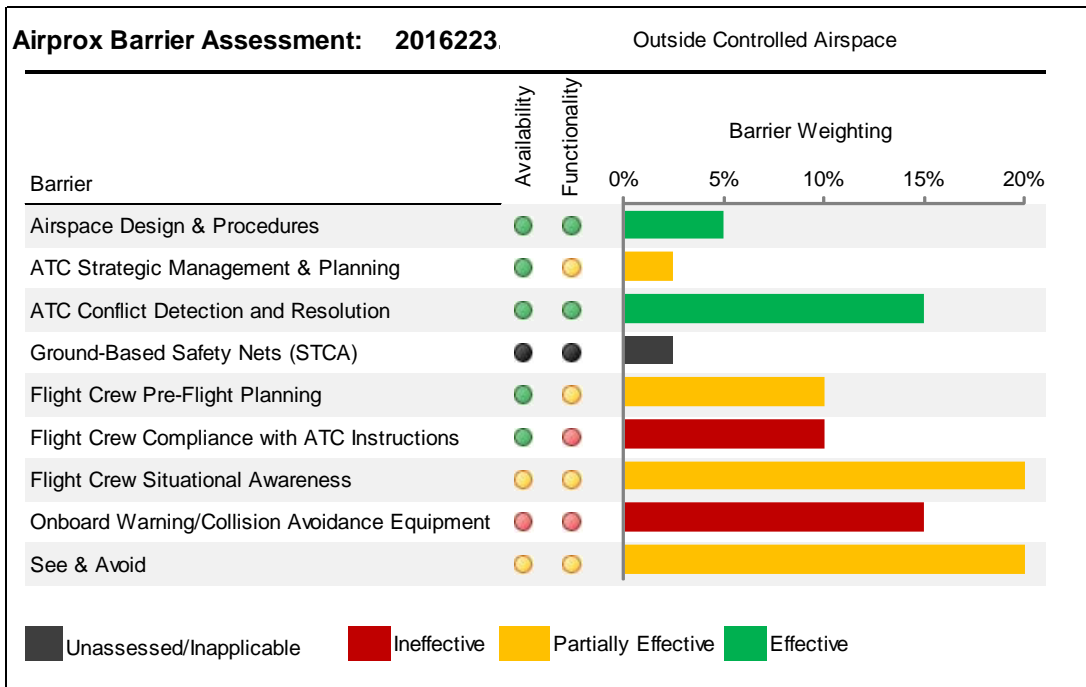
- **Flight Crew Compliance with ATC Instructions** was **ineffective** because the Chinook crew were given Traffic Information, but didn't act on it.
- **Flight Crew Pre-flight Planning** was only **partially effective** because although the tug and glider pilots knew about the Odiham MATZ, they still chose to operate there in poor weather without calling ATC.
- **Onboard Warning/Collision Avoidance Equipment** was **ineffective** because: the TAS on the Chinook and the FLARM on the tug were not compatible; the tug was not transponder equipped; and neither the Chinook or Odiham ATC were FLARM equipped.
- **See-and-avoid** was only **partially effective** because the Chinook had been in cloud just before the incident.
