AIRPROX REPORT No 2016232

Date: 04 Nov 2016 Time: 1030Z Position: 5136N 00105W Location: Benson MATZ

PART A: SUMMARY OF INFORMATION REPORTED TO UKAB

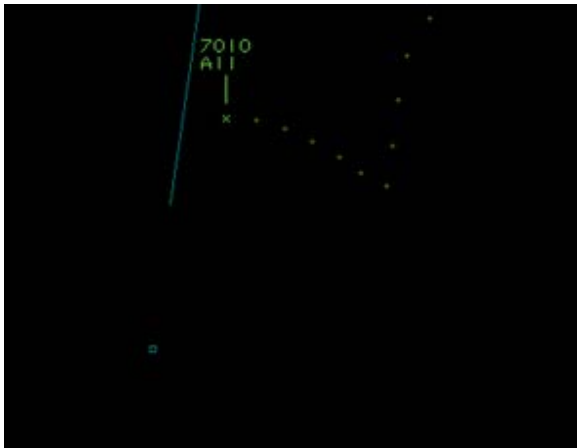
Figure 1: Geometry at 10:31:06

At 10:31:06 (Figure 1), the Chinook was cleared for take-off with the Tutor going around to deadside.

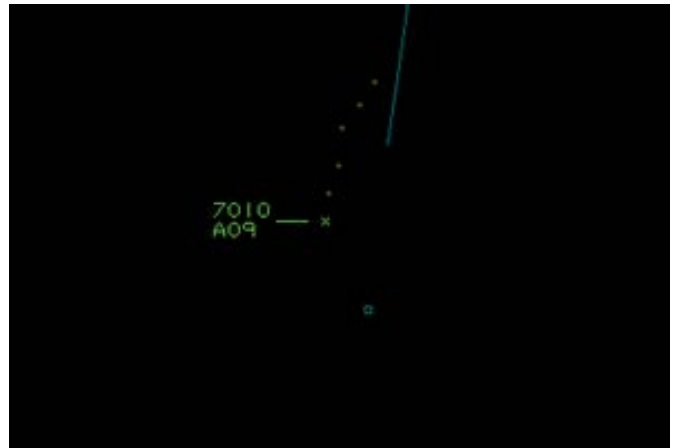
Figure 2: Geometry at 10:31:36

(Tutor SSR 7010 going around; Chinook not seen)

At 10:31:36 (Figure 2), the Chinook was airborne and transferred from Benson Tower to Benson Approach while the Tutor was mid-point dead side.

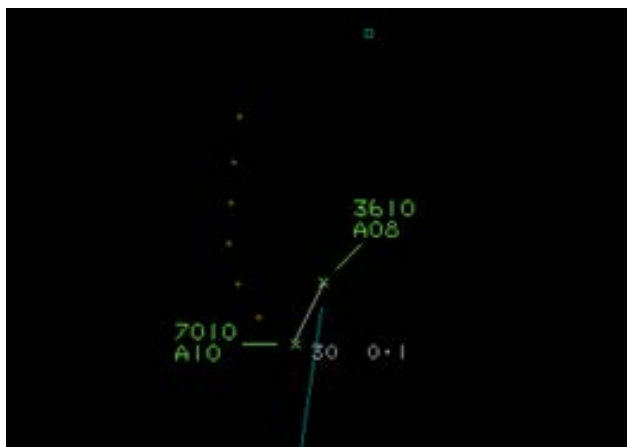
Figure 3: Geometry at 10:32:23
(Tutor SSR 7010; Chinook SSR 3610)

At 10:31:40, the Chinook pilot checks in with Benson Approach while climbing through 400ft QFE, requesting a Traffic Service. The Benson Approach controller passed TI on the Tutor, which was then in the Chinook's 12 o'clock, half a mile, crossing right to left, indicating 100ft above. The Chinook pilot reported visual with the Tutor and said that they would join behind, downwind, due to the Airprox. The Chinook was first visible on the radar replay at 10:32:23 (Figure 3).

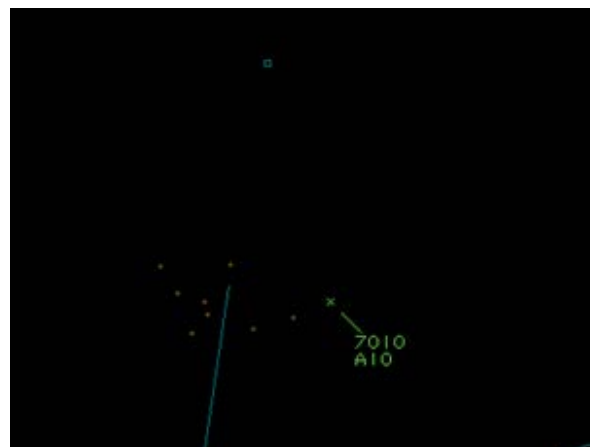
Figure 4: Geometry at 10:32:37
(Tutor SSR 7010; Chinook not seen)

At 10:32:37 (Figure 4), the Chinook changed back to Benson Tower frequency and reported joining downwind to land. They stated that they were not certain of the position of all circuit traffic and that they had just had an Airprox.

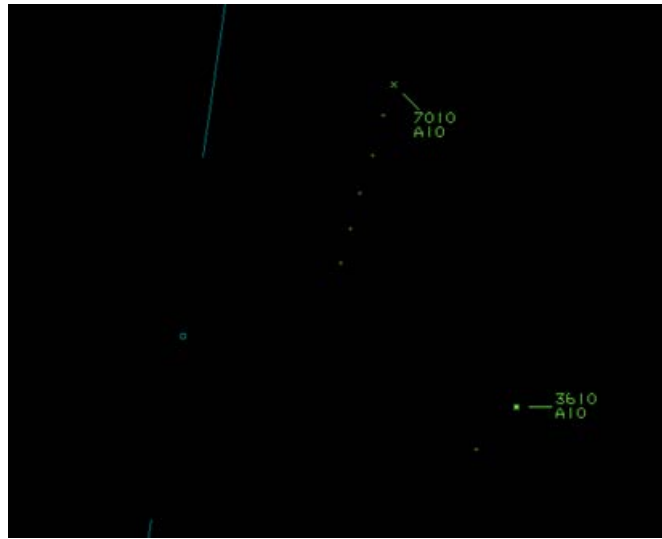
Figure 5: Geometry at 10:33:27 (Tutor SSR 7010; Chinook SSR 3610)

At 10:33:27 (Figure 5), the Chinook became visible once again on the radar replay while positioning downwind to land.

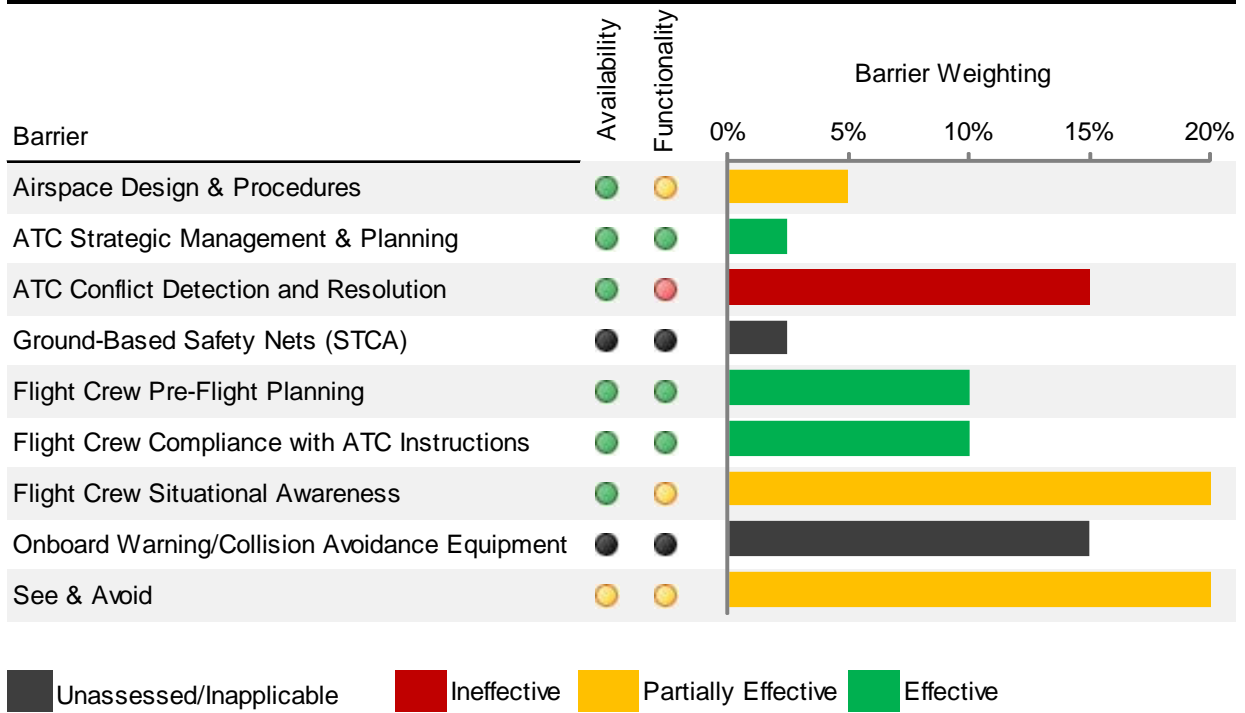
Airprox Barrier Assessment: 2016232.

- **Airspace Design and Procedures** was assessed as being **partially effective** because current procedures allowed the Chinook pilot to change to the Approach frequency whilst effectively still part of the visual circuit; this serves not only to limit the Chinook pilots awareness of circuit traffic but also prevents any instructions the tower controller may need to convey at the early stage of flight within the visual circuit.

- **ATC Conflict Detection and Resolution** was considered **ineffective** because the tower controller released the Chinook with the Tutor in close proximity and, although the Supervisor noticed the proximity of the Tutor and Chinook to each other, the controller did not detect the confliction early enough to carry out sufficient control to prevent the situation from occurring.

- **Situational Awareness** was assessed as being **partially effective** because although all the aircraft were initially on the same frequency, the Chinook pilot's SA was reduced when he changed frequency with only a generic and arguably misinformed awareness of the other aircraft's position from the No2 crewman.

- **See and Avoid** was assessed as being **partially effective** because: a) the Chinook pilot was initially not visual with the Tutor and was relying on the No2 crewman to maintain visual contact and update him; b) the No2 crewman may have misinterpreted the Tutor's flightpath; c) when the Chinook pilot gained visual contact with the Tutor he considered that he needed to carry out emergency avoiding action to maintain separation; and d) the Tutor pilot was initially visual with the Chinook, lost contact as he passed by, and then only became visual again just before he turned downwind.
