AIRPROX REPORT No 2015008

Date: 8 Feb 2015 Time: 1105Z Position: 5220N 00055W Location: 5nm NW Sywell
(Sunday)

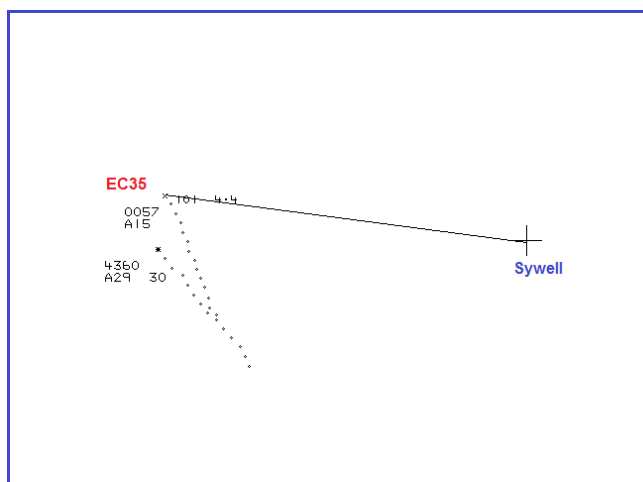
Swanwick MRT at 1105:05

At 1105:05, area radar recording showed the EC135 in the approximate reported position of the occurrence, 4.4nm west-northwest of Sywell airfield at an altitude of 1500ft. Another aircraft, not involved in the occurrence, is shown displaying the Coventry conspicuity squawk 4360 indicating 2900ft. However the radar did not show the Microlight or any intermittent contacts in the vicinity.

It was not therefore possible to show the geometry of the encounter and it is likely that the London Information FISO was not aware of the Microlight.
