## AIRPROX REPORT No 2015012

Date: 17 Feb 2015 Time: 1444Z Position: 5056N 00140W Location: Stoney Cross

### PART A: SUMMARY OF INFORMATION REPORTED TO UKAB

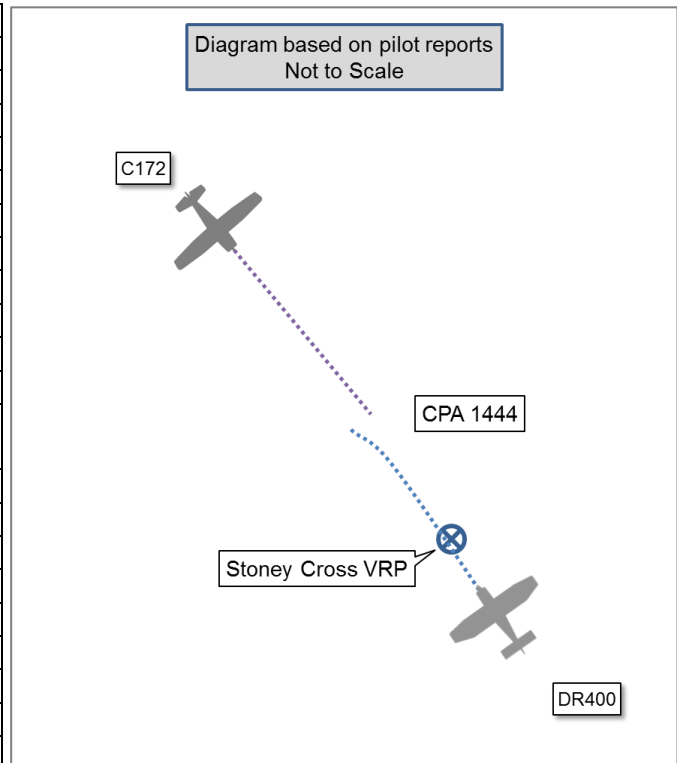
**THE DR400 PILOT** reports en-route via Beaulieu and Stoney Cross VRPs. The pilot had been in receipt of a Basic Service from Solent Radar and Bournemouth Radar and, on passing Stoney Cross VRP, was instructed to call Boscombe Zone. During the initial call, he observed a C172, slightly right of the canopy windscreen centre strut compass housing on top of the instrument panel. It was on a reciprocal heading at the same level, so the DR400 pilot made an immediate avoiding action left turn, remaining level. He then banked right, and observed the C172 pass down his right-hand side, remaining level. The C172 pilot did not appear to have seen him and took no avoiding action. The DR400 pilot filed the incident and, on enquiry, was told by the Boscombe Zone controller that the Cessna pilot was not in radio contact and that no squawk had been observed by either Boscombe or Bournemouth Radar controllers.

He assessed the risk of collision as 'High'.

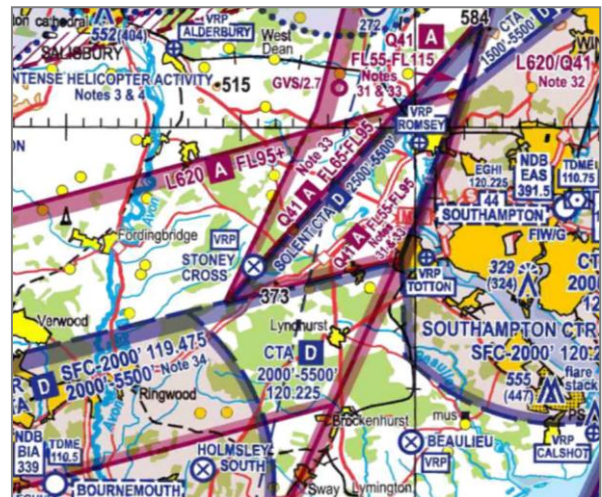
**THE C172 PILOT** reports en-route via the Stoney Cross and Beaulieu VRPs. Once south of the Alderbury VRP, he requested a Basic Service with Solent Radar and was issued a squawk and to report at the Beaulieu VRP, where he continued his onward flight. The pilot reported that he was not aware of an incident at any time during the flight. He did recall that Solent Radar advised of another aircraft in the area but, with good lookout, no traffic was seen. The pilot noted that the C172 was fitted with a Traffic Awareness System, from which he did not recall receiving an alert.
