**AIRPROX REPORT No 2015021**

Date: 12 Mar 2015 Time: 1605 Z Position: 5306N 00009W Location: RAF Coningsby

**PART A: SUMMARY OF INFORMATION REPORTED TO UKAB**

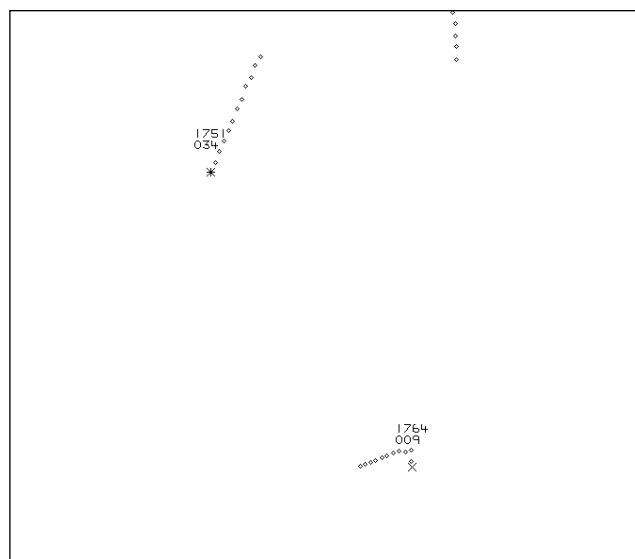
At 1602:24 (Figure 1), the Aerodrome Controller responded to the Tucano downwind call by informing the pilot that three Typhoons were 7nm from the field and soon to join.

Figure 1: Geometry at 1602:24 (Typhoon lead squawking 1751; Tucano squawking 1764)

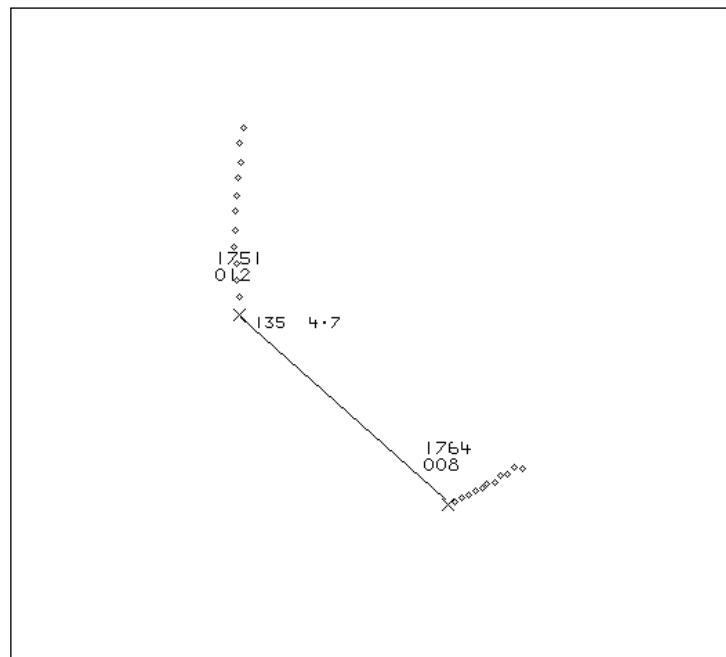
At 1603:37 (Figure 2), the Tucano was cleared to touch-and-go.

Figure 2: Tucano cleared to touch-and-go at 1603:37

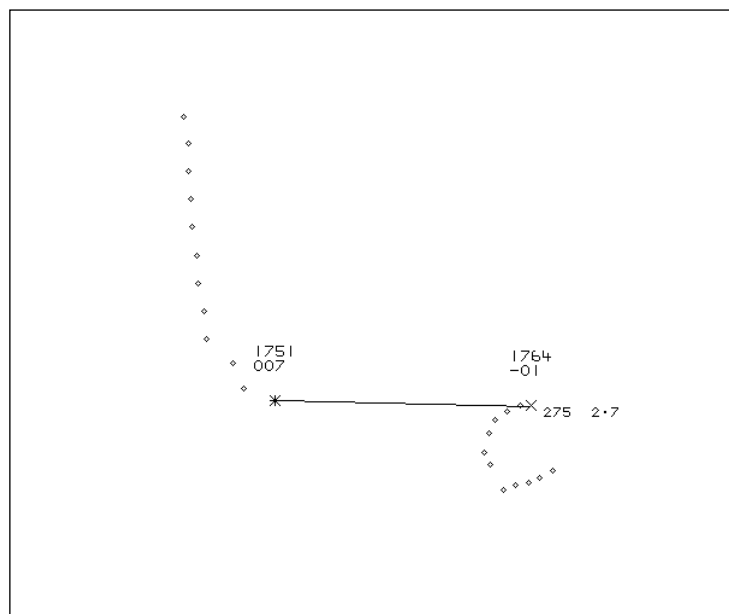
At 1604:11 (Figure 3), the Jetstream pilot called the Aerodrome Controller at the approximate point for the Typhoon Initials call at 3nm finals offset by 0.5 nm to the north.

Figure 3: 1604:11: Jetstream called Tower as Typhoon at Initials Point

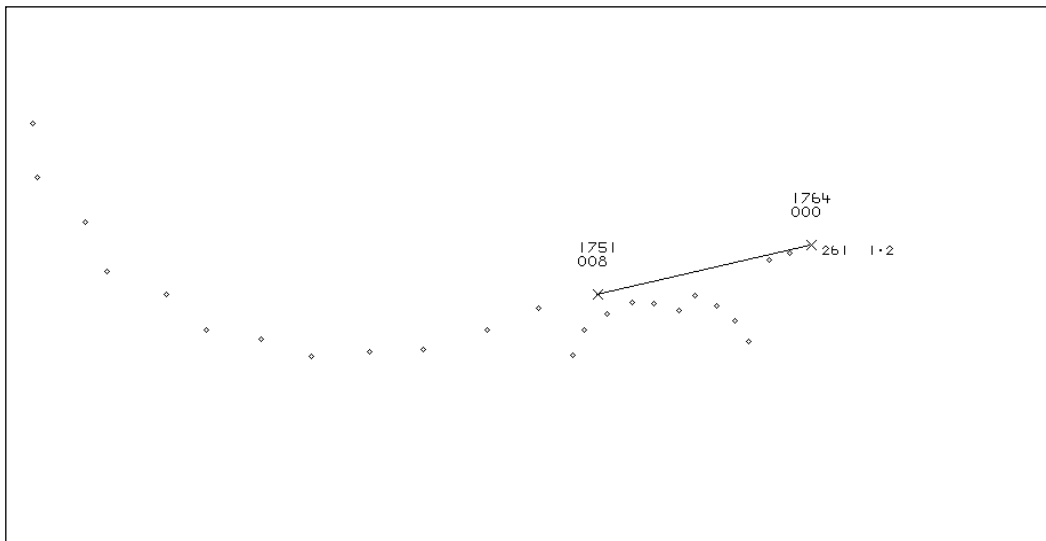
At 1604:42 (Figure 4), The Aerodrome Controller transmitted, “[Tucano C/S] request you extend upwind to allow the Typhoons ahead.”

Figure 4: Geometry at 1604:42 as Tucano instructed to extend upwind

The prolonged conversation with the Jetstream pilot meant that the Typhoons were 0.5nm from the RW07 threshold prior to the controller requesting that the Tucano extend upwind. MAA Regulatory Article 3225(1) 1.b states that controllers and pilots should consider ATC instructions as mandatory within a MATZ.

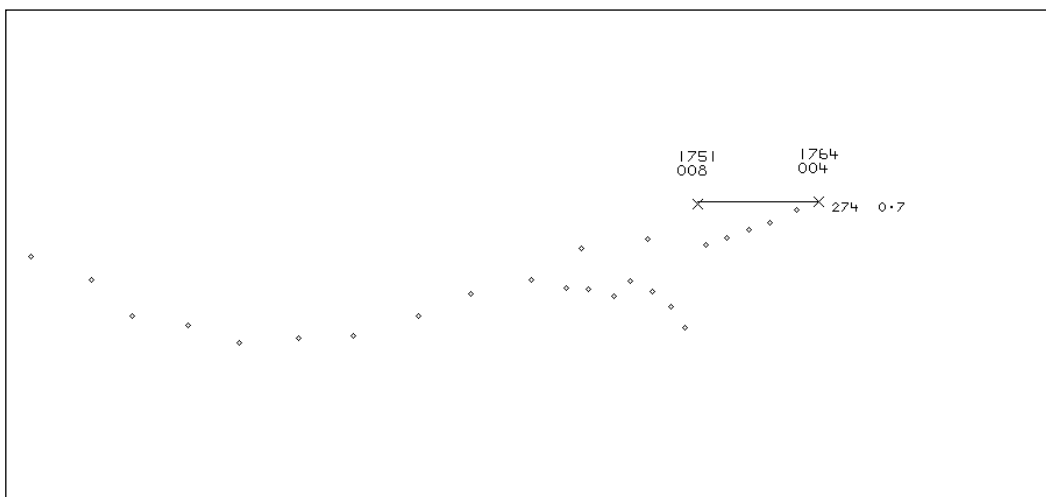
The Tucano pilot confirmed extending upwind at 1604:54 (Figure 5).

Figure 5: Geometry at 1604:54

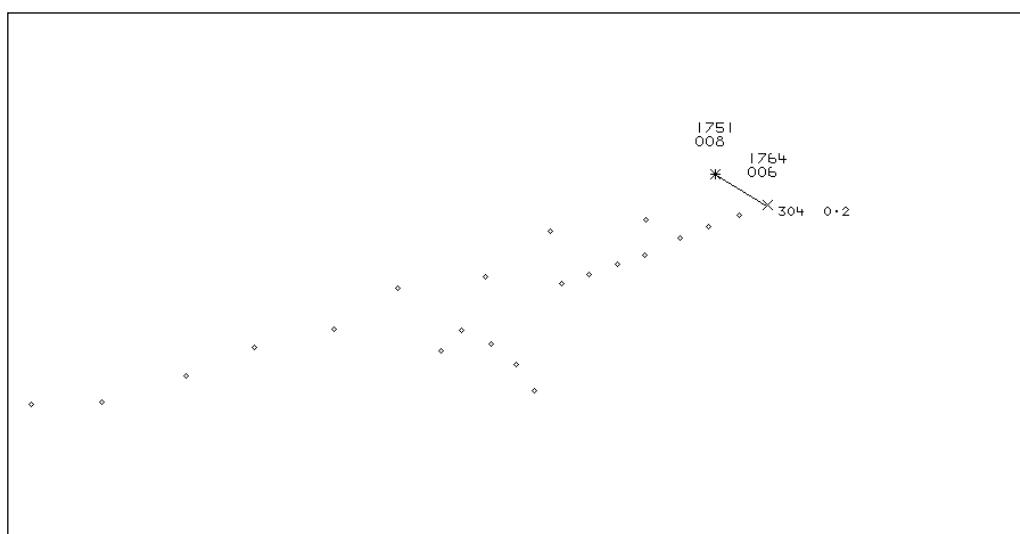
The CPA was estimated between 1605:03 (Figure 6) and 1605:10 with 0.1nm horizontal and 100ft vertical separation.

Figure 6: Immediately prior to CPA at 1605:03
