AIRPROX REPORT No 2015031

Date: 4 Apr 2015 Time: 1155Z Position: 5146N 00049W Location: 2km NW Henton NDB (Saturday)

PART A: SUMMARY OF INFORMATION REPORTED TO UKAB

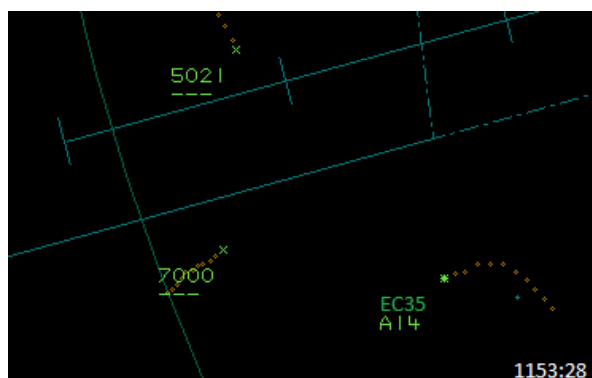
Figure 1.

At 1153:28 (Figure 1) the Luton Radar controller updated the Traffic Information stating that the aircraft was north-west of the EC135 by 2nm tracking left to right and then advised of further traffic north of the EC135 by 2nm converging from the right-hand side. Neither aircraft was displaying height information.

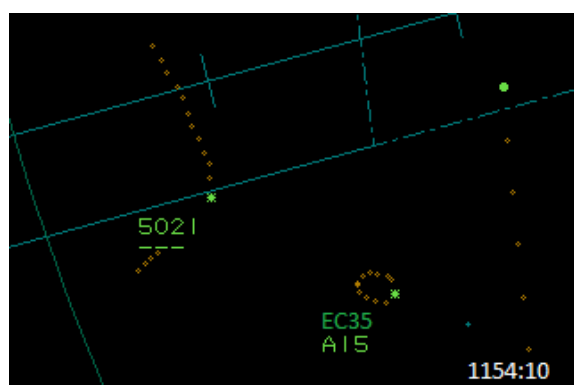
Figure 2.

The EC135 pilot entered a right-hand orbit. The Luton Radar controller updated the Traffic Information to the EC135 pilot stating that one contact had disappeared and the other one was passing on his western side with no height information tracking south-bound (Figure 2). The EC135 pilot reported being visual with the traffic.

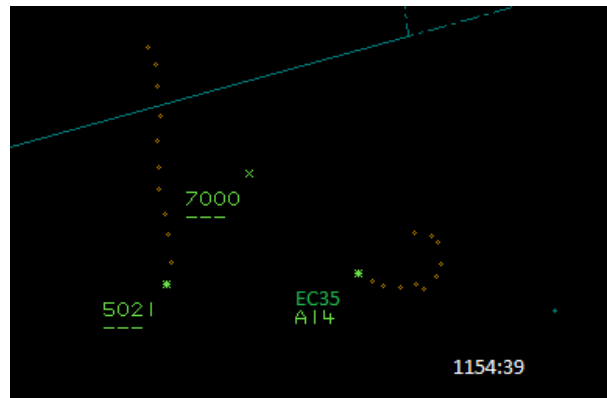
Figure 3.

At 1154:39 an aircraft squawking 7000 appeared on the radar recordings 0.8nm north-west of the EC135 (Figure 3).

The Luton Radar controller passed Traffic Information on aircraft observed on radar to the EC135 pilot prior to the Airprox. It is likely that the controller did not see the aircraft squawking 7000 prior to the EC135 pilot reporting the Airprox on frequency because the 7000 squawk was only visible on radar for 17 seconds prior to the Airprox occurring.

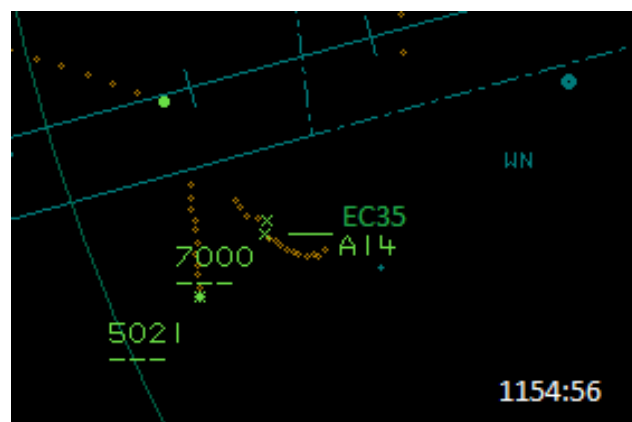
At 1154:56 the EC135 pilot reported that he had “*just had an Airprox with an aircraft that’s climbed up towards us er is now flying out to the east*”. Figure 4 shows the EC135 north-west of Henton with the aircraft squawking 7000 just to the north of the EC135 at the closest lateral point 0.1nm. The Luton Radar controller stated that the aircraft had just appeared on radar and was climbing through the EC135’s level (this was not actually possible to determine as the 7000 squawk had no associated Mode C). For clarity of position, Figure 4 shows the EC135’s label in a different position to that seen by the Luton Radar controller. On the original recordings the 7000 squawk was garbling with the EC135’s label which may have led the controller to believe that the EC135’s Mode C belonged to the 7000 squawk.

The Board quickly decided that the cause of the Airprox was a sighting issue. The EC135 pilot had reported that he had only sighted the C172 at a range of 400ft, and the C172 pilot had not seen the EC135 at all. Consequently it was decided that the cause of the Airprox was a late sighting by the EC135 pilot and a non-sighting by the C172 pilot. The Board then turned its attention to the risk. The Board opined that although the EC135 pilot had taken avoiding action to prevent a collision, safety margins had been much reduced below the normal because the two aircraft had passed 0.1nm apart at a similar altitude. Consequently the Airprox was categorised as risk Category B.

Cause: A late sighting by the EC135 pilot and a non-sighting by the C172 pilot.

Degree of Risk: B.
