AIRPROX REPORT No 2015047

Date: 20 Apr 2015 Time: 1315Z Position: 5202N 00115W Location: Linton on Ouse

PART A: SUMMARY OF INFORMATION REPORTED TO UKAB

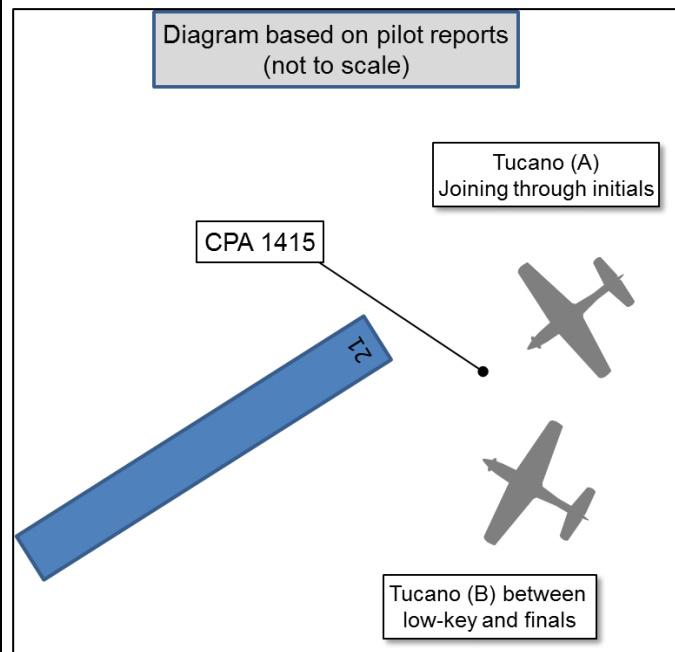
Recorded	Aircraft 1	Aircraft 2
Aircraft	Tucano	Tucano
Operator	HQ Air (Trg)	HQ Air (Trg)
Airspace	Linton ATZ	Linton ATZ
Class	G	G
Rules	VFR	VFR
Service	Aerodrome	Aerodrome
Provider	Linton	Linton
Altitude/FL		
Transponder	A,C,S	Off
Reported		
Colours	Black	Black
Lighting	Strobes, Nav and landing lights.	Strobes, Nav and landing lights.
Conditions	VMC	VMC
Visibility	8km	>10km
Altitude/FL	1000ft	NK
Altimeter	QFE (1031hPa)	QFE
Heading	210°	300°
Speed	200kt	110kt
ACAS/TAS	TCAS I	TCAS I
Alert	Nil	Nil
Separation		
Reported	300ft V/NK H	200ftV/ 0.5nm H
Recorded	NK

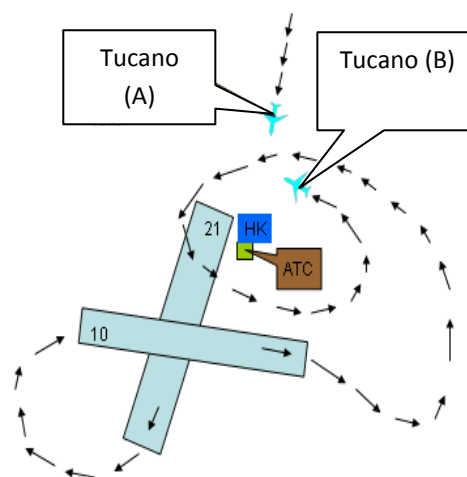
The Airprox occurred between a station-based Tucano (A) and a visiting Tucano (B) both under an Aerodrome Control Service with the Linton Aerodrome Controller. The radar replay was not able to capture Tucano (B) who was believed to be non-squawking in the visual circuit. The diagram below shows the Occurrence Safety Investigation (OSI) interpretation of events.

Tucano (B) had been completing a climbing left-hand turn to 2500ft to conduct a PFL prior to departing back to Cranwell. The pilot left high-key and flew a left-hand pattern instead of a right-hand pattern. As Tucano (B) flew from low-key to finals, he came close to Tucano (A) who was flying through deadside. The perceived severity and risk of collision was 'medium'. The first

sighting was at 0.5nm and the minimum separation was 0.5nm and 200ft. The PFL was flown the wrong way around the circuit pattern.
