**AIRPROX REPORT No 2015053**

Date: 9 Apr 2015 Time: 1527Z Position: 5146N 00158W Location: 10nm SE Gloucester

**PART A: SUMMARY OF INFORMATION REPORTED TO UKAB**

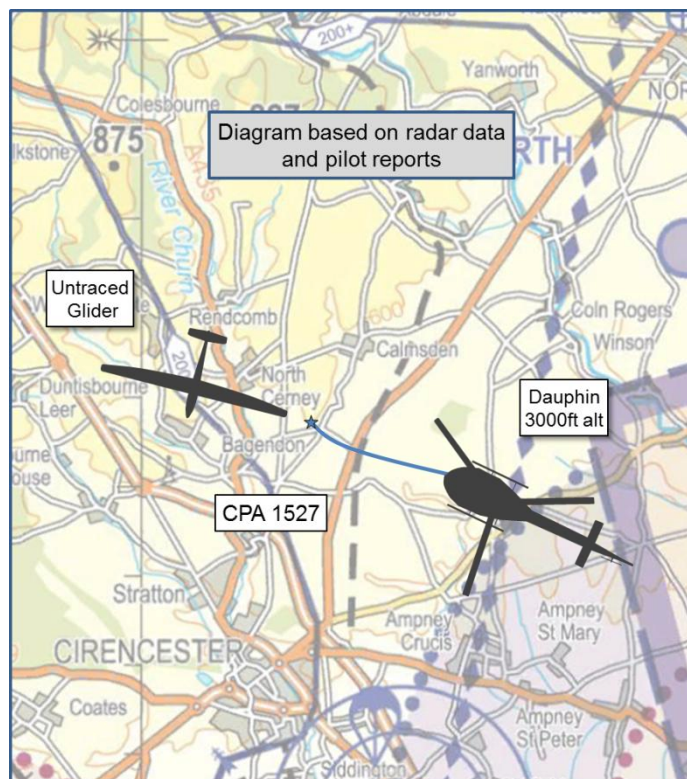
**THE DAUPHIN PILOT** reports that he was on a Procedural IRT sortie, VFR, at 3000ft. They had just left the Brize frequency, where they were receiving a Traffic Service, and had been handed-over to Gloster. Just prior to establishing communication with Gloster, a glider was seen 2000-1000m ahead, it was crossing and closing from the right. The instructor took control and made an avoiding action turn to the right. The glider did not register with TCAS and had not been reported by Brize Radar prior to handover.

An Airprox was reported on 9<sup>th</sup> April at 1529 between a Dauphin helicopter and a glider. The Dauphin had just left the Brize frequency and had not yet established contact with Gloster so did not receive any Traffic Information. The instructor saw the glider and took avoiding action by turning to the right. The glider did not show on the NATS radars and could not be traced.
