AIRPROX REPORT No 2015083

Date: 8 Jun 2015 Time: 1105Z Position: 5153N 0021W Location: Gloucestershire Airport

PART A: SUMMARY OF INFORMATION REPORTED TO UKAB

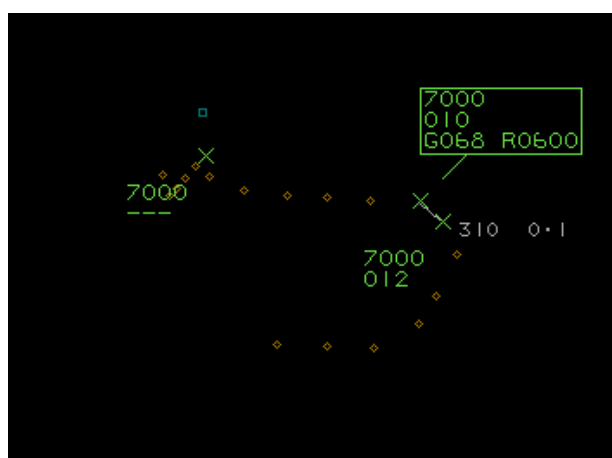
CPA occurred between 1105:30 (Figure 1) and 1105:34 (Figure 2).

Figure 1 – (Swanwick MRT at 1105:30) The C152 was heading east and indicating 1000ft, the C42 was in a left turn and indicating 1200ft.

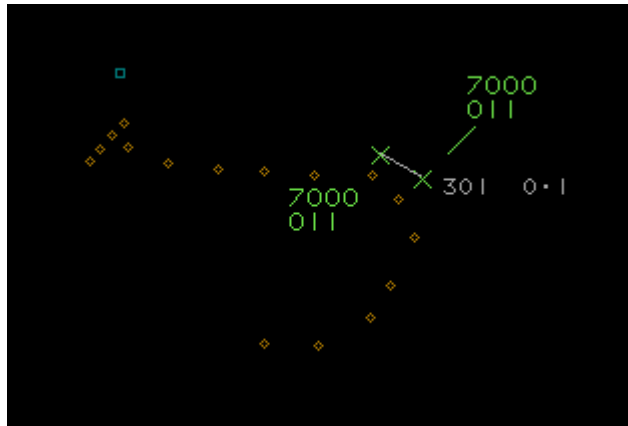
Figure 2 - (Swanwick MRT 1105:34) The C152 was the easterly of the two contacts.
