AIRPROX REPORT No 2015095

Date: 27 Jun 2015 Time: 1334Z Position: 5214N 00004W Location: 8nm west of Cambridge (Saturday)

PART A: SUMMARY OF INFORMATION REPORTED TO UKAB

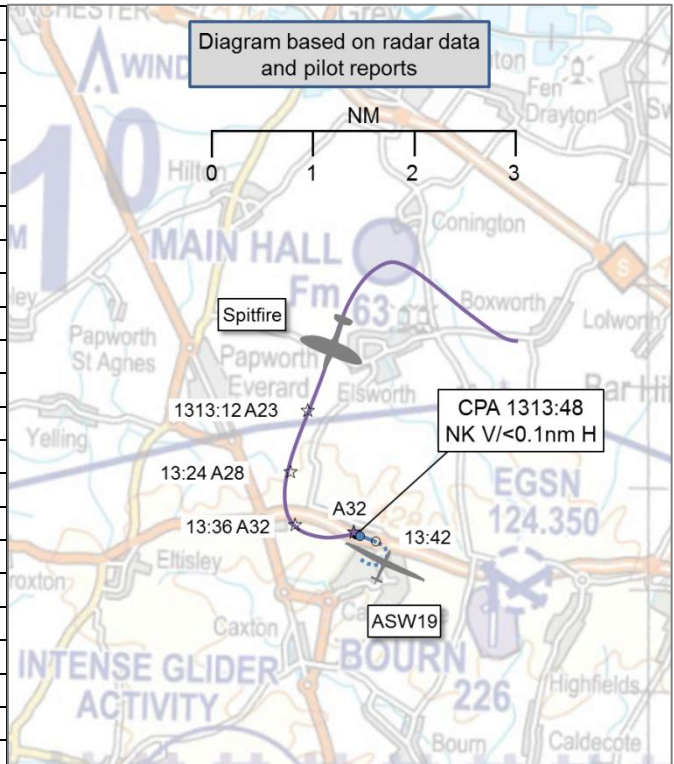
THE ASW19 PILOT reports finishing a short cross-country task, making a final climb in a local thermal, at about 2-3 knots vertical velocity in a left hand turn, before making a short final glide back to his home airfield. He had been listening to Cambridge ATC as he approached the area, but had switched to his home airfield frequency in preparation for the final glide. He was aware that a WW2 fighter aircraft had been operating in the Papworth Everard area earlier in the day, so was not surprised when he spotted one travelling from his right to left in that area a few kilometres away. The aircraft was at a similar altitude to him. Soon afterwards he watched the aircraft commence a turn. Due to the position of the sun and aircraft colour scheme, only a black silhouette was visible and it was not initially possible to determine if the aircraft had turned away or towards him. A few seconds later he assessed that it had turned towards. He slowed his own turn rate to keep the other aircraft in view, and initially assessed that it would pass close to him but safely to his left provided he stopped turning. The aircraft continued to make small adjustments and, within a few seconds, was pointing straight at him. He 'waggled his wings' to see if the other aircraft would respond, but it did not. He was now conscious that its pilot probably could not see him due to the poor forward visibility of such aircraft, but that he was flying straight towards him. With limited options due to speed differential and poor manoeuvrability of the glider, he immediately made a sharp right turn, and the other aircraft passed less than 100m behind and 50ft above him. As he looked to reacquire the aircraft, now on his right, he saw it in a gentle left turn slightly above but now several hundred metres away.

The Spitfire pilot was operating under a Basic Service from Cambridge Radar. He was observed on radar operating in the vicinity of Gransden Lodge. An intermittent primary only contact appeared on radar for a short period in an area the Spitfire had passed, but this could not be identified, and it was not possible to measure the CPA.
