AIRPROX REPORT No 2015100

Date: 2 Jul 2015 Time: 1455Z Position: 5305N 00018W Location: 3nm NE Coningsby

PART A: SUMMARY OF INFORMATION REPORTED TO UKAB

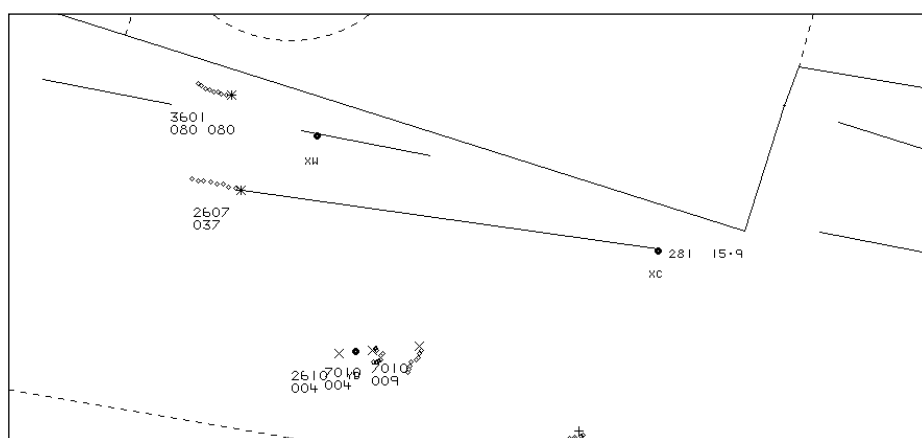
At 1451:54, the CGY Approach controller called the Departures controller and identified the Sentinel (squawk 2607) on a northerly pattern at Cranwell, predicted that the Tornado could get away before him and stated that after that all departures would be restricted to 1200ft QFE. At 1452:12 (Figure 1), the Tornado was released by the CGY Departures controller.

Figure 1: Tornado released by CGY Departures with Sentinel 15.9nm away.

The Coningsby Departures controller had been provided a plan by the Approach controller and was well aware of the Sentinel positioning. Departures released the Tornado with 15.9nm separation (Figure 1). Once the Tornado was airborne, Departures issued almost continuous transmissions to provide a climb to FL130, Traffic Information and then a stop climb at 1200ft. The Traffic Information was inaccurate (north-east versus west) and this was likely to have been a slip by the controller. Once it was apparent that the original plan of lateral separation would not work, Departures issued the 'stop climb' instruction to the Tornado to provide vertical separation. The Departures controller had not witnessed this scenario before and the Sentinel would have been quicker than most tracks experienced in the Cranwell pattern.

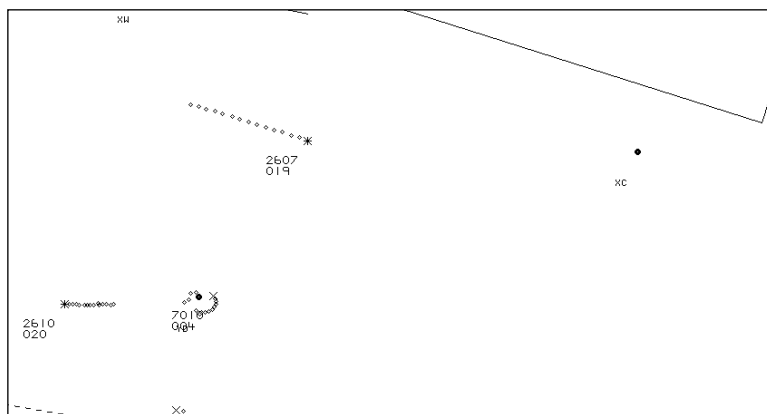
Room). At 1453:49, the Aerodrome Controller provided a ‘rolling’ call on the Tornado as it was departing. At 1454:19 (Figure 2), CBY Approach had informed Cranwell Departures that the Tornado would be turning north and separation on the Sentinel would be lateral.

Figure 2: CGY inform CWL of lateral separation on Tornado outbound turning north.

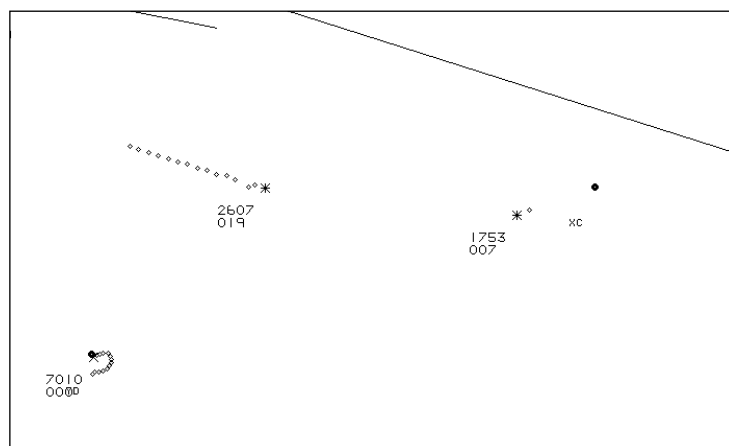
At 1454:20, the Aerodrome Controller called Traffic Information as, “Traffic west, eight miles, tracking er east, Cranwell inbound indicating one thousand eight hundred feet.” At 1454:37 (Figure 3), CGY Departures identified the Tornado, applied a Traffic Service and approved the SID2 to FL130.

Figure 3: Tornado (squawk 1753) approved on SID2 climbing to FL130.

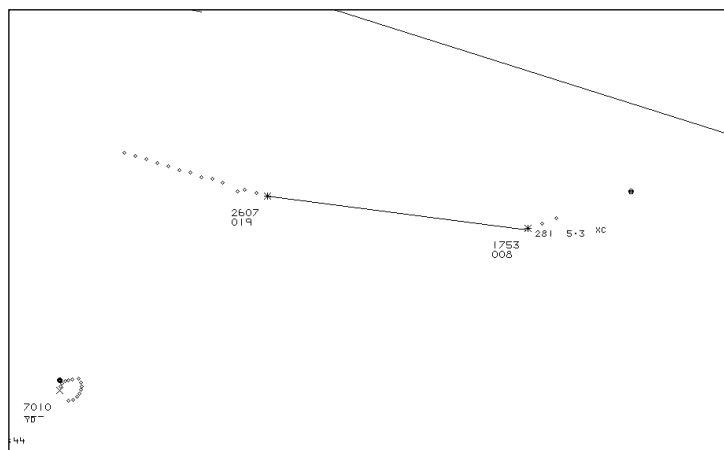
At 1454:44 (Figure 4), an update was provided by CBY Departures, “previously called traffic now east north east, four miles tracking east at one thousand eight hundred feet.” The Sentinel was in fact west by 5nm.

Figure 4: Traffic Information at 1454:44.

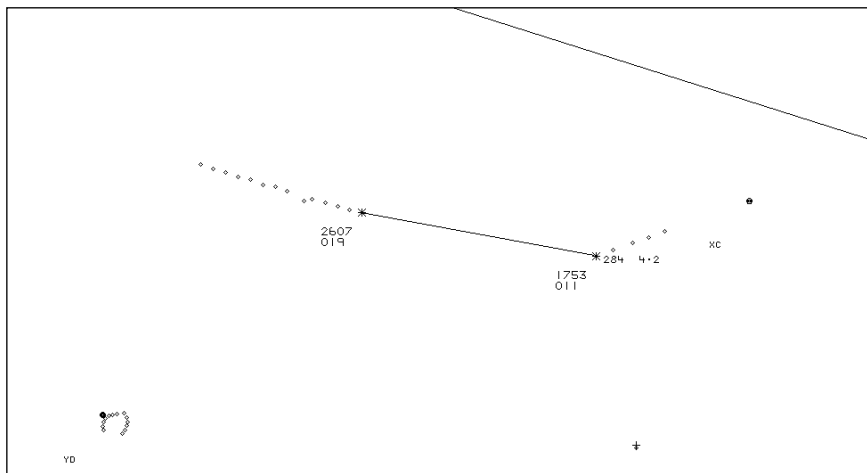
At 1454:52 (Figure 5), the CBY Departures controller issued a stop climb at 1200ft. The Tornado pilot readback the stop climb and questioned the 'traffic to the east' call.

Figure 5: CGY Departures issued a stop climb instruction to the Tornado.

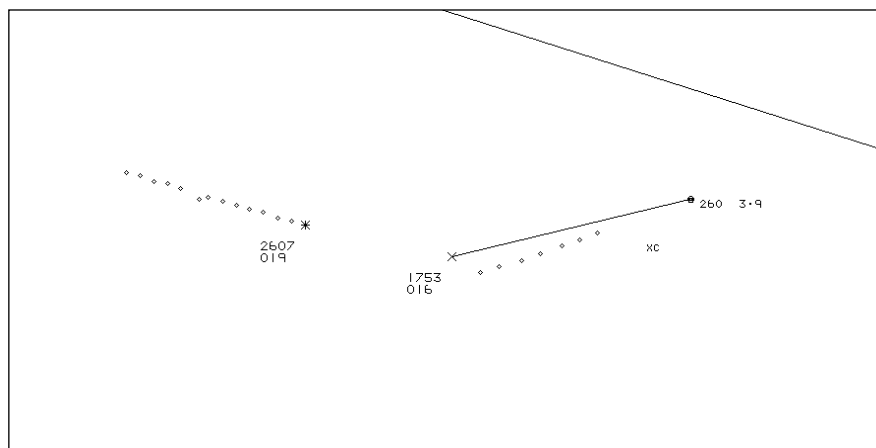
The Tornado was in the right turn at 1455:04 (Figure 6).

Figure 6: Tornado turning right at 3.9nm from CGY.

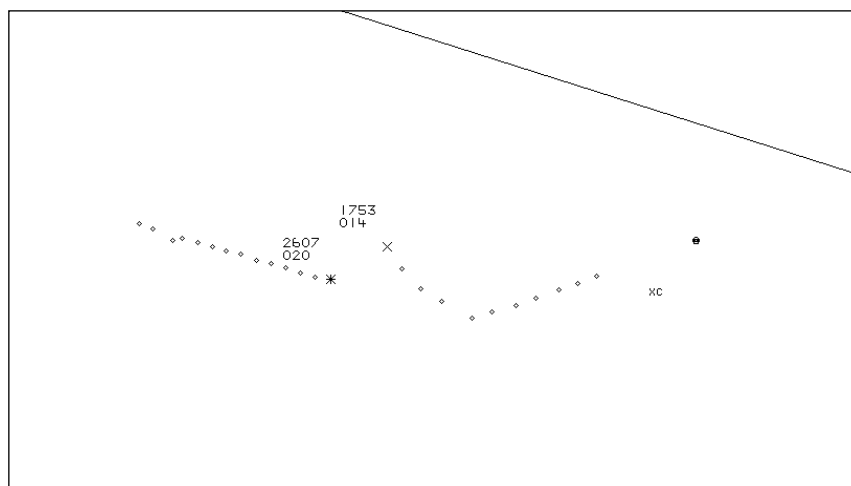
The Tornado reported a TCAS RA at 1455:08. The CPA was estimated between 1455:08 and 1455:16 (Figure 7) with a height separation of 1000ft and 1.1nm horizontally.

Figure 7: Geometry at 1455:16.

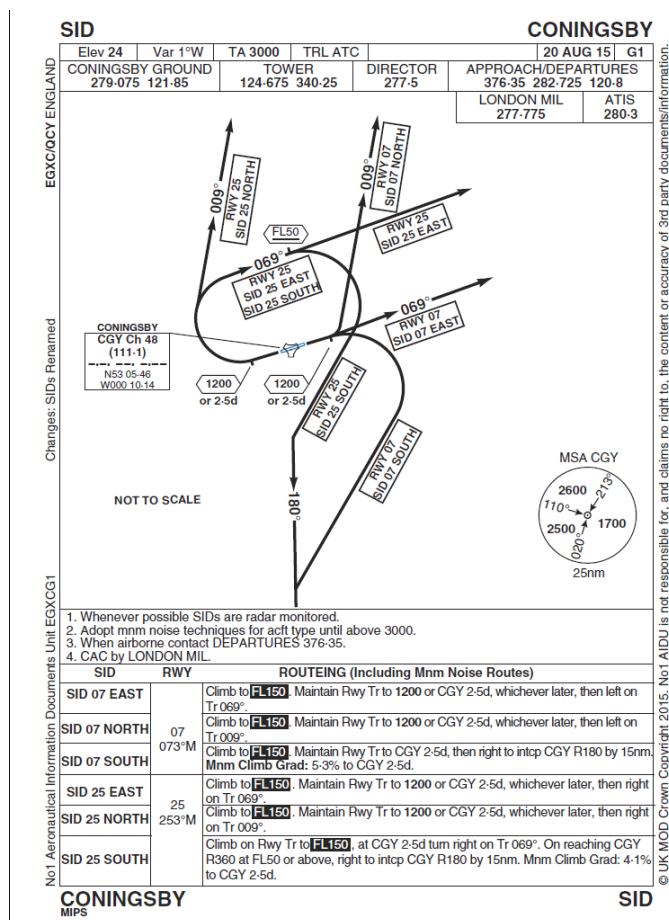
The CGY SIDs are outlined in Figure 8. The SID2 approved on the tape transcript refers to the SID25 North.

Figure 8: Coningsby SIDs.
