AIRPROX REPORT No 2015111

Date: 14 Jul 2015 Time: 1815Z Position: 5230N 00236E Location: BARMI

PART A: SUMMARY OF INFORMATION REPORTED TO UKAB

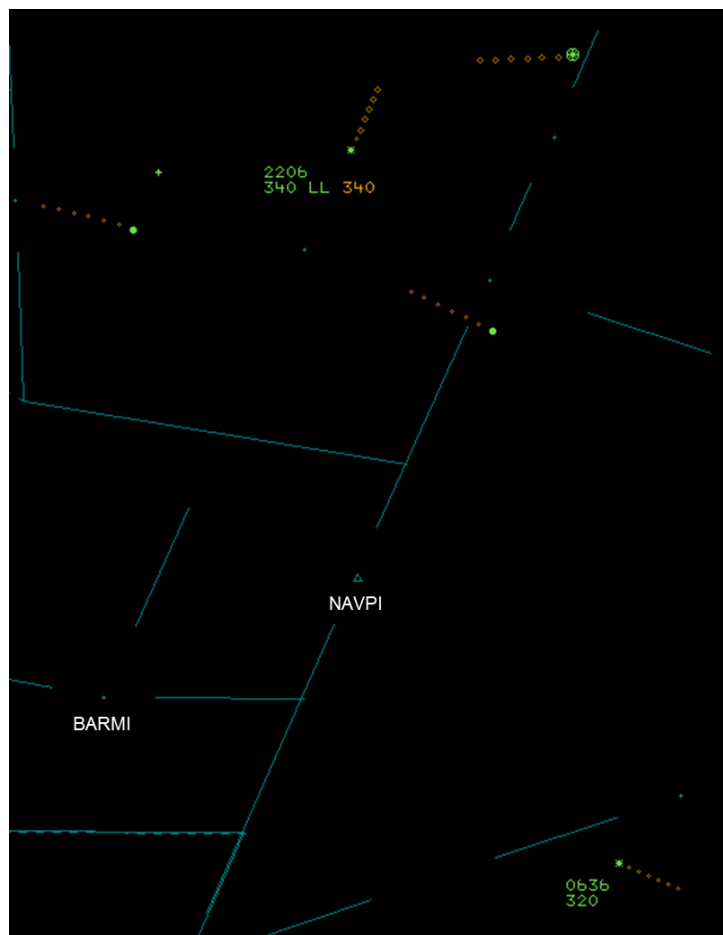
Figure 1 – 1812:01

At 1812:01, the B737 (transponding 2206) was on a south-westerly track maintaining FL340 and the C5 (transponding 0636) 30nm to the SSE of the B737, was on a north-westerly track maintaining FL320 (Figure 1).

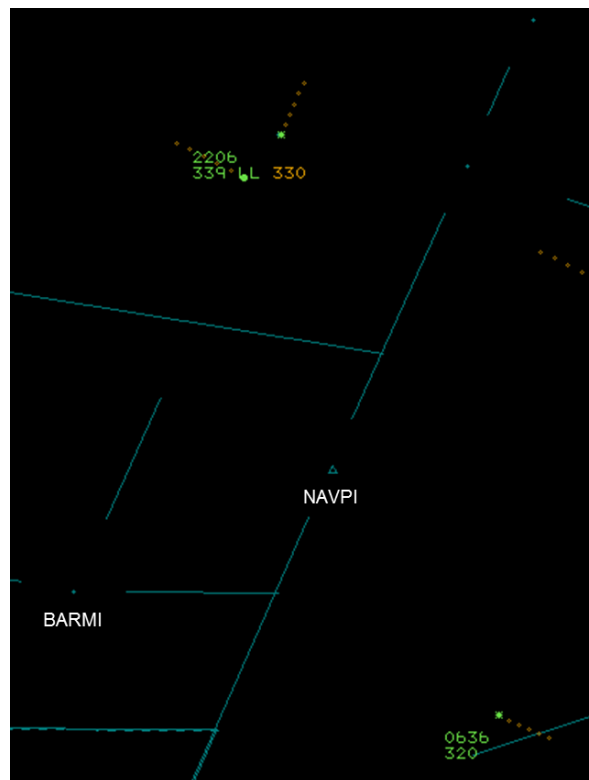
Figure 2 – 1812:43

At 1812:43 the B737 pilot commenced descent to FL330. The C5 was still maintaining FL320, now 24nm southeast of the B737 (Figure 2).

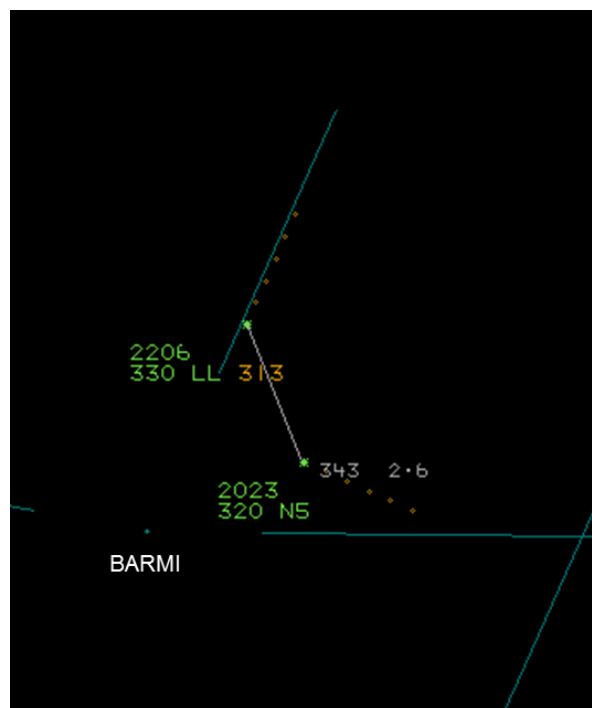
Figure 3 – 1815:02

At 1815:02, the B737, still maintaining FL330, selected a lower FL in the SFL (FL313 at this point). (The C5 squawk had changed to 2023) (Figure 3).

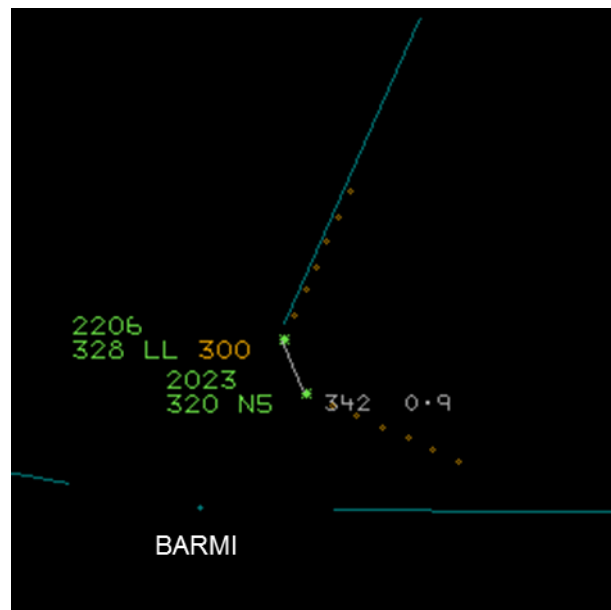
Figure 4 - 1815:14

At 1815:14, with FL300 now set in the SFL, the B737 was observed commencing descent, passing FL328. The aircraft were separated by 0.9nm horizontally and 800ft vertically (Figure 4).

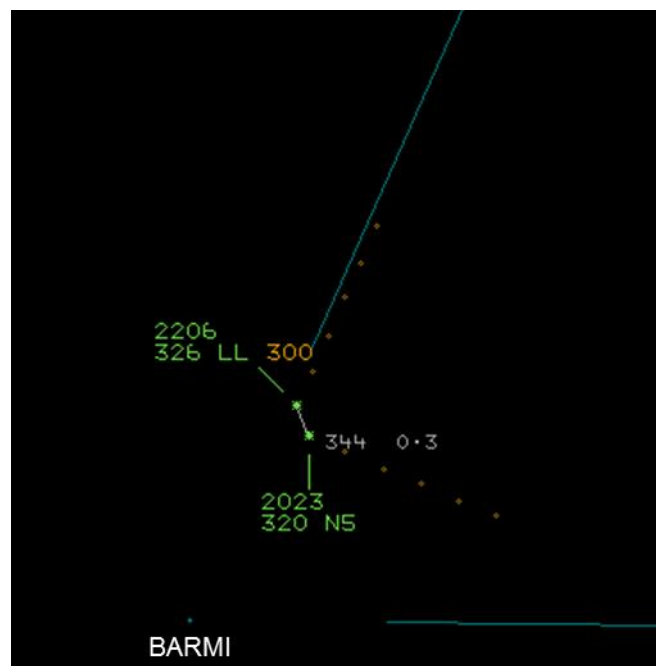
Figure 5 - 1815:18

At 1815:18 the aircraft were separated by 0.3nm horizontally and 600ft vertically (Figure 5). The pilot of the C5 reported “responding to an RA, in the descent.” The ATSU investigation report confirmed that both a high-level STCA and a Cleared Flight Level (CFL) deviation alert were displayed to the controller at 1815:20.

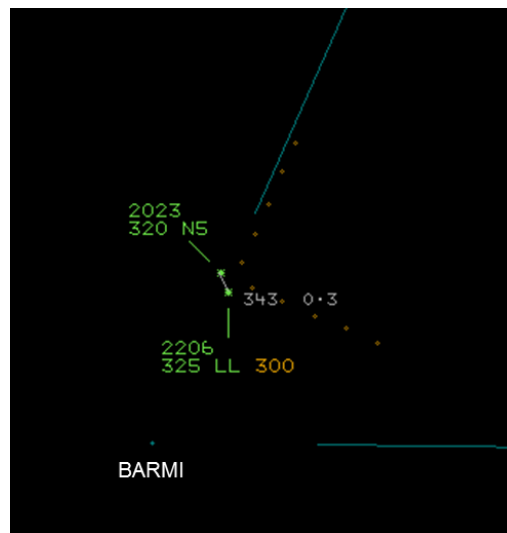
Figure 6. 1815:23

By 1815:23 both aircraft had passed each other, 0.3nm horizontally and 500ft vertically apart and were diverging (Figure 6).

Due to the relative speeds of both aircraft and the radar replay refresh rate, CPA was assessed to have taken place between 1815:18 and 1815:21, with the aircraft separated at the end of this period by 0.3nm horizontally and 500ft vertically.
