**AIRPROX REPORT No 2015122**

Date: 31 Jul 2015 Time: 1158Z Position: 5300N 00046W Location: 4nm south of Newark

**PART A: SUMMARY OF INFORMATION REPORTED TO UKAB**

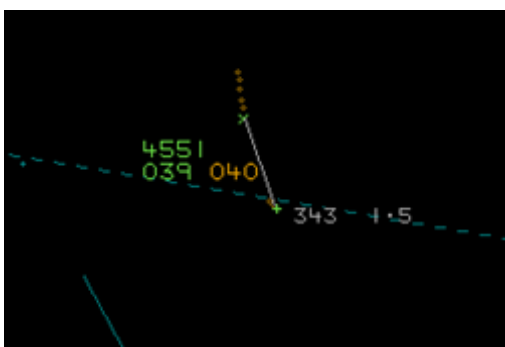
At the time reported by the DA42 pilot in his Airprox report, the DA42 had a primary radar contact in its vicinity on the area radar recording (indicated by leader line on Figure 1 below), but the primary contact disappeared within 10sec of having first appeared. East Midlands ATC also reported in their review of the incident, that a primary contact was visible in close proximity to the DA42 on the controller's radar display.

Figure 1: 1157:48 aircraft changes squawk – (primary contact visible 1.5nm SSE of DA42)

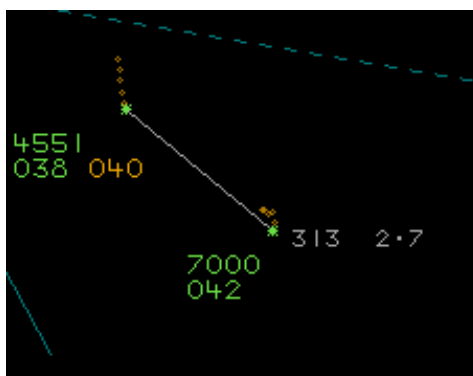
At the time the DA42 was formally identified and a Traffic Service confirmed the controller immediately passed Traffic Information on another contact in the vicinity (Figure 2). This contact was transponding 7000 with Mode C altitude information. There were no other contacts visible in the immediate vicinity of the DA42 on the area radar recording.

Figure 2: 1158:58 DA42 identified and passed Traffic Information on unknown traffic 2.7nm SE
