## AIRPROX REPORT No 2015135

Date: 12 Aug 2015 Time: 1343Z Position: 5415N 00138W Location: Leeming MATZ

### PART A: SUMMARY OF INFORMATION REPORTED TO UKAB

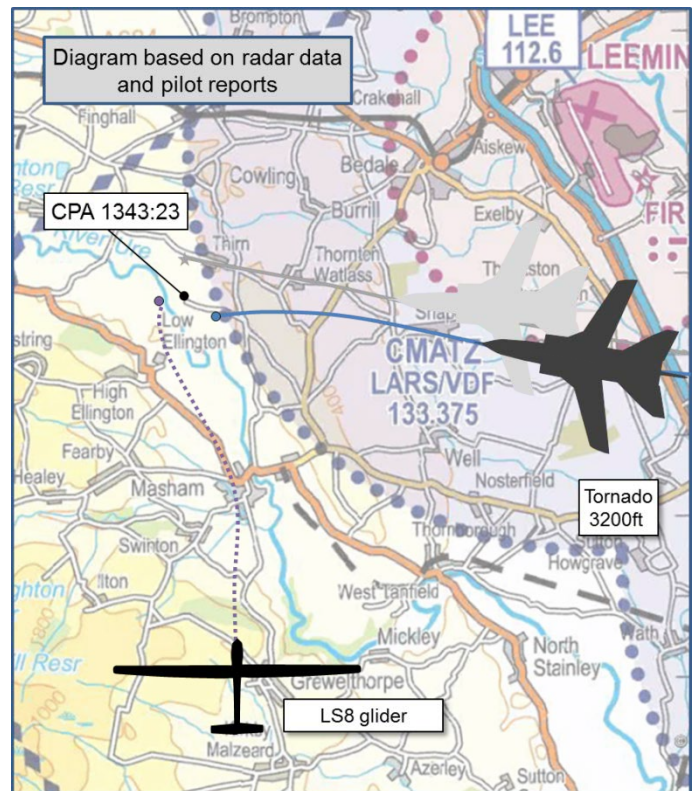
**THE TORNADO PILOT** reports that he was the No.2 in a formation of two Tornados, in the descent from medium altitude to low-level, entering at a point west of Leeming. The formation was receiving a Traffic Service from Leeming in the descent. Initial descent was given to 2700ft to keep clear of traffic in the Leeming MATZ. Whilst in the descent, the lead pilot called for the No.2 to 'bunt' because of an unobserved glider on the nose, 150ft above. The pilot did so and his aircraft passed about 300ft below the glider, which was operating at the base of the clouds. The pilot reported that the glider had been obscured by the canopy bow, and was unknown to Leeming ATC.

**THE LS8 GLIDER PILOT** reports that he was on a cross-country flight; thermal conditions had deteriorated but visibility was excellent. As he approached his turning point at Masham at 2500ft, he decided to continue to fly north to connect with some good looking clouds to the nnw. He approached the cloud at 2200ft and saw a Buzzard circling to his right, so he turned towards it and entered the thermal, circling right to stay in the lift. He completed his first 360° turn when he saw something that at first he thought was the Buzzard but quickly realised was an aircraft approaching from the east. He then recognised it as one of a pair of Tornados, by which time they were abeam and to the north and slightly below him. He was climbing at around 3-400ft per minute at the time; although the time between sighting and closest point of approach was only 1 or 2 seconds, he did not feel that there was a threat of collision, and did not take any avoiding action - he believed that the Tornados didn't either. He continued thermalling, and saw the Tornados disappear up the valley. He did not call RAF

The unit looked at the contributory factors to the incident and found that, for the 28 seconds prior to the incident; the crew lookout had been biased towards the northwest due to previous Traffic Information by ATC. The glider was not transponding, and the pilot had not informed Leeming of his height and position. The incident would be raised at the next Airspace Users Working Group to encourage the glider community to engage with Leeming Zone when flying close to the airfield.

The normal barriers to an Airprox of this nature would be ACAS, lookout and Traffic Information. The Tornados were not fitted with TCAS and the glider was not transponding. Many of the gliders appear to have been detected by Primary Surveillance Radar allowing some information. The unit investigation found that the crew were concentrating their lookout to the right of track following information, expecting traffic to pass 3 miles north of their position. Traffic Information was passed as: northwest at 15nm, 12 o'clock at 5nm, and northwest by 3-5nm, 12 o'clock 1-3nm and then 11 o'clock at 1nm. The updates were constant and it is not known if the Airprox glider was the one called or even appeared on the controller's radar screen. Lookout was crucial to avoid an Airprox, and the limitations of visually acquiring gliders in fast jets are well known. Primus 1 did become visual and quickly advised Primus 2 to bunt to increase separation. See-and-avoid eventually helped separate tracks, albeit with only around 300ft separation.

The Board then looked at the cause of the Airprox and quickly agreed that it was a late sighting by both pilots. Turning to the assessment of risk, Board members agreed that the Tornado pilot's bunt had increased the separation, but they also noted that both pilots had assessed that the two aircraft would not have collided even if the Tornado pilot had not taken any action. Furthermore, they noted that the glider pilot had not felt the need to take avoiding action himself. Therefore, the Board assessed the risk as Category C; effective avoiding action had been taken.

Cause: A late sighting by both pilots.
