AIRPROX REPORT No 2015134

Date: 29 Jul 2015 Time: 1328Z Position: 5426N 00058W Location: 17nm ESE Newcastle

PART A: SUMMARY OF INFORMATION REPORTED TO UKAB

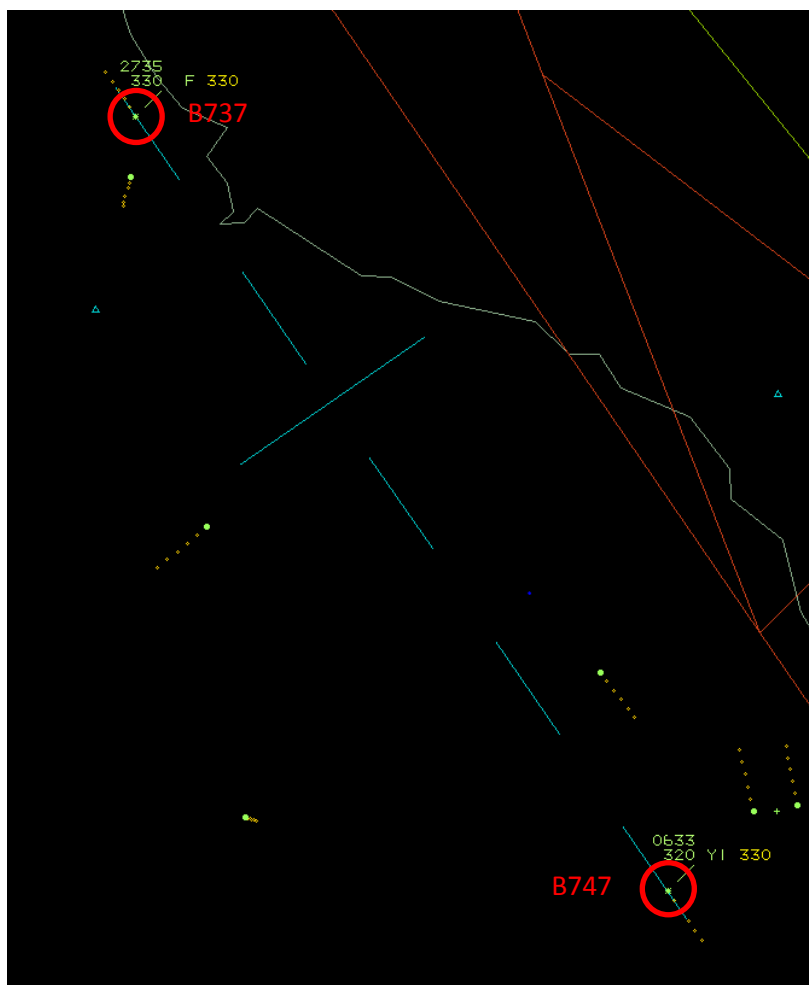
Figure 1: 1325:15, B737 squawk 2735, B747 squawk 0633

At 1325:15, the B737 was southeast bound, level at FL330 with the B747 north-west bound, 41.7nm southeast of the B737 at FL320 (see Figure 1). The B747 pilot requested a climb to FL340, but due to other conflicting traffic was only cleared to FL330.

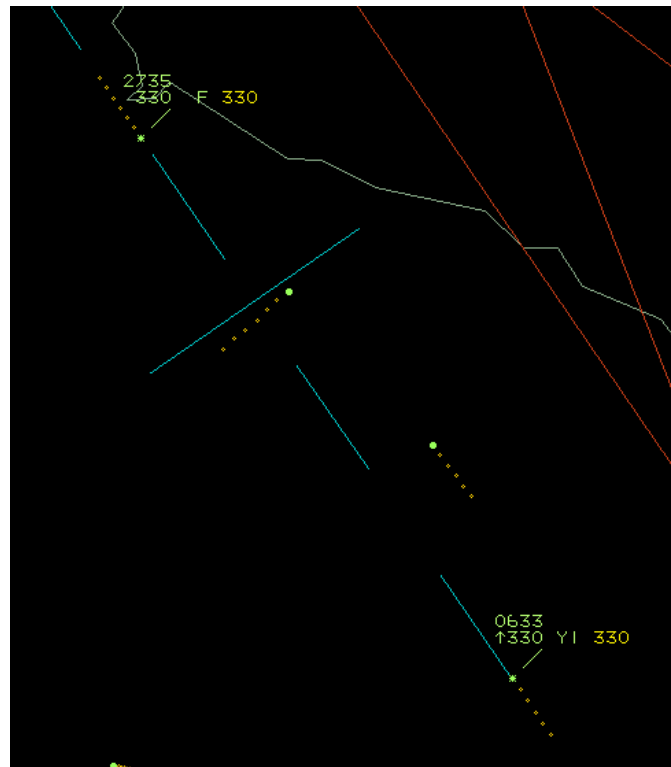
Figure 2: 1326:19

At 1326:19, the B747 levelled-off at FL330, with both aircraft now 25nm apart (see Figure 2).

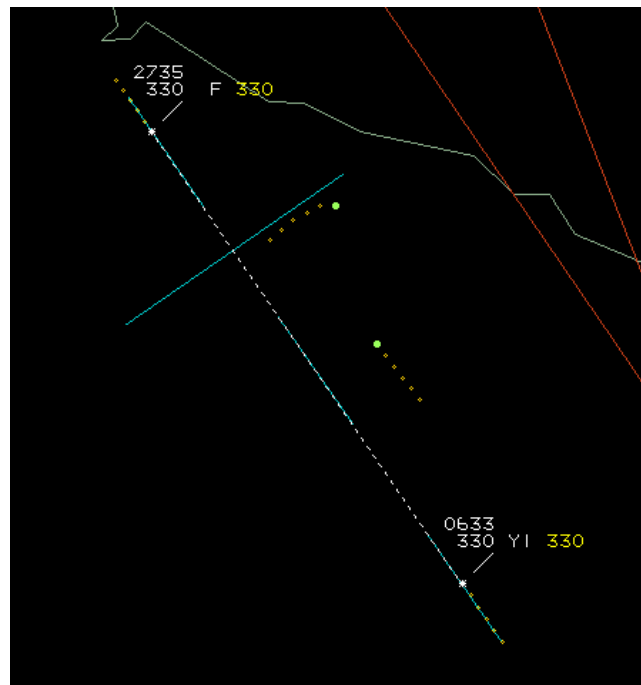
Figure 3: 1326:39

At 1326:39, a Low Level STCA appeared on the controller's display (see Figure 3).

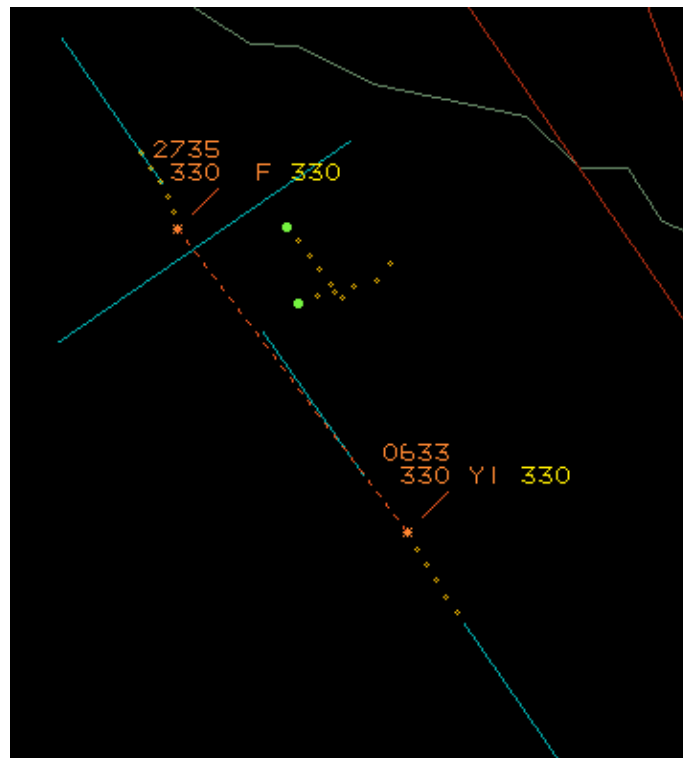
Figure 4: 1327:20

Another pilot called on frequency which was ignored by the controller who, following the initiation of High Level STCA on his display at 1327:20 (see Figure 4), issued an avoiding action right turn to the B747 pilot, on to a heading of 090°, with the B737 10.7nm ahead, which was observed to be commencing a right turn.

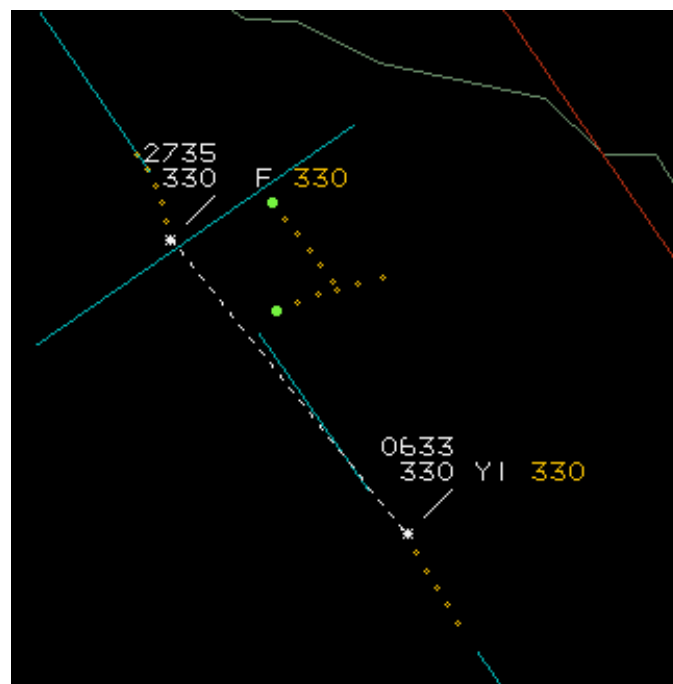
Figure 5: 1327:25

At 1327:25, the STCA was downgraded to a Low Level alert (see Figure 5).

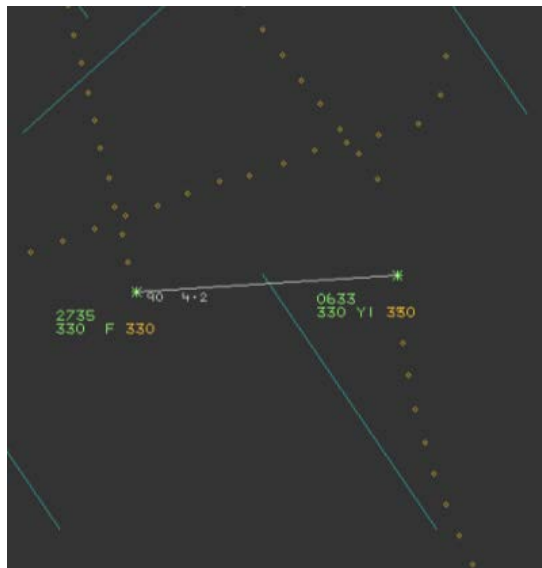
Figure 6: 1327:55.

CPA was at 1327:55 with the aircraft separated by 4.2nm with both aircraft at the same level (see Figure 6).
