AIRPROX REPORT No 2015138

Date: 15 Aug 2015 Time: 1656Z Position: 5117N 00009W Location: M25 N abeam Redhill

PART A: SUMMARY OF INFORMATION REPORTED TO UKAB

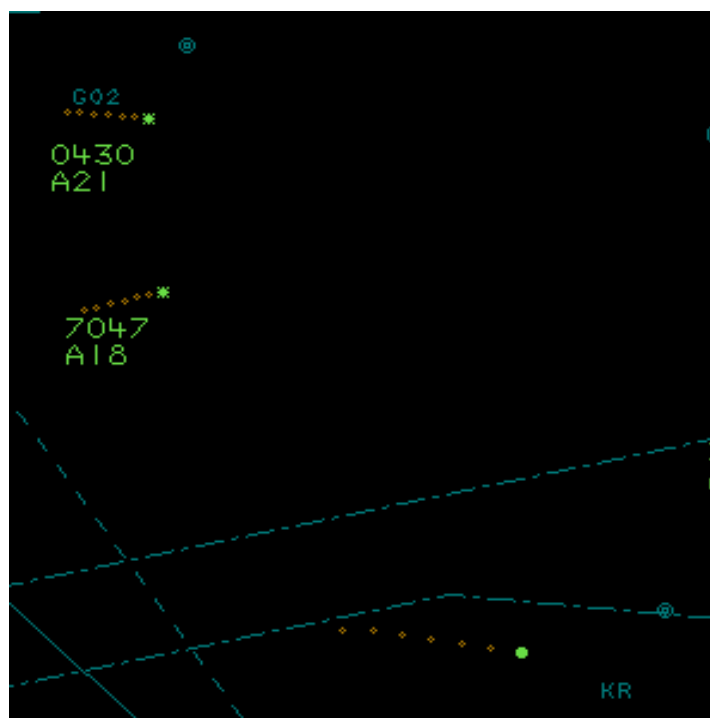
Figure 1: at 1653:30

A review of the Radar data was used to identify the aircraft: the C172 was squawking 7047 and the PA28 was squawking 0430 (Figure 1 – Redhill Airfield bottom right, annotated ‘KR’).

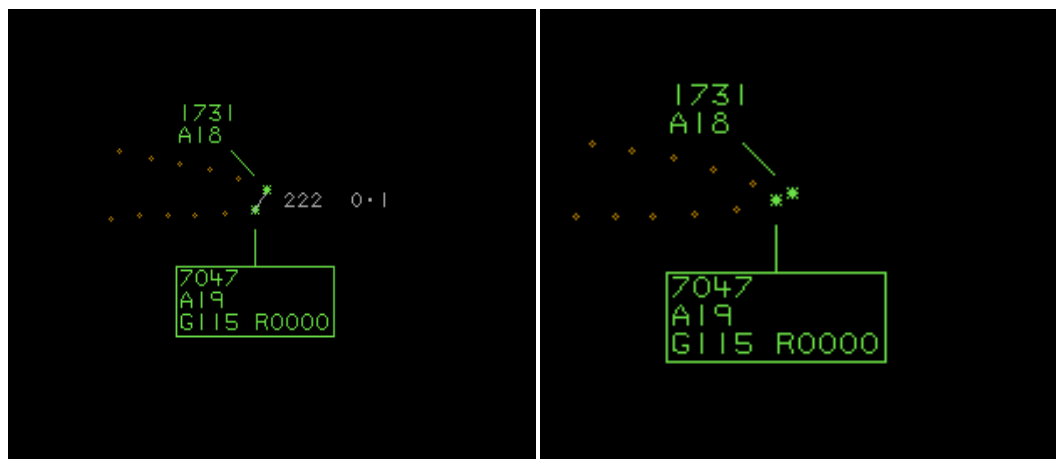
Figure 2.

Figures 2 and Figure 3 show two consecutive Radar sweeps made at 1655:50 and 1655:56 respectively. The CPA occurred at Figure 3, when the aircraft were less than 0.1nm horizontally and 100ft vertically apart. There was no mention of the event on the radio and Biggin Hill were not aware that an Airprox had occurred.
