AIRPROX REPORT No 2015156

Date: 30 Aug 2015 Time: 1235Z Position: 5558N 00358W Location: Cumbernauld Aerodrome

PART A: SUMMARY OF INFORMATION REPORTED TO UKAB

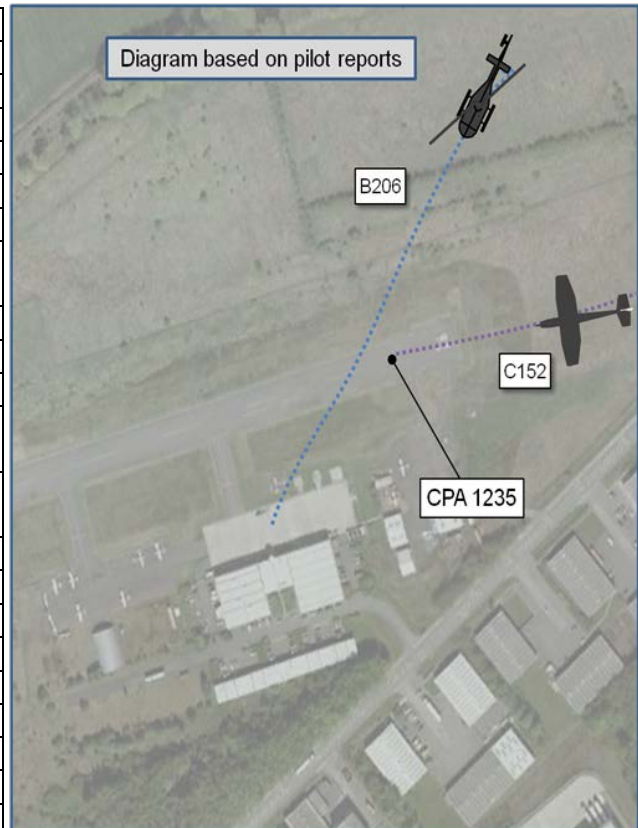
THE C152 PILOT reports that whilst returning to Cumbernauld he changed from Scottish information to Cumbernauld radio at the southern edge of Stirling, and proceeded south towards Denny. He received airfield information from Cumbernauld radio upon reaching Denny, and was informed that there was no known traffic to affect. Joining the circuit on right base, he began to hear calls from the B206 with various messages being passed, some non-standard R/T such as 'tight right base' and finally being 'number two'. The B206 indicated that he had visual on the C152, and the C152 pilot made all the standard calls at the correct time and place. He could not see the B206 on his final approach until he was on short final. The B206, at approx 200ft AGL, cut across the runway at right angles from north to south (right to left in the C152 pilots view) slowing over the runway, and finally hovering off to the left-hand side of RW26. He continued his approach but, upon reaching the threshold and on beginning to round out, he was caught in the B206 downwash, he began to lose control of the aircraft, experiencing a wing drop. He immediately applied full power and managed to recover enough to execute a go around. He completed a circuit and landed without incident.

The C152 was joining Cumbernauld ATZ from the north for an approach to RW26 to land and called the Cumbernauld Air/Ground Operator at 1228:24. The C152 pilot was told there was no known traffic and subsequently reported right base for RW26 at 1231:51. At 1232:42 the B206 pilot called inbound from the north and was told about a C152 joining from the north onto right-base. At 1233:37, the B206 pilot reported tight right-base and visual with the C152, who's pilot immediately reported finals and was issued the surface wind. At 1234:11, the B206 pilot reported final and, at 1235:00, the C152 pilot reported a wake turbulence encounter.

An Airprox was reported when a C152 and a B206 flew into proximity at 1235 on Sunday 30th August 2015. Both pilots were operating under VFR in VMC; both pilots were on the Cumbernauld Air/Ground radio frequency in the visual circuit. The C152 pilot, upon being informed that there was no known traffic to affect his join, opted for a right base join for RW26. Shortly afterwards, the B206 also joined right base; when the B206 was closer to the aerodrome he repositioned in the circuit to cross the runway ahead of the C152 and land on the grass landing area. The C152 pilot only saw the B206 when the C152 was on short final to the runway. The C152 pilot continued his approach and, when rounding out over the threshold, began to lose control; he commenced a go-around and recovered the aircraft safely.

Upon reviewing the C152 video recording, the Board quickly determined that the B206 had indeed cut across the C152 on approach much closer than would have been desirable. That being said, and notwithstanding that the C152 pilot clearly experienced a degree of wing-drop during the final stages of the landing, it did not seem to GA members that the time separation between the aircraft was necessarily the cause of the wing-drop. Helicopter pilot members were also somewhat sceptical that the downwash of a B206 would have such an effect given the separation between the 2 aircraft, but stressed that the actual local wind conditions could not be known and might conceivably have exacerbated any effects. In the end, the Board could not come to any definitive conclusions about the downwash and its effect on the C152.

In discussing the cause and risk of the incident, the Board quickly agreed that the cause was that the B206 pilot had not conformed to the traffic pattern. Although the B206 had come into proximity with the C152, the Board's review of the associated video caused them to determine that no risk of collision had existed (although they acknowledged that the potential for an incident resulting from the downwash was present). The Board therefore assessed the collision risk as Category C.
