AIRPROX REPORT No 2015180

Date: 9 Oct 2015 Time: 1635Z Position: 5110N 00040W Location: 5nm SW Guildford

PART A: SUMMARY OF INFORMATION REPORTED TO UKAB

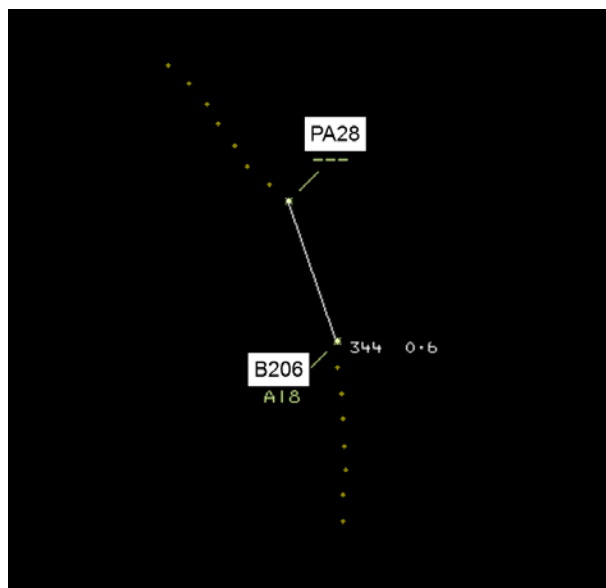
Figure 1: 1634:21

At 1634:15, another pilot advised Farnborough LARS (W) that they were going to change to another frequency. The Farnborough controller instructed them to standby and, at 1634:21 (Figure 1), commenced passing Traffic Information on the PA28 to the B206 pilot.

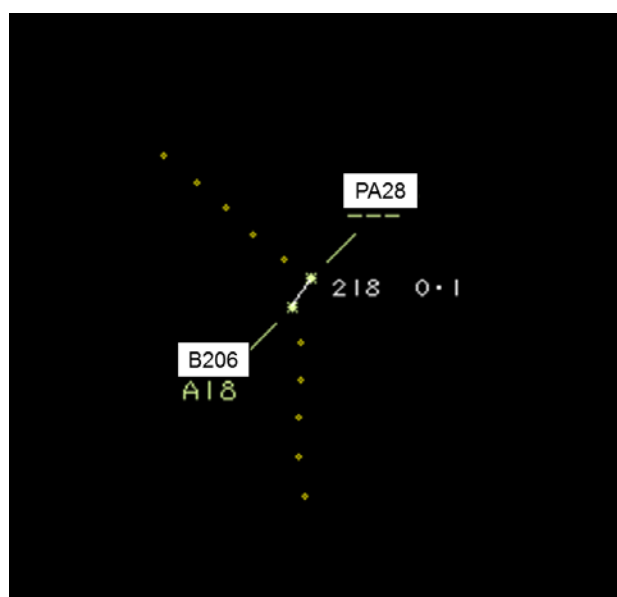
Figure 2: 1634:32

The B206 pilot momentarily keyed his transmit switch but did not reply until asked by the controller if he was visual, which the B206 pilot confirmed at 1634:32. Reciprocal information was then passed to the PA28 pilot at 1634:37, and the sighting of the B206 by the PA28 pilot was confirmed at 1634:42. CPA was at 1634:32 (Figure 2) with the aircraft separated by less than 0.1nm horizontally.
