AIRPROX REPORT No 2015192

Date: 18 Oct 2015 Time: 1338Z Position: 5139N 00203W Location: Kemble Airfield

PART A: SUMMARY OF INFORMATION REPORTED TO UKAB

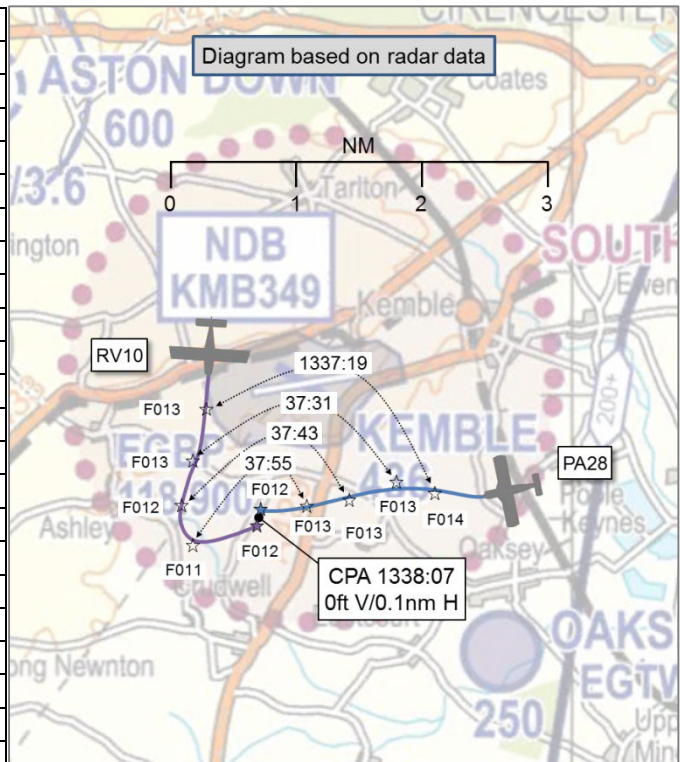
An Airprox was reported when a PA28 and a Vans RV10 flew into proximity downwind at Kemble at 1338 on Sunday 18th October 2015. Both pilots were operating under VFR in VMC, both in receipt of an Airfield Flight Information Service from Kemble Tower. The RV10 had mistakenly joined for the reciprocal runway.

Members quickly agreed that the RV10 pilot had mistakenly flown a left-hand overhead join for RW26 and had flown into conflict with the PA28, downwind right-hand for RW08, the notified runway in use. Members commended the RV10 pilot for his open and honest report, and commented that this incident served as a valuable lesson in human fallibility and the need, whenever possible, to double-check one's actions. In this case, the RV10 pilot could have been alerted to his mistake when he turned to the left in the overhead, the opposite direction to the notified circuit pattern. The simple prompt 'circuit to the right, keep the airfield to the right' (substitute with 'left' as appropriate) during overhead joins has saved the day for many pilots. In the event, both pilots saw each other at about the same time, and the RV10 pilot took avoiding action. Some members felt that safety margins had been much reduced but, by a narrow margin, the majority felt that this was not the case and that the RV10 pilot's avoiding action had been sufficiently timely and effective.

Cause: The RV10 pilot mistakenly joined for the reciprocal runway and flew into conflict with the PA28.

Degree of Risk: C.
