AIRPROX REPORT No 2015197

Date: 27 Oct 2015 Time: 0936Z Position: 5815N 00257W Location: 15nm SSE Wick

PART A: SUMMARY OF INFORMATION REPORTED TO UKAB

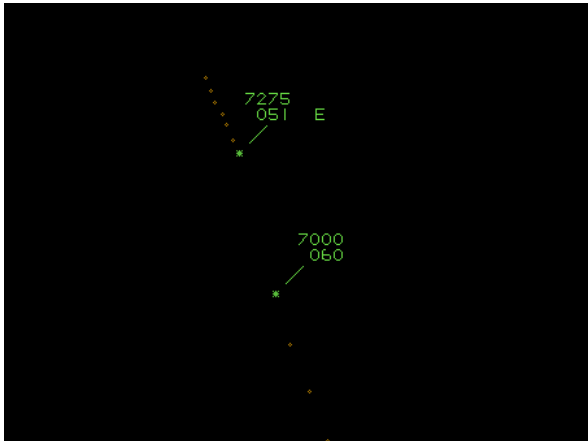
Figure 1: Prestwick Radar at 0936:24

At 0936:19 the controller asked the C172 for a position report. The pilot replied at 0936:24 by saying he was 12.5NM from Wick and passing FL52 climbing. (Figure 1). The controller immediately responded with an instruction to maintain FL50 as there was traffic above. CPA occurred at 0936:30 (Figure 2).

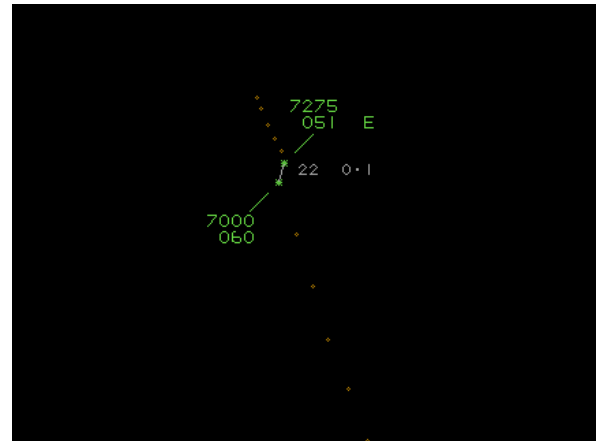
Figure 2: Prestwick Radar at 0936:30

Turning to the cause and risk, the Board quickly agreed that the cause of the Airprox was that the C172 pilot had climbed through his cleared level and into conflict with the JS41. The Board then discussed the risk, and determined that effective and timely action had been taken by Wick ATC to resolve the situation; therefore, the risk was assessed as Category C.

Cause: The C172 pilot climbed through his cleared level and flew into conflict with the JS41.
