AIRPROX REPORT No 2014042Date/Time: 14 Apr 2014 1315ZPosition: 52 11N 000 13W
(3.8nm W of Gransden Lodge)Airspace: London FIR (Class: G)Aircraft 1 Aircraft 2Type: Ventus CT Robin DR400Operator: Civ Club Civ ClubAlt/FL: 2430ft 2000ft
QFE (1014hPa) NKConditions: VMC VMCVisibility: >10km 10nmReported Separation:

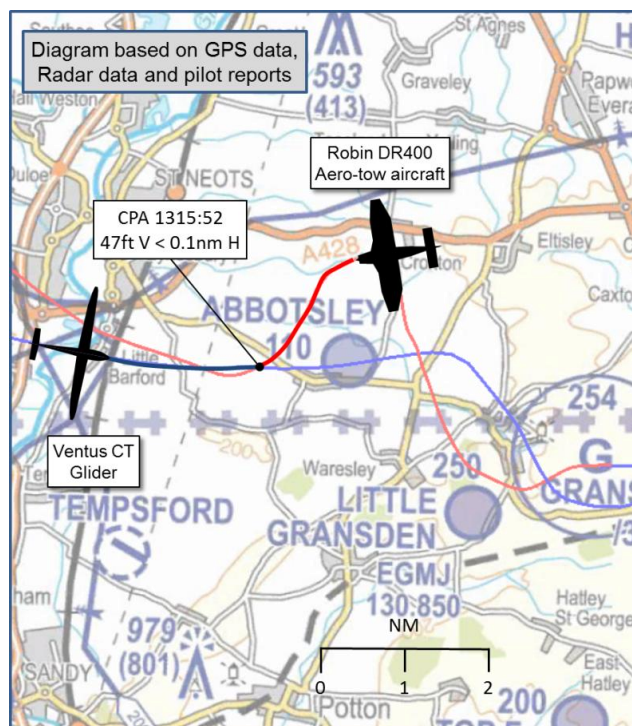
50ft V/50m H NK

Recorded Separation: 47ft V/<0.1nm H

An Airprox was reported 3.8nm to the west of Gransden Lodge Glider Site, in Class G airspace, between a Ventus CT glider and a Robin DR400-180R, which was trailing a tow-rope having been engaged in aero-tow duties. The Ventus pilot saw the Robin and took avoiding action; the Robin pilot did not see the Ventus. The radar replay and GPS logger files indicated a CPA of <0.1nm and 47ft.
