AIRPROX REPORT No 2014095**Date/Time:** 19 Jun 2014 1445Z**Position:** 5150N 00123W
(5nm NE Brize Norton)**Airspace:** Oxford AIAA (Class: G)**Aircraft 1** **Aircraft 2****Type:** Merlin PA34**Operator:** HQ JHC Civ Trg**Alt/FL:** 1000ft 1300ft
QNH (1023hPa) QNH (1023hPa)**Conditions:** VMC VMC**Visibility:** 10k 9k**Reported Separation:**

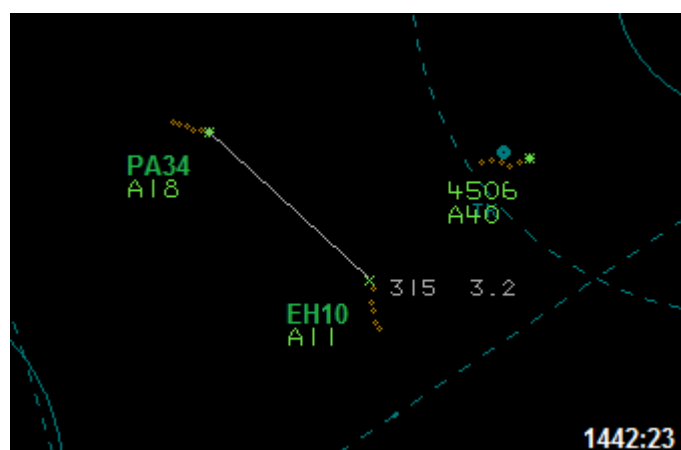
Figure 1. (EH10 = Merlin)

The PA34 pilot was conducting the NDB DME 100 procedure under a Traffic Service agreed at 1414:30 and at 1442:23 reported that they were passing four miles (Figure 1). The Merlin was 3.2nm southeast of the PA34, tracking north, indicating 1100ft. The Oxford Radar controller had initiated a phonecall to Brize Norton to co-ordinate other traffic and was on the phone when the PA34 reported at 4nm. The PA34 was instructed to contact Oxford Tower.

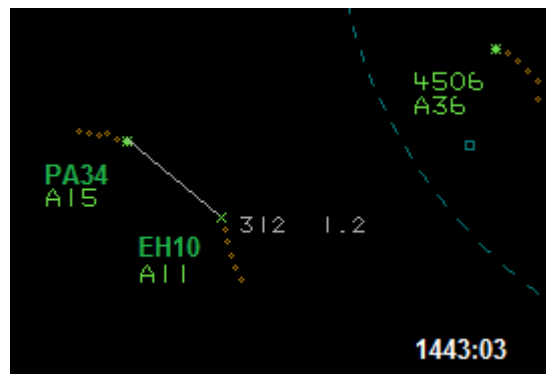
Figure 2.

At 1442:37, the PA34 pilot reported base turn complete, passing four miles, to Oxford Tower and was instructed to report downwind right-hand low level which was read back correctly. The two aircraft continued to converge. At 1443:03 the Oxford Radar controller, who was engaged on another operational phonecall, passed Traffic Information on the Merlin to the traffic squawking 4506 (Figure 2).

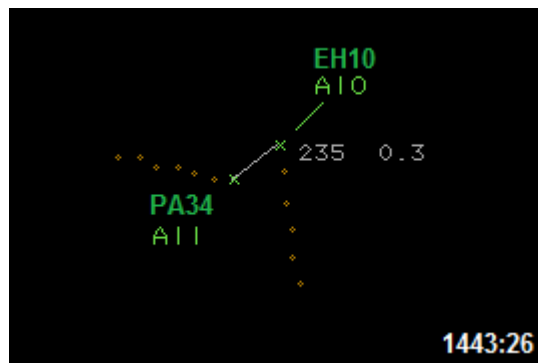
Figure 3.

The Oxford Radar controller then attempted to pass Traffic Information on the Merlin to the PA34 pilot before realising that the PA34 had already transferred to the Tower. The Oxford Radar controller was heard to comment “*bet he’s got traffic on that in the tower*”. There were no transmissions made on the Oxford Tower frequency after the PA34 pilot read back the instruction to report downwind until, at 1443:26 the PA34 pilot reported that a helicopter had just flown in front of them (Figure 3). This was acknowledged by the Tower controller who stated that it looked like a military helicopter. CPA occurred shortly afterwards as the Merlin turned left and was measured as 0.2nm/100ft.

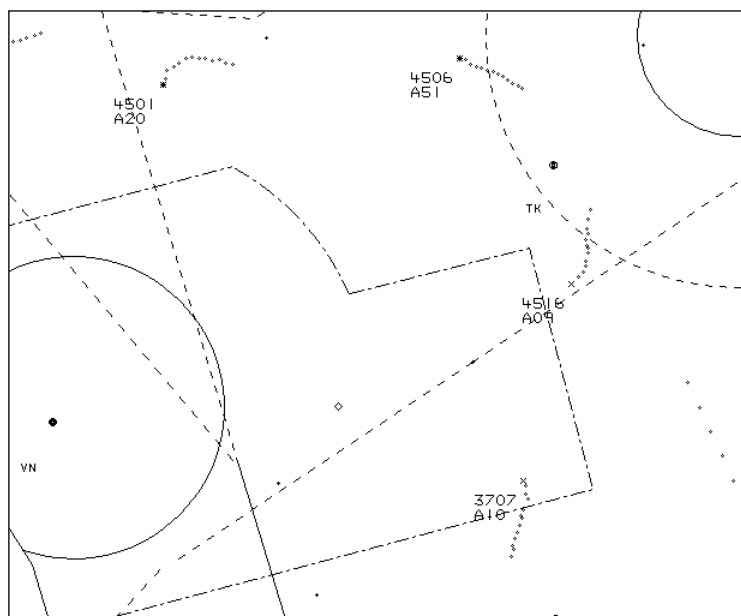
At 1435:14, the Merlin was cleared to cross the Brize Zone not above 1300ft Brize QNH 1023hPa, maintaining VMC. At 1440:07, traffic was called as, *“traffic north three miles manoeuvring, indicating two hundred feet below believed to be ah in the visual circuit for Oxford.”* The Merlin reported looking for the traffic (Figure 4) .

Figure 4: Traffic Information at 1440:07 (Merlin squawk 3707, non-airprox traffic 4516; PA34 squawk 4501).

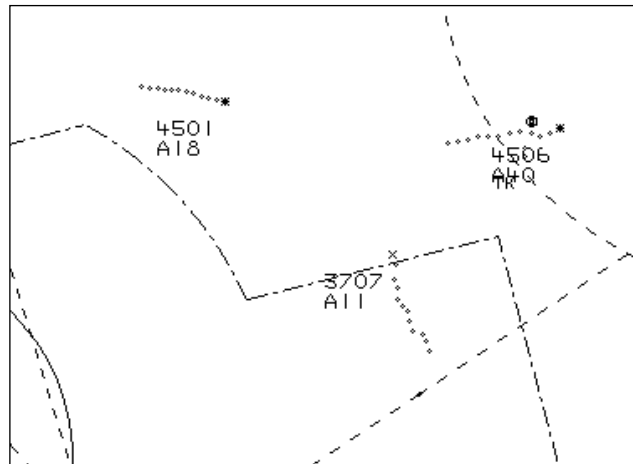
At 1442:24, the Merlin departed the Brize Zone and reverted to a Basic Service (Figure 5) .

Figure 5: Geometry 1442:24 as the Merlin departed the Brize Zone.

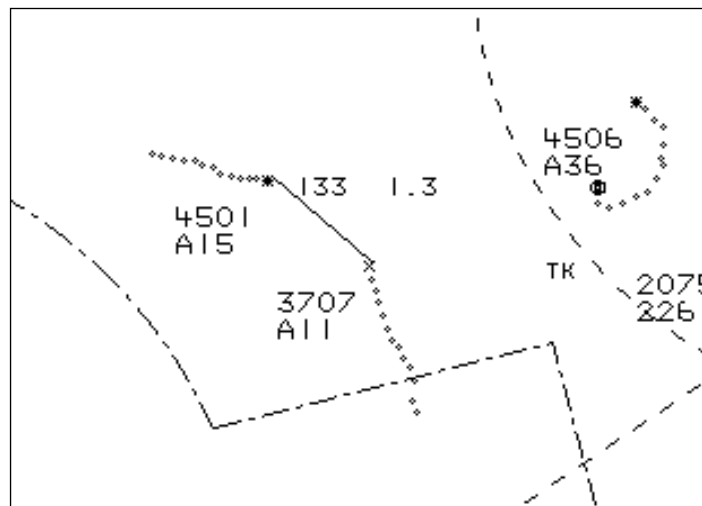
At 1442:58, the Merlin declared clear of the Brize Zone, squawking 7000 and changing to the en-route frequency (Figure 6).

Figure 6: Geometry at 1442:58 as the Merlin reported intention to change to en-route frequency.

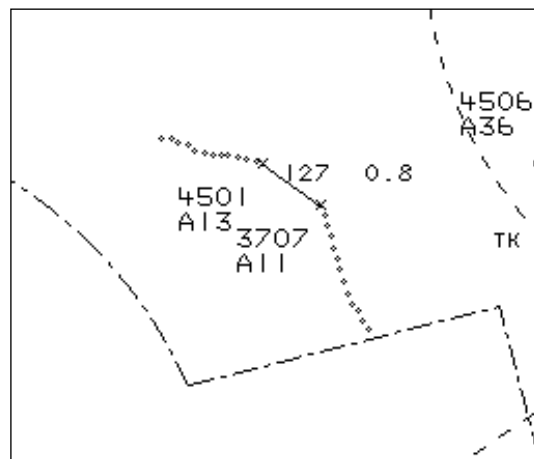
At 1443:12, the controller replied with, “[Merlin c/s] roger, traffic northwest half a mile crossing left right ah indicating two hundred feet above descending.” The Merlin pilot replied with, “looking” (Figure 7).

Figure 7: At 1443:12 Traffic Information from Brize.

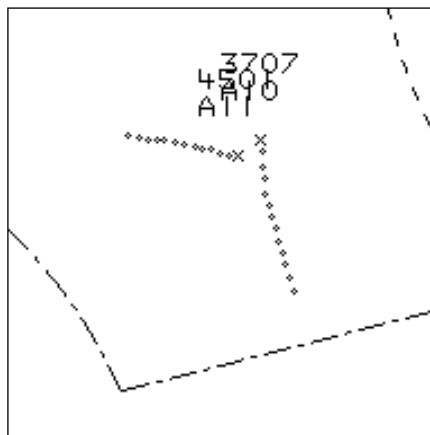
The CPA on radar replay was at 1443:28 with 100ft height separation and 0.2nms lateral separation (Figure 8) .

Figure 8: CPA at 1443:28.
