AIRPROX REPORT No 2014121

Date/Time: 21 Jul 2014 1426Z

Position: 5302N 00026W
(RAF Cranwell)

Airspace: Cranwell ATZ (Class: G)

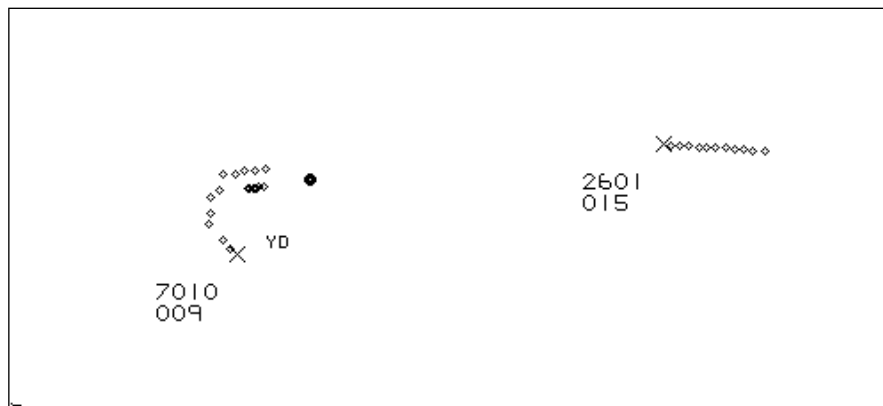
At 1425:09, the King Air pilot called downwind with the Tutor at 4.5nm on final approach, Figure 1.

Figure 1: Geometry at 1425:09 King Air downwind call (King Air 7010, Tutor 2601)

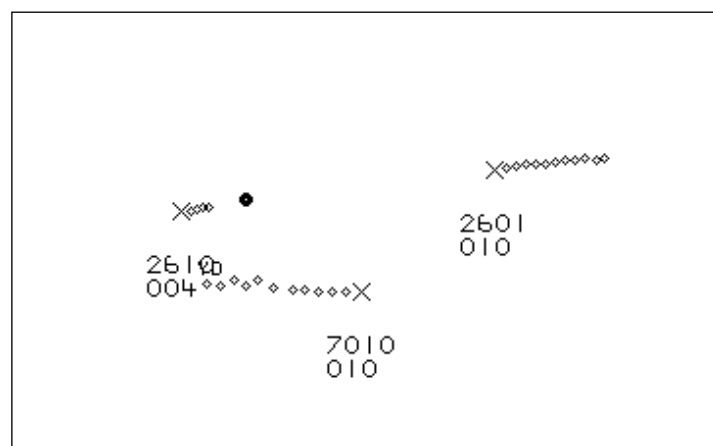
At 1426:05, the Tower controller broadcasted that the Tutor was at 3nm and continuing the instrument approach, Figure 2.

Figure 2: Geometry at 1426:05 with Tutor 3 nm call

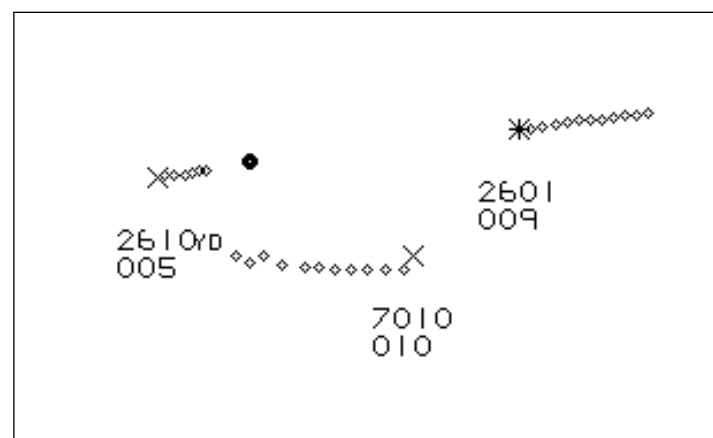
The King Air pilot called finals at 1426:12, Figure 3.

Figure 3: Geometry at 1426:12 as King Air pilot called finals

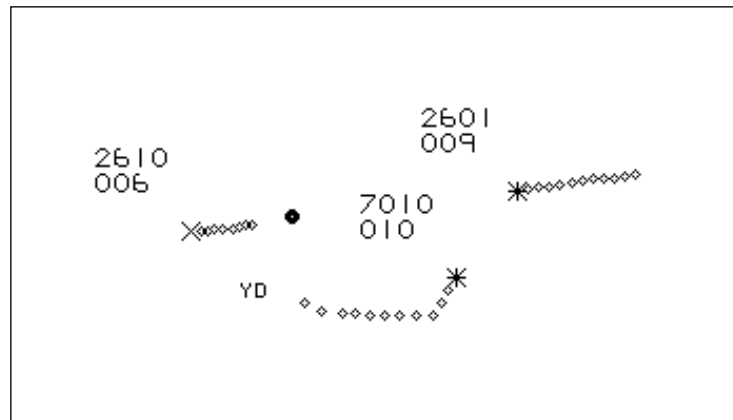
The King Air pilot was instructed to 'go around circuit height' at 1426:21, Figure 4.

Figure 4: Geometry at 1426:21 as King Air pilot instructed to 'go around circuit height'

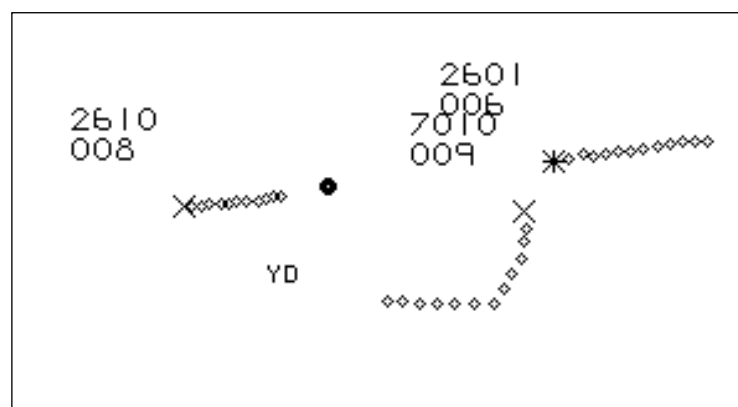
At 1426:30, the Tutor pilot broadcast that he was breaking clear of the King Air. The CPA on radar replay was at 1426:38 with 0.5nm lateral separation at the same height, Figure 5.

Figure 5: Tutor initiated avoiding action at 1426:30
