AIRPROX REPORT No 2014131

Date/Time: 11 Jul 2014 1515Z

Position: 5237N 00102W
(Leicester Aerodrome
- elevation 469ft)

Airspace: Leicester ATZ (Class: G)

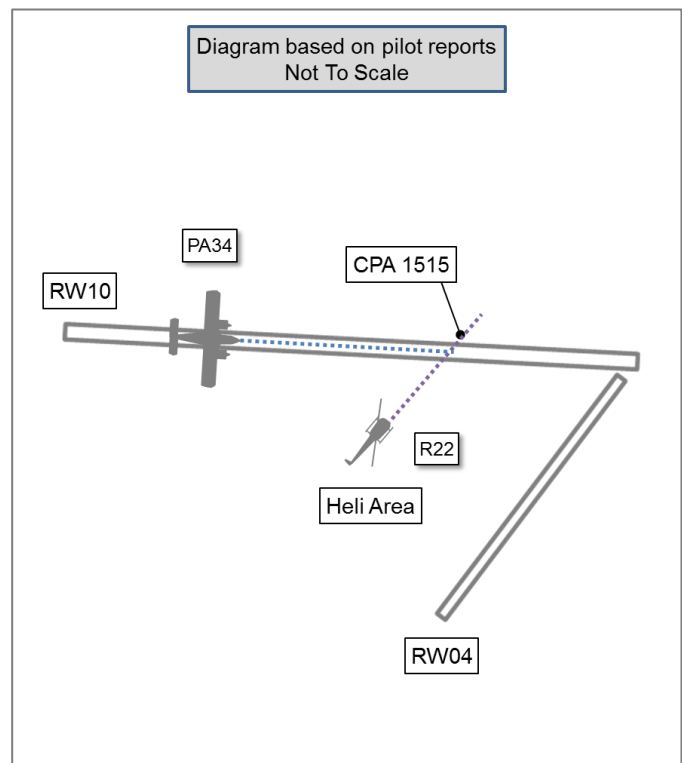
The Airprox occurred within Class G airspace of the Leicester ATZ. Both pilots reported that they had made appropriate RT calls on the A/G frequency. The PA34 pilot was conducting circuits on the main RW10 as the runway in use (RW04) was too short for his type of aircraft. The R22's pilot departed from RW04 not realising that the PA34 was on final approach to RW10. The pilot of the R22 reported sighting the PA34 when he was climbing out. At that time the PA34 was in the downwind position RW10. The pilot of the PA34 reported that he was visual with the R22 departing and considered that he took appropriate action to resolve the situation by initially changing his intention of carrying out a touch-and-go into making a full-stop landing. He only reverted to his original intention after the R22 had cleared RW10.

Cause: The R22 pilot flew across an active runway and in front of the PA34.

Degree of Risk: C.
