AIRPROX REPORT No 2014133

Date/Time: 3 Aug 2014 1114Z (Sunday)

Position: 5129N 00020E
(3.5nm SSW of Thurrock)

Type: Fournier RF5 PA28
Motorglider

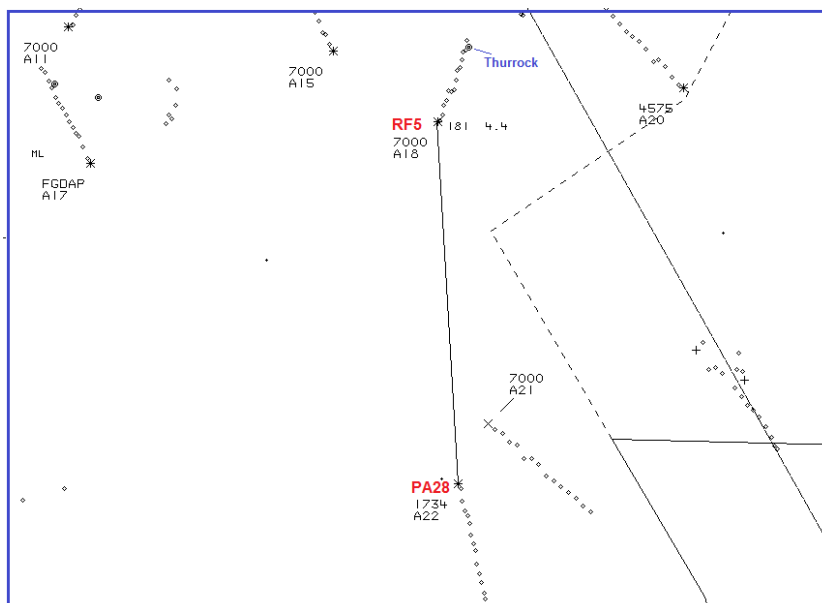
Figure 1 – Swanwick MRT at 1112:44

At 1112:44 the PA28 had reported this traffic in sight and the controller then passed Traffic Information on an aircraft approaching from the north [the RF5], “(PA28)c/s further traffic north of you four miles southbound one thousand eight hundred feet not working this unit”. There was no response from the PA28 pilot. The RF5, squawking 7000, was 1nm south-southwest of Thurrock airfield, tracking south at an altitude of 1800ft and in the PA28’s half past twelve at a range of 4.4nm – Figure 1.

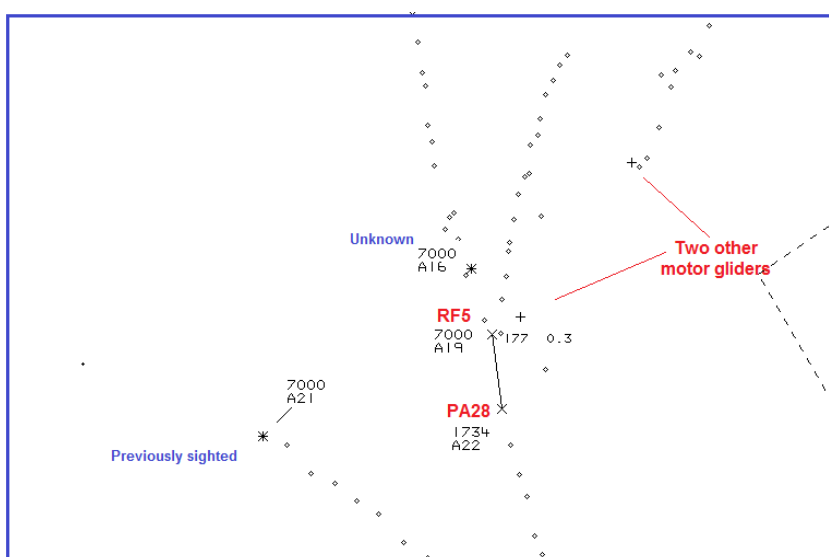
Figure 2 – Swanwick MRT at 1114:12

At 1114:10 the controller updated the Traffic Information “(PA28)c/s the other traffic is just north of you range less than a mile pass [1114:20] on your righthand side further traffic west of you one and a half miles two thousand one hundred feet”. There was no response from the PA28 pilot. Radar showed the vertical distance between the two aircraft was 300ft – Figure 2.

It is likely that the two aircraft passed abeam each other whilst Farnborough were transmitting the Traffic Information. The PA28 pilot's written report indicated that the RF5 passed at high speed from right to left, immediately in front of and slightly below.
