AIRPROX REPORT No 2014157**Date/Time:** 21 Aug 2014 0837Z**Position:** 5137N 00012W
(5.25nm SE Elstree)**Airspace:** London FIR (Class: G)**Aircraft 1** **Aircraft 2****Type:** HS125 Untraced Light Aircraft**Operator:** HQ Air (Ops) Unknown**Alt/FL:** 2100ft NK
QNH (1016hPa)**Conditions:** VMC NK**Visibility:** 30km NK**Reported Separation:**
0ft V/50m H NK V/NK H**Recorded Separation:**

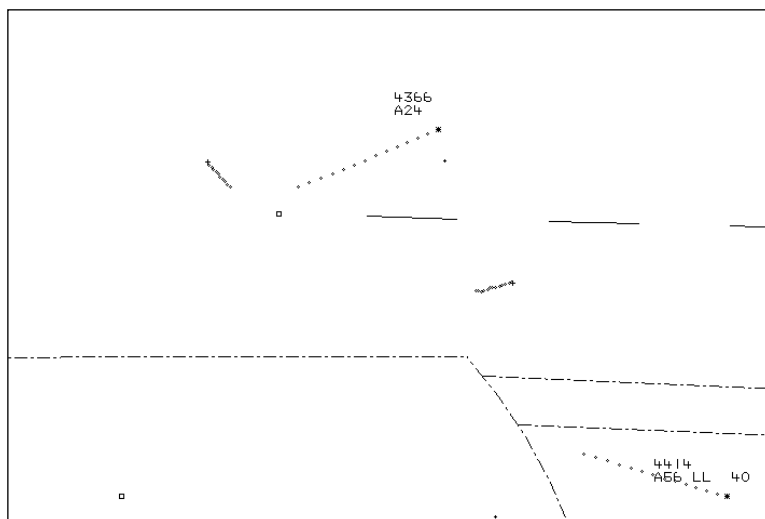
The Traffic Information was passed as 'southeast, 3nm, no height' (Figure 1).

Figure 1: Traffic Information at 0835:32; radar replay at 0838:05; Primary contact southeast at 3nms (BAE125 squawking 4366).

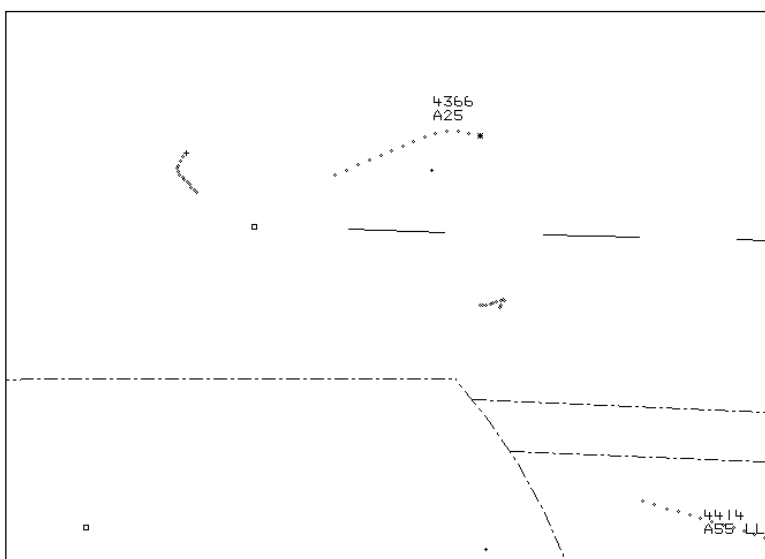
The next instruction from the controller was to turn right onto 220° to pick up the ILS Localiser. The conflicting traffic can be viewed by its trail but the primary contact had disappeared from radar.

Figure 2: At 0835:51 on transcript and 0838:25 on radar replay as the BAE 125 is in the right turn.

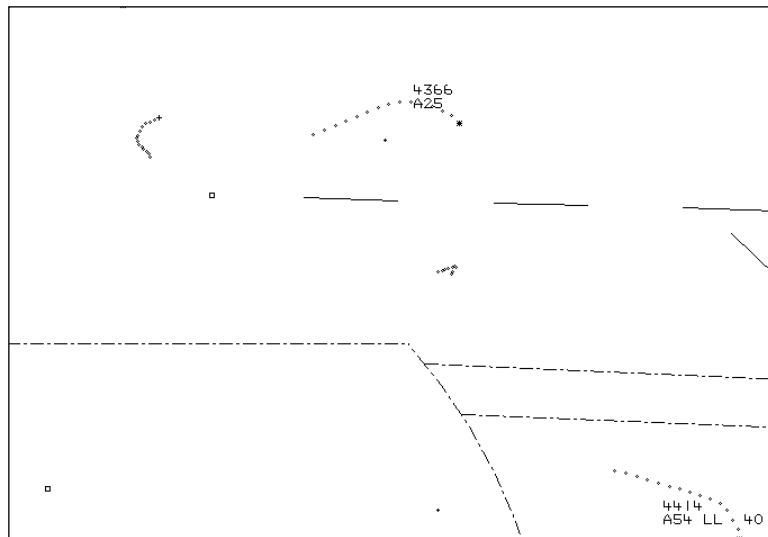
The conflictor had faded from radar and the information was passed to the pilot as 'south, 2.5nm, height unknown' (Figure 3).

Figure 3: At 0836:20 on transcript and at 0838:34 on radar replay, as the controller reported the conflict fade from radar.

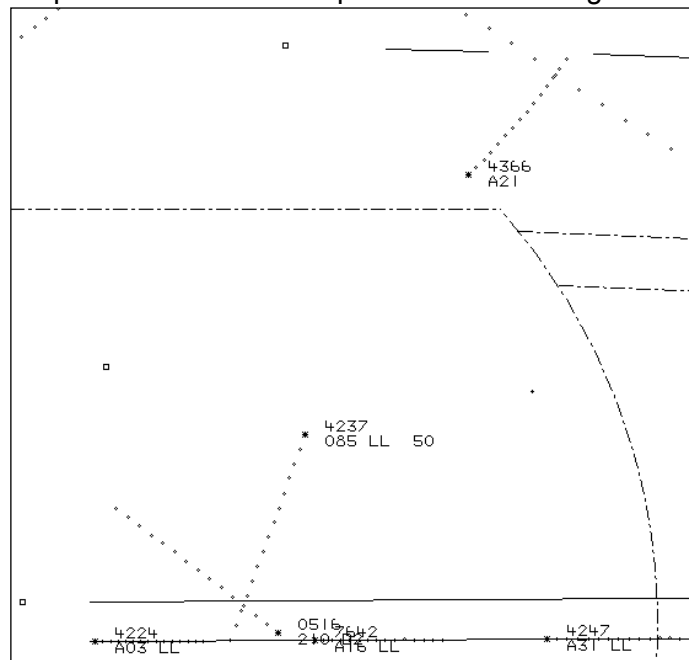
The crew declared the Airprox in their 5 o'clock position with nothing showing on radar (Figure 4).

Figure 4: At 0837:58 on transcript and estimated at 0840:06 on radar replay, as Airprox is reported by the crew.
